National Transportation Safety Board  
Office of Aviation Safety  
Washington, DC 20594

WPR23FA034

**INVESTIGATIVE SUPPLEMENTAL MATERIAL**

Location: Snohomish, Washington  
Date: 11/18/2022  
Time: 1019 Pacific standard time  
Airplane: Cessna 208B EX Caravan

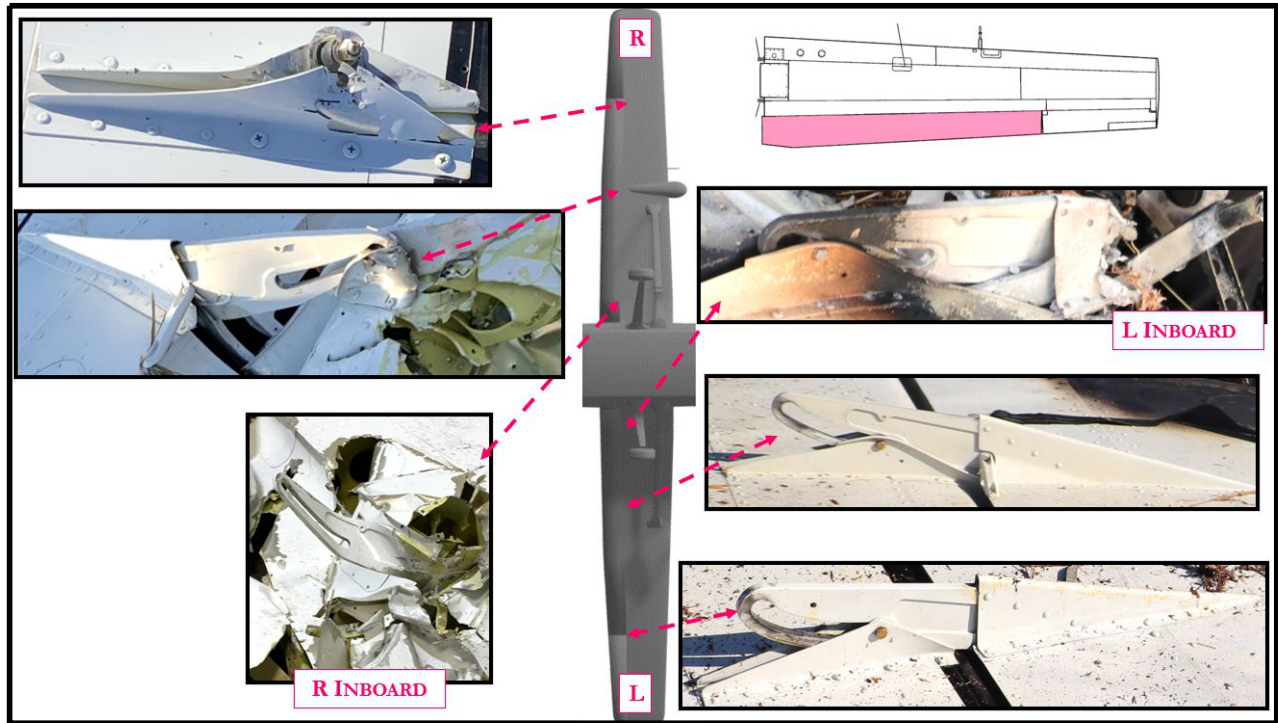
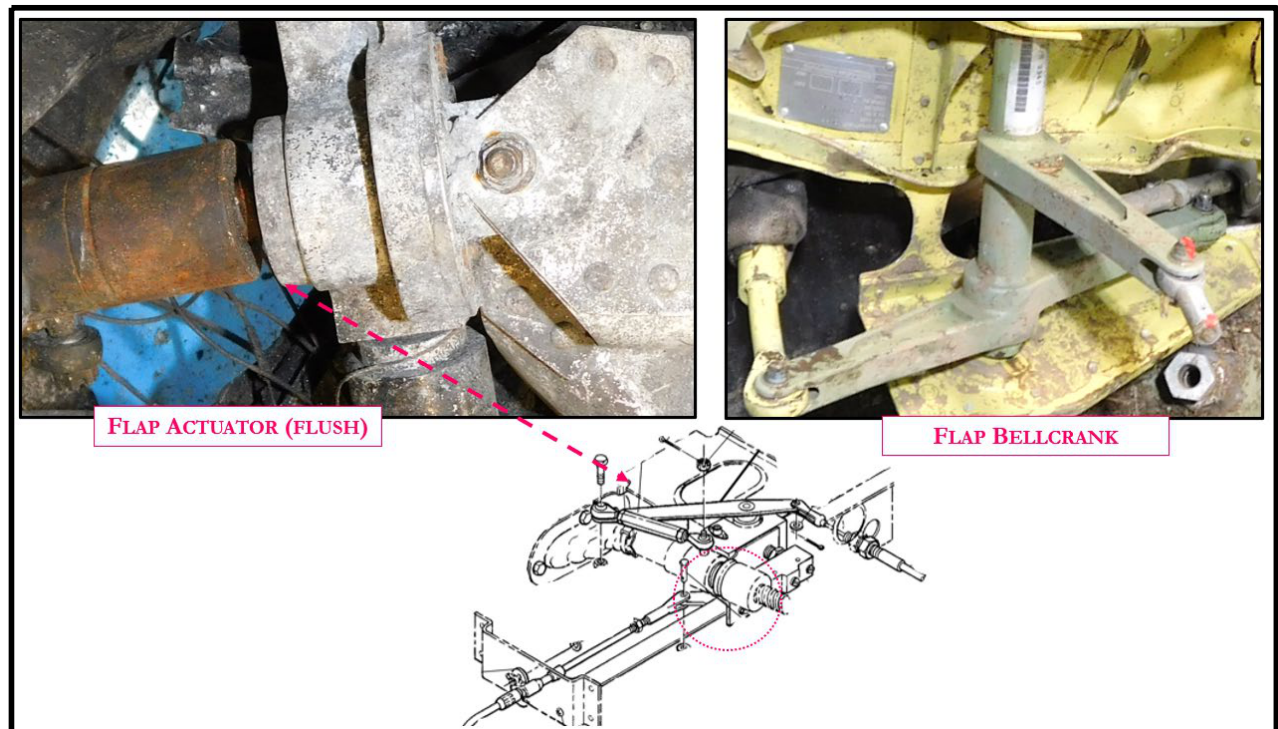
The right wing flap was severely fragmented, exhibiting numerous diagonal cuts that created a saw-like pattern. The outboard flap attach point was deformed, and the corresponding flap surface remained intact for about 6 feet. The inboard portion of this section was cut diagonally, with a rough and jagged edge that extended up into the flap.

Five fences remained attached to that section of the flap. The mid-flap attach point remained affixed to a section of the control surface measuring approximately 3 feet. The control rod was bent inward and remained attached to the bell crank, with the control rod at the bell crank continuing inboard. The inboard flap attach point was deformed, and the control surface was not attached. The flap motor jackscrew, located in the upper cabin, was found flush, consistent with the flaps being fully down.

Figure 24: Flap attach points

Figure 25: Flap actuator and bellcrank

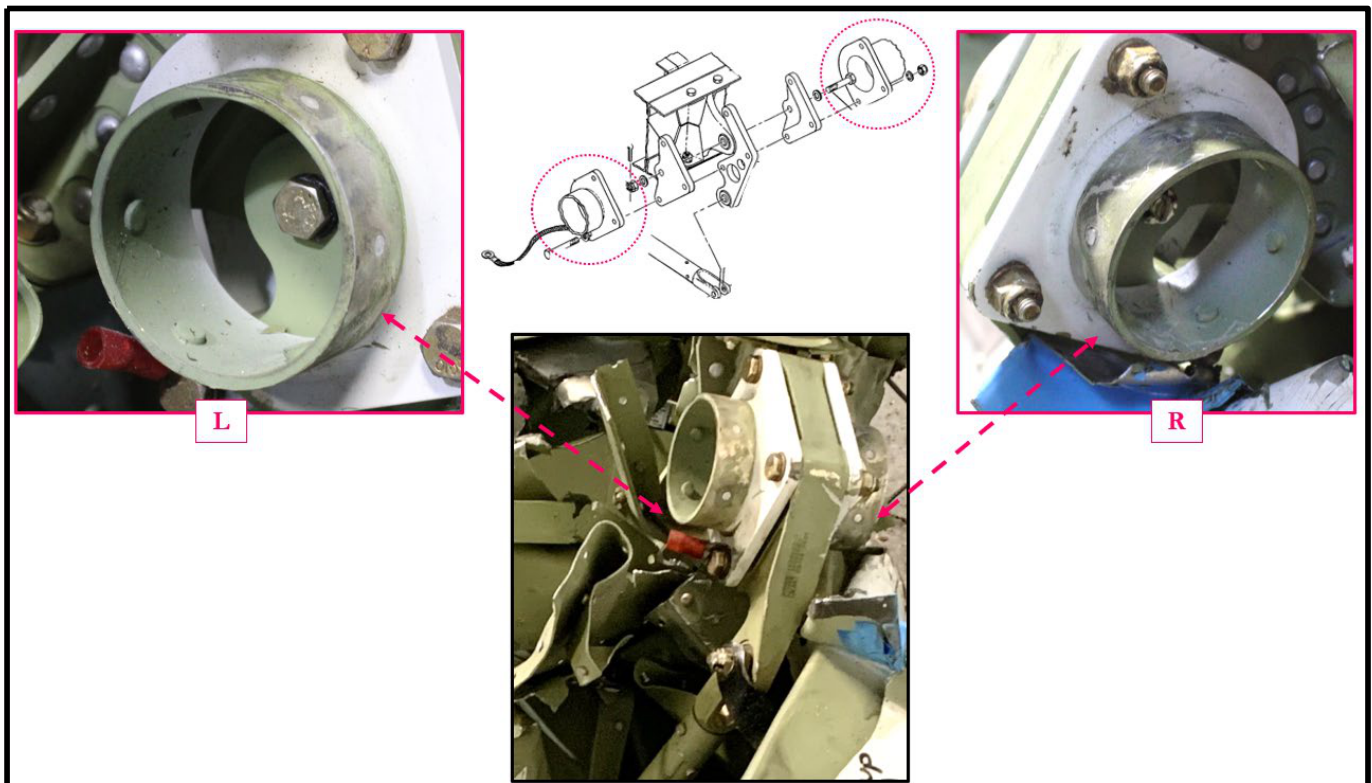
The elevator control cables were attached at the mixing bar and continued aft to the empennage. The control tube was attached to the bellcrank but had separated at the aft bulkhead. The remaining section of the control tube was still attached to the aft elevator bellcrank. The elevators had separated from the circular tubing, with the rivets sheared and the right elevator control tube torn downward. Both elevator control surfaces were separated from the entirety of the control tube.

Figure 26: Elevator control tube center (showing push rod forward)

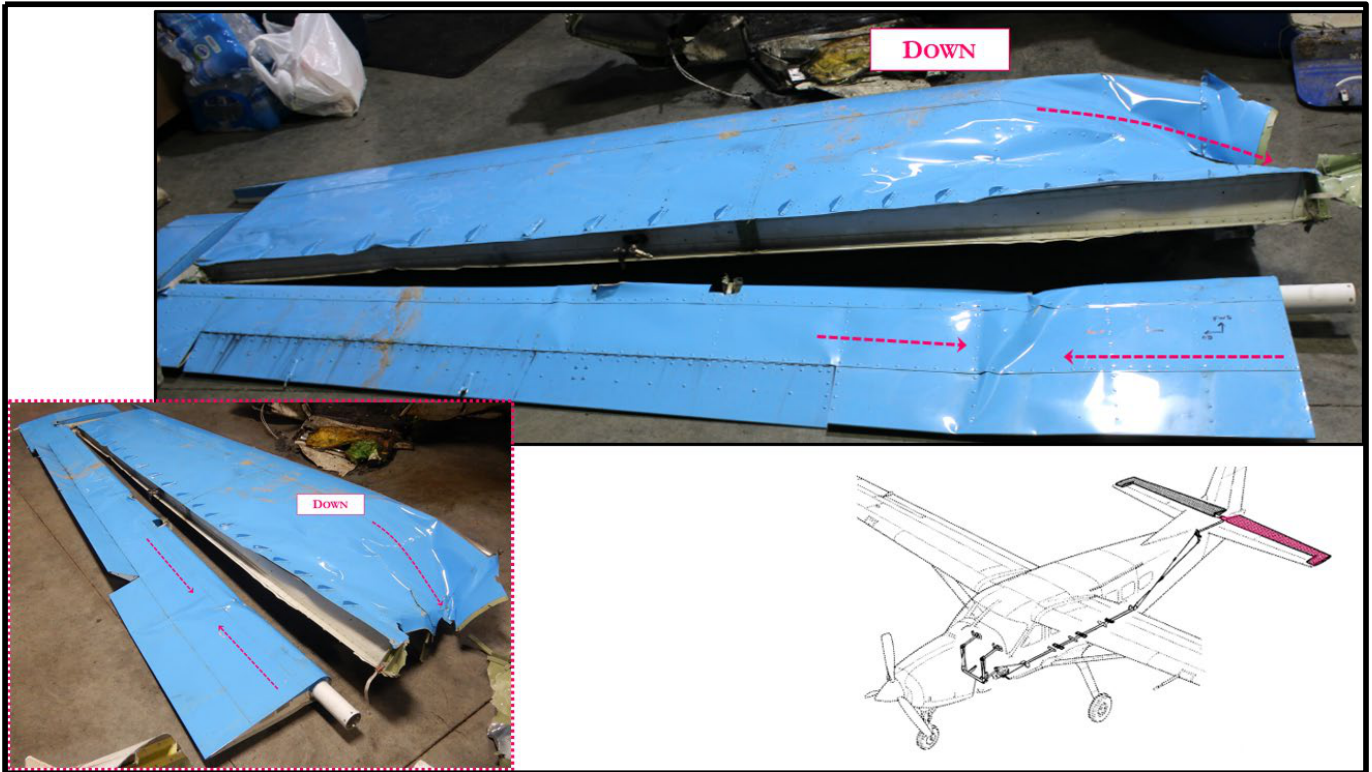
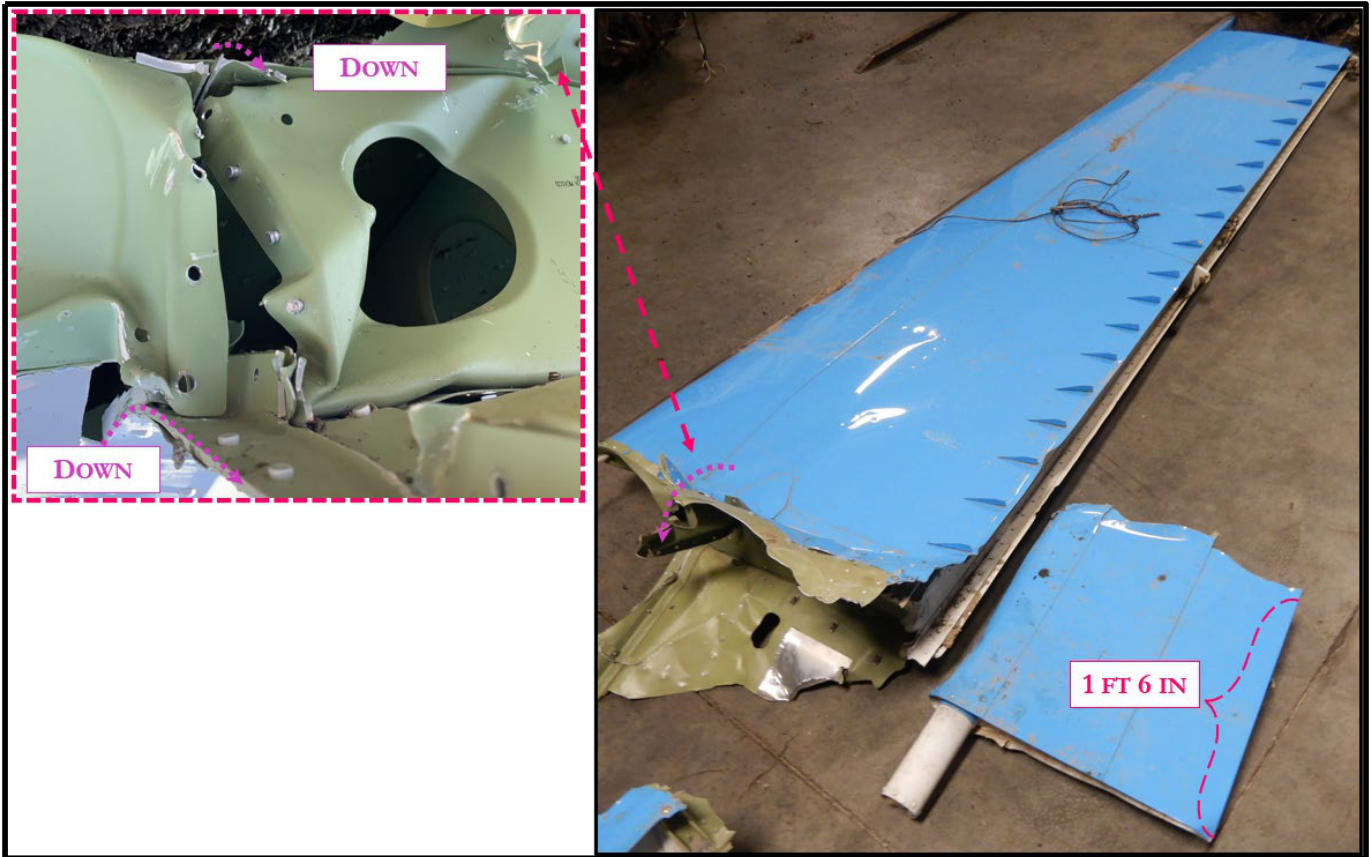
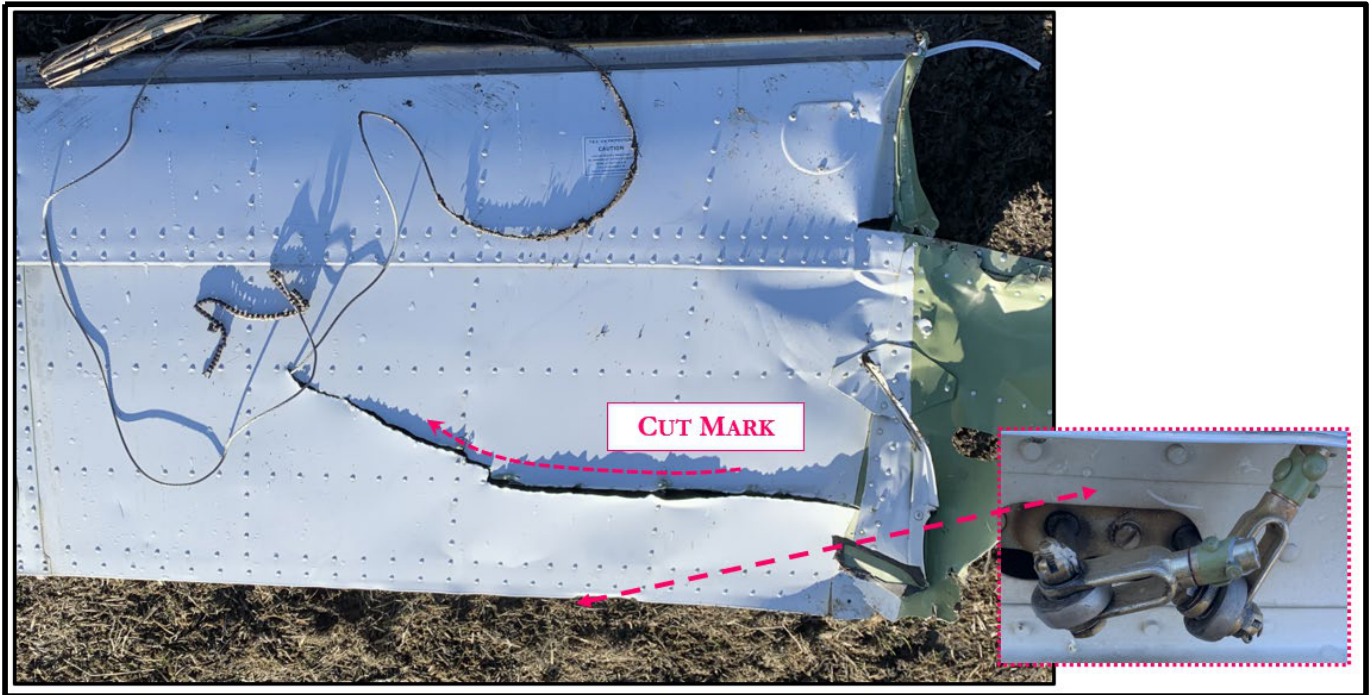
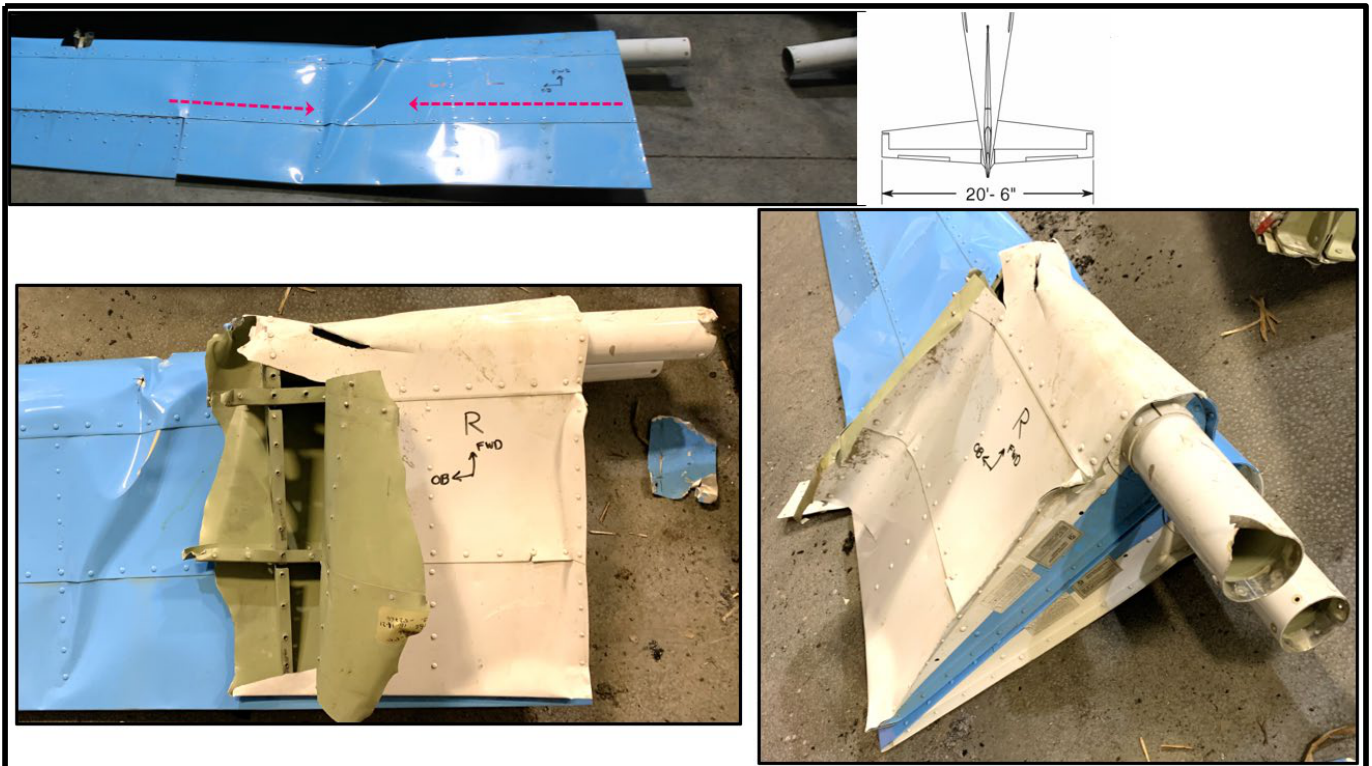
The left elevator remained intact but had torn at the mid and aft attach points. The left horizontal stabilizer contained the actuator, which Textron Aviation found the left elevator trim tab trailing edge down (airplane nose up). The inboard webbing and spars exhibited downward bending consistent with a negative load.

Figure 27: Left horizontal stabilizer and elevator (upper skin)

Figure 28: Right horizontal stabilizer and elevator (upper skin)

Figure 29: Right horizontal stabilizer (lower skin and elevator attach point)

Figure 30: Comparison of the inboard right and left elevator bends (left upper elevator and bottom right elevator)

Only a portion of the right elevator, part number 2634000-70, was located, with the most inboard piece found measuring about 1 foot 6 inches. The left horizontal stabilizer remained intact, with the elevator attached at both the outboard and midsections. The trim cables were separated from the chain and displayed broomstrawing at the sprockets, which showed evidence of crush deformation. The control cable had sawed through the bottom of the right horizontal stabilizer to approximately 30 inches outboard.

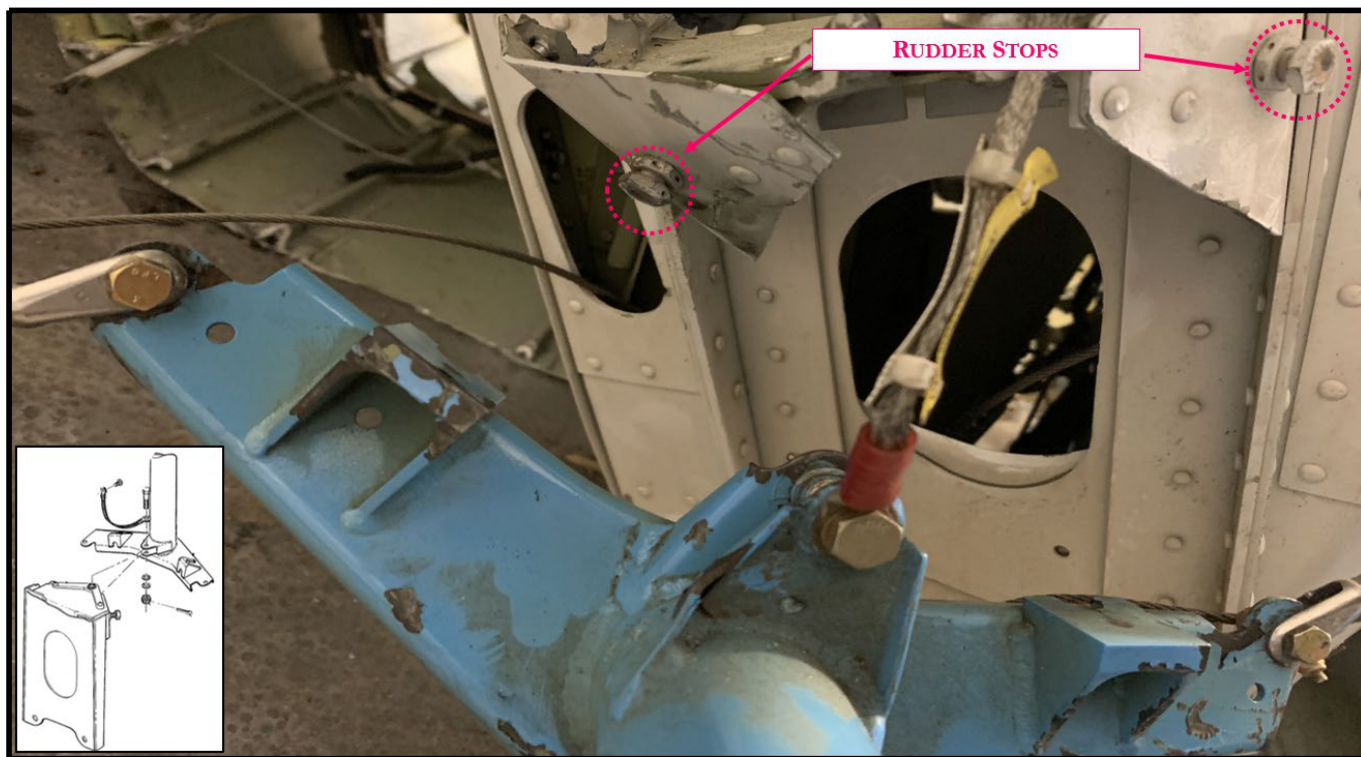
The pilot's rudder pedals had been consumed by fire, with only the metal bases remaining. The right seat pedals were intact, though the outboard pedal showed deformation extending further outboard. The rudder control cables remained attached to the mixing bar and continued aft to the empennage. The cables were still connected to the aft bellcrank and showed no evidence of deformation. The cables continued further aft and were attached to the rudder control horn. The rudder control horn had separated at its pivot bearing, and there was evidence of rust and scraping on the control horn as well as wear on the respective stops.

Figure 31: Rudder stops
