GARMIN 1000NXi SUPPLEMENTAL MATERIAL

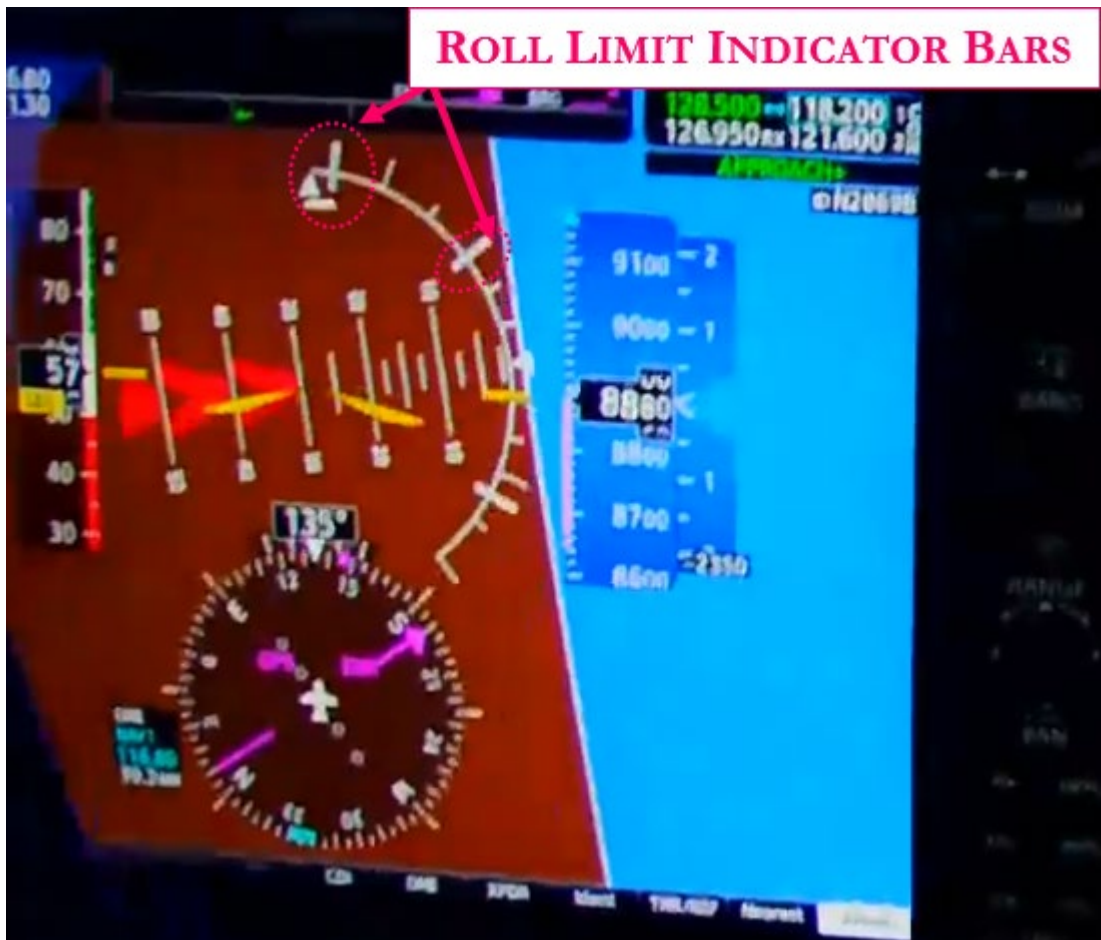
Figure 9: Airplane PFD showing past 75°

A review of the cockpit video from Flight 07, revealed that the pilot activated the autopilot and yaw damper on several occasions. At a recorded time of 1514:51, when the pilot was performing the stall for the test point 5.6L, the airplane rolled left and passed the 45° threshold which was seen to activate the ESP (the Roll Limit Indicator Bars moving). The airplane continued to roll past 75° and reached a maximum roll of about 83°, before returning to level.

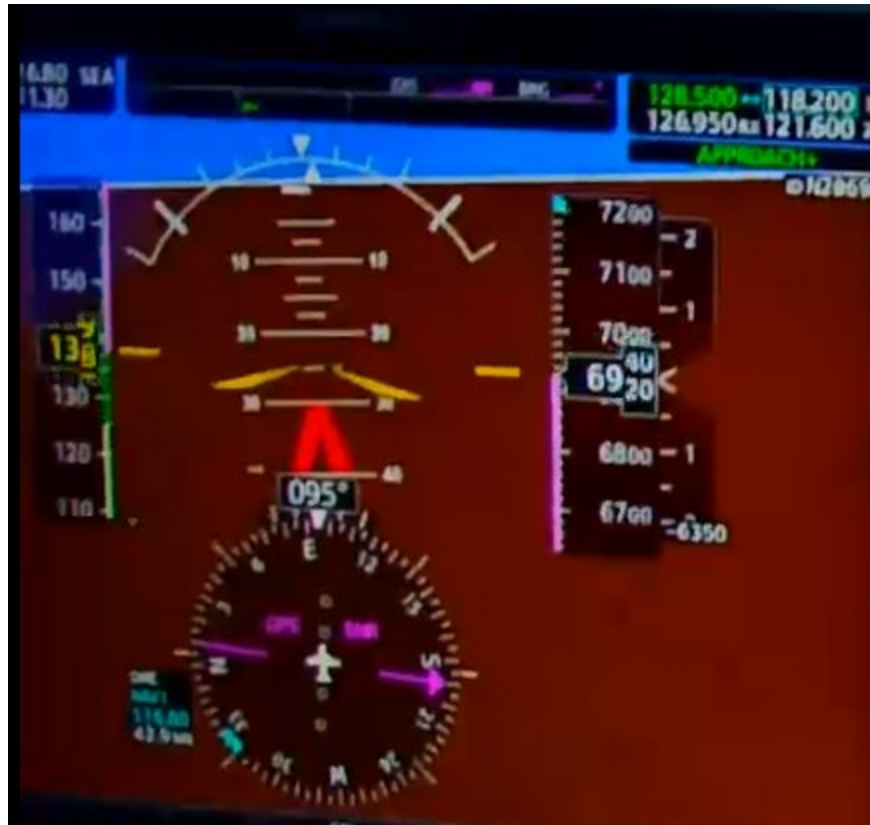
Figure 10: Airplane's PFD displaying red chevrons and the amber airspeed

At 1521:44 as the pilot was leveling off and having recovered from a stall, the pilot had the airplane pitching in a nose-low attitude in excess of 30°. The attitude indicator displayed red chevrons pointing up indicating an unusual attitude. The magenta airspeed trend vector line predicted V_{mo} within 6 seconds and the actual airspeed readout turned yellow.

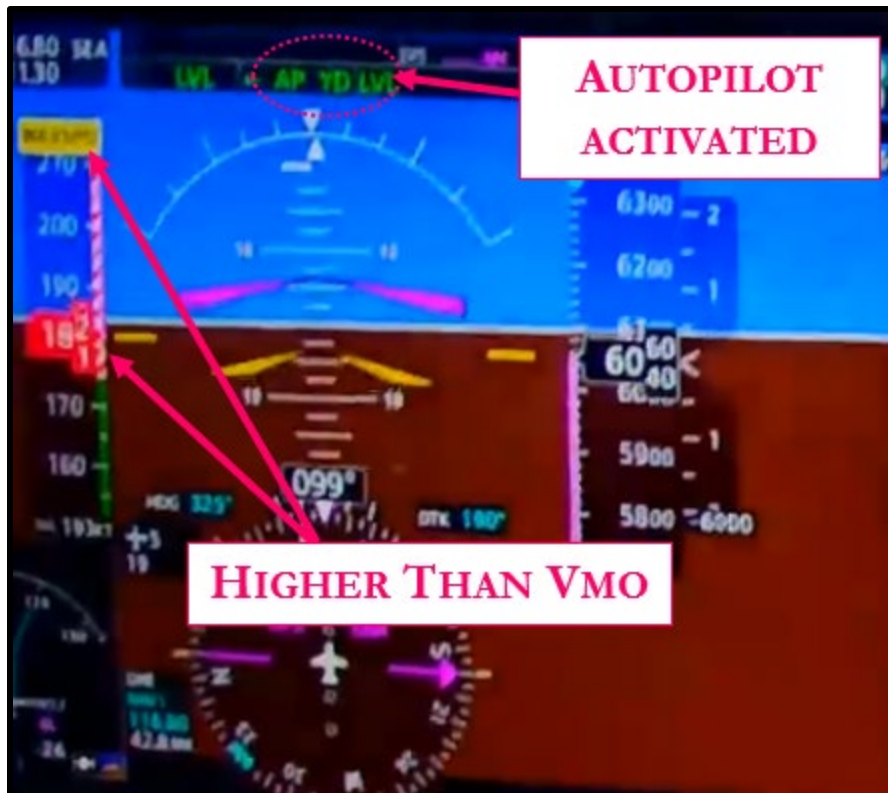
Figure 11: Autopilot activating from ESP engagement

At 1521:45 the autopilot turned on into LVL mode indicating that the airplane was below the nose-down attitude of 20° for more than 10 seconds. There is a beeping in the cockpit and the MAXSPD amber warning illuminated as the speed increased to 183kts. The autopilot disconnected at 1521:53, presumably by the pilot disengaging it on the control yoke. Thereafter, the Instrument Lead became airsick and they decided to return back to base.
