National Transportation Safety Board

WPR22FA055

INVESTIGATIVE SUPPLEMENT

Location: Medford, Oregon
Date: 12.05.2021
Time: 1652 Pacific standard time
Airplane: Piper PA-31-350 Navajo Chieftain

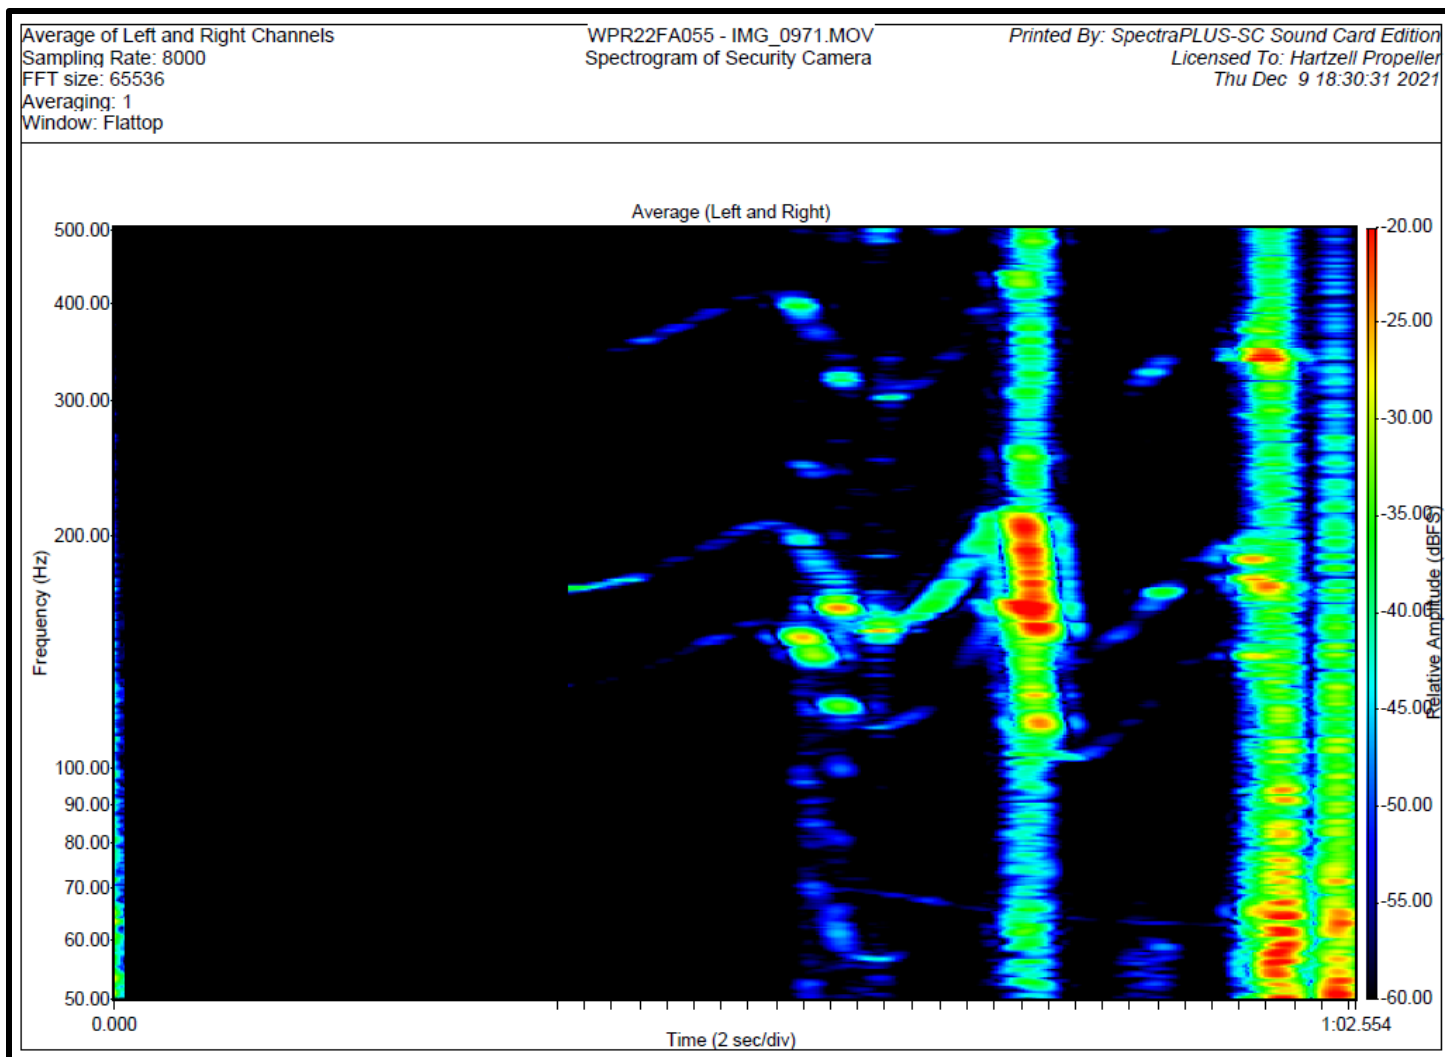
Figure 8: Hartzell Spectrogram Graph

According to Hartzell, the spectrogram showed evidence of a 4-blade prop operating near the 2575 engine rating and what appeared to be the engine exhaust (3/rev). There was no evidence of a propeller windmilling. The last two bright vertical bands (broad spectrum noise) are consistent with the impact and then the explosion.

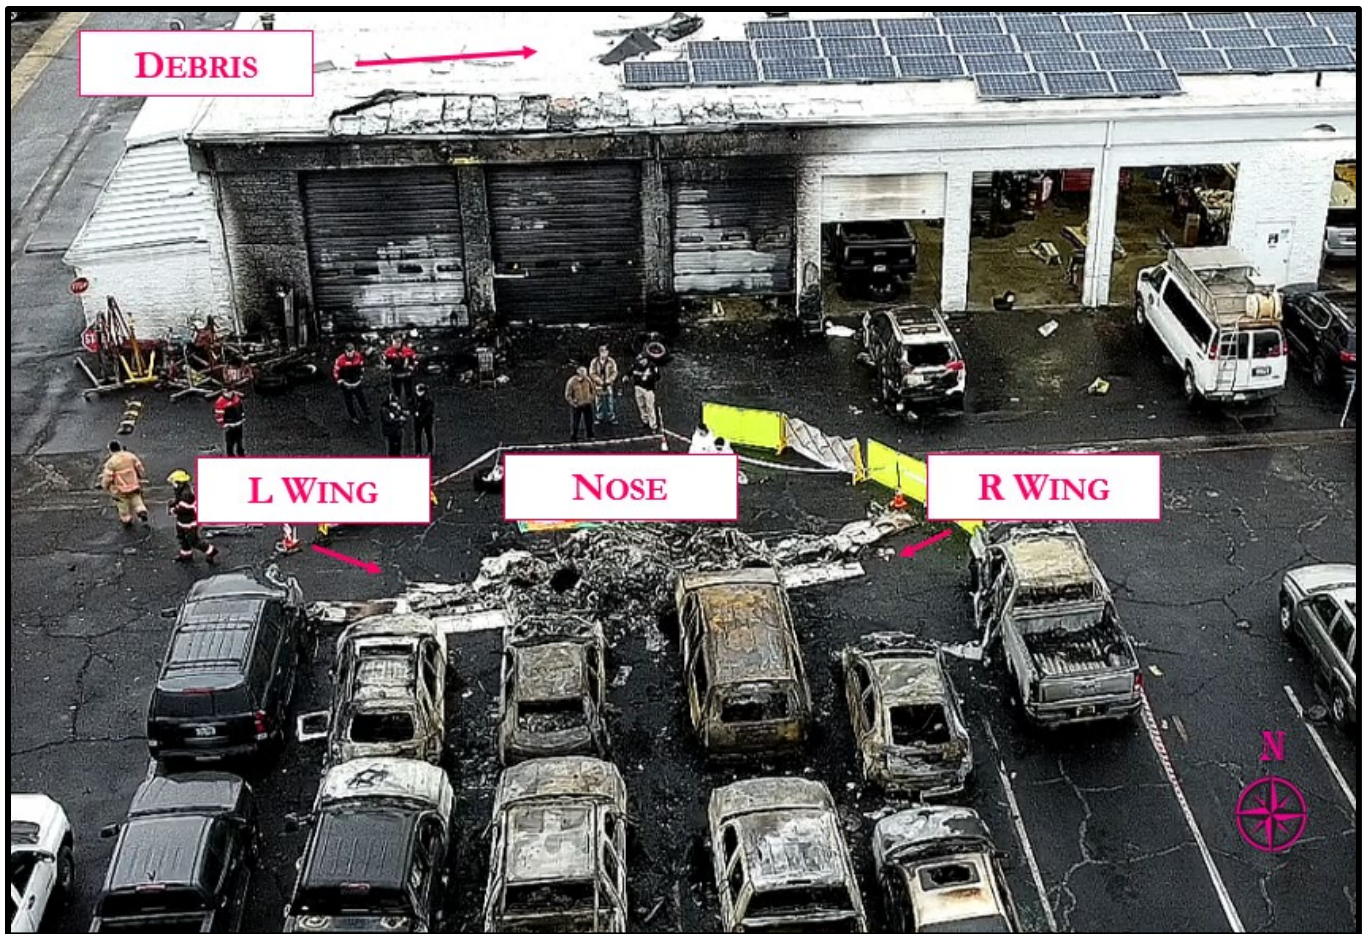
Figure 11: Accident Site

The accident site was located in a car dealership parking area 2,180 ft west-southwest from the departure end of runway 32. In character, the impact area was flat asphalt surrounded by numerous automobiles and adjacent to large garage door bays [the unoccupied Service Center]. The wreckage was found distributed on the dealership roof and throughout the parked automobiles, with the nose coming to rest on a heading of north. Approximately 13 automobiles were damaged and 11 were destroyed.

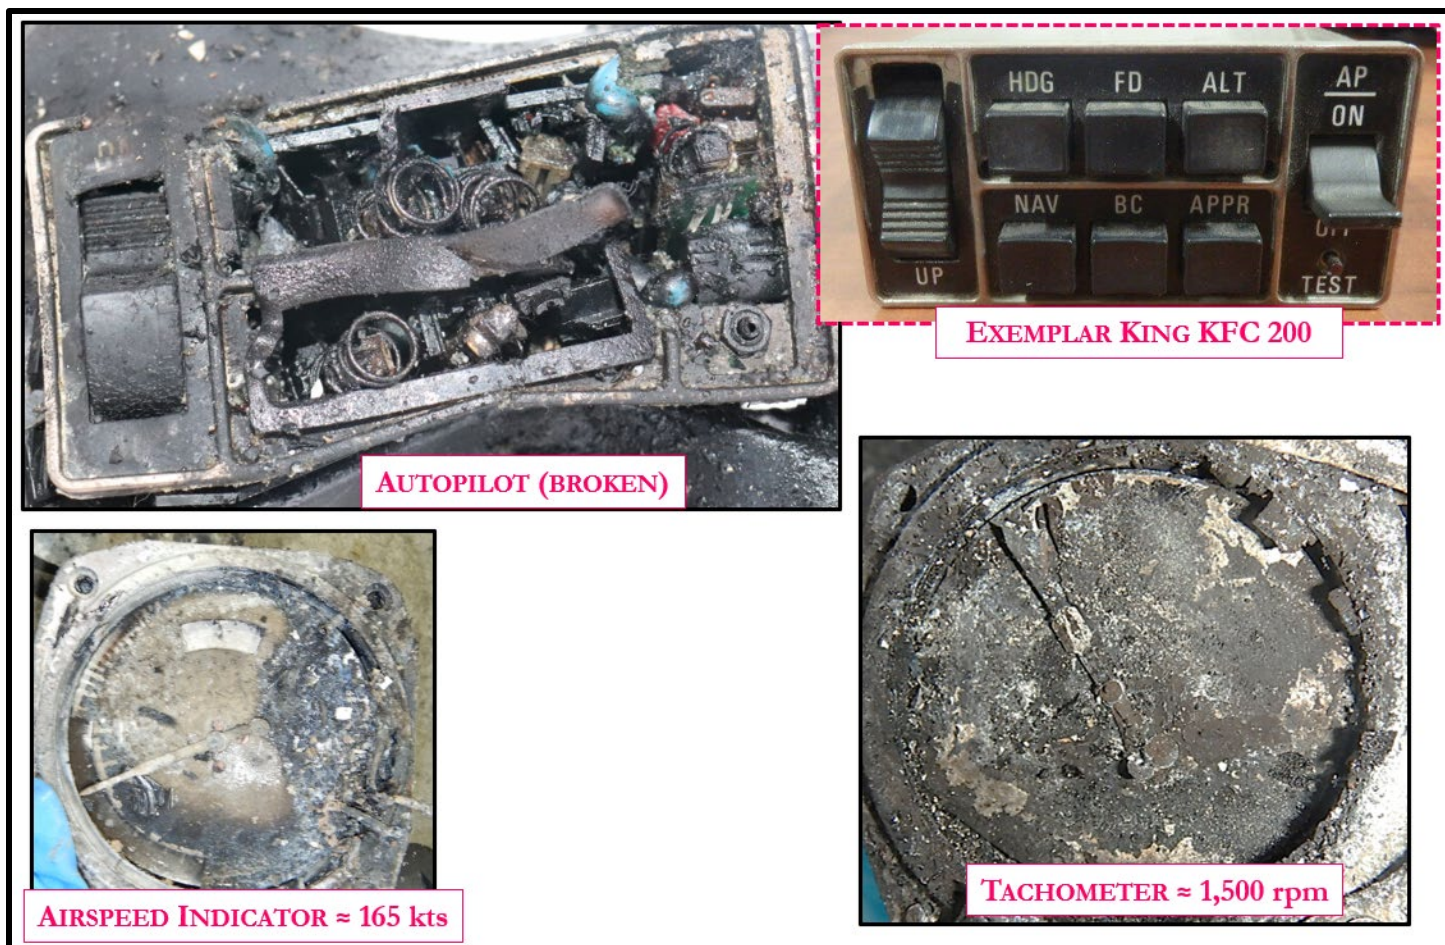
Figure 15: Instruments That Were Recognizable

The fuselage sustained aft crush damage and was partially consumed by the post-impact fire. The nose section sustained the most fragmentation with the nose landing-gear displaced aft, aligning with the main wing-spar. The instrument panel had sustained major thermal damage with the instruments and radios separated; there was limited meaningful information that could be derived from the gauges due to the damage. The landing gear lever remained attached within the instrument panel and was positioned midway through its range.

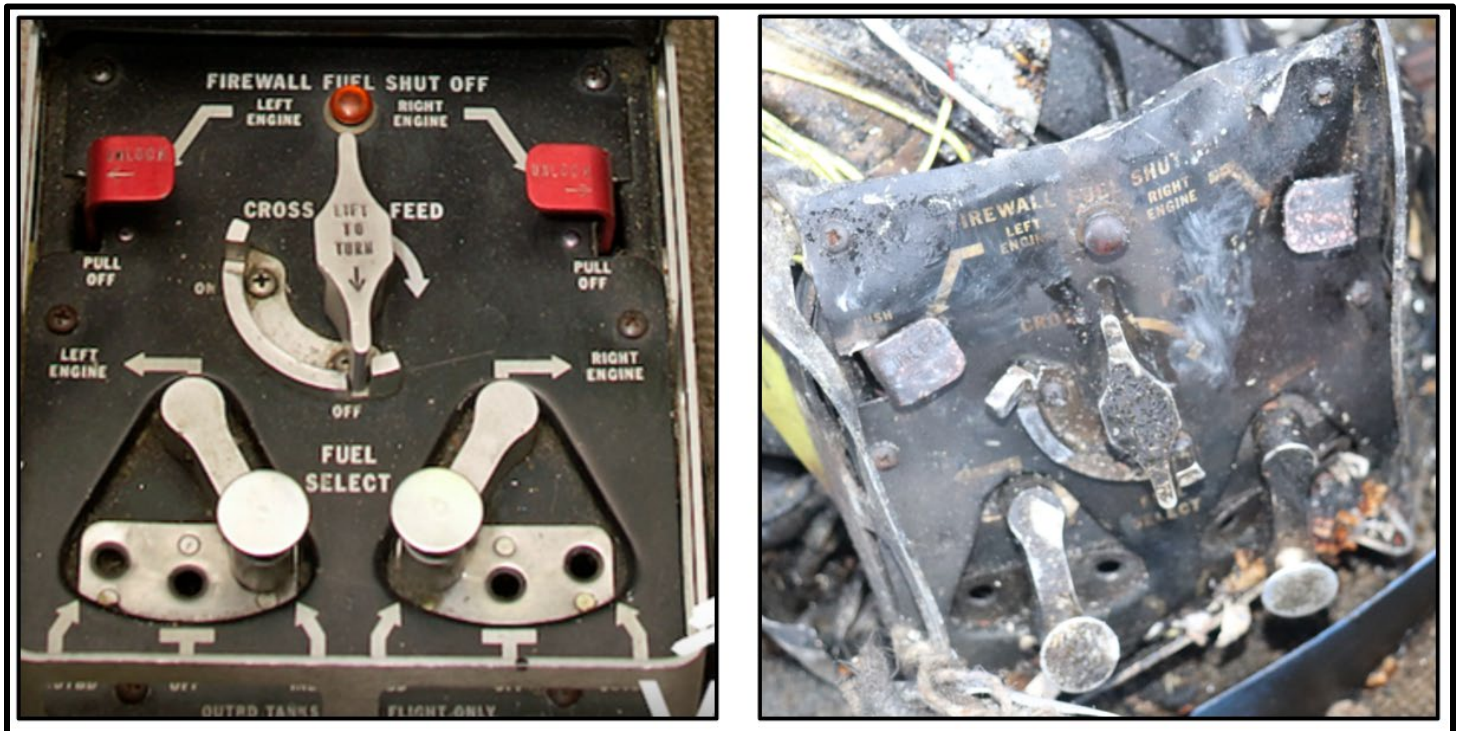
Figure 16: Fuel Selector (left side exemplar and right side as found at accident site)

The fuel caps were found secure in the wings. In the wing root area of the right wing, the fuel system components had sustained damage from both impact and thermal effects. The fuel selector valve was found positioned to the outboard tank, and the firewall shutoff valve was identified to be in the open position. Within the wing root area of the left wing, the fuel system components had suffered damage from both impact and thermal effects. The fuel selector valve was discovered near the outboard tank, the firewall shutoff valve was found in the closed position, and the crossfeed valve was open. The fuel selector in the cockpit was thermally damaged.

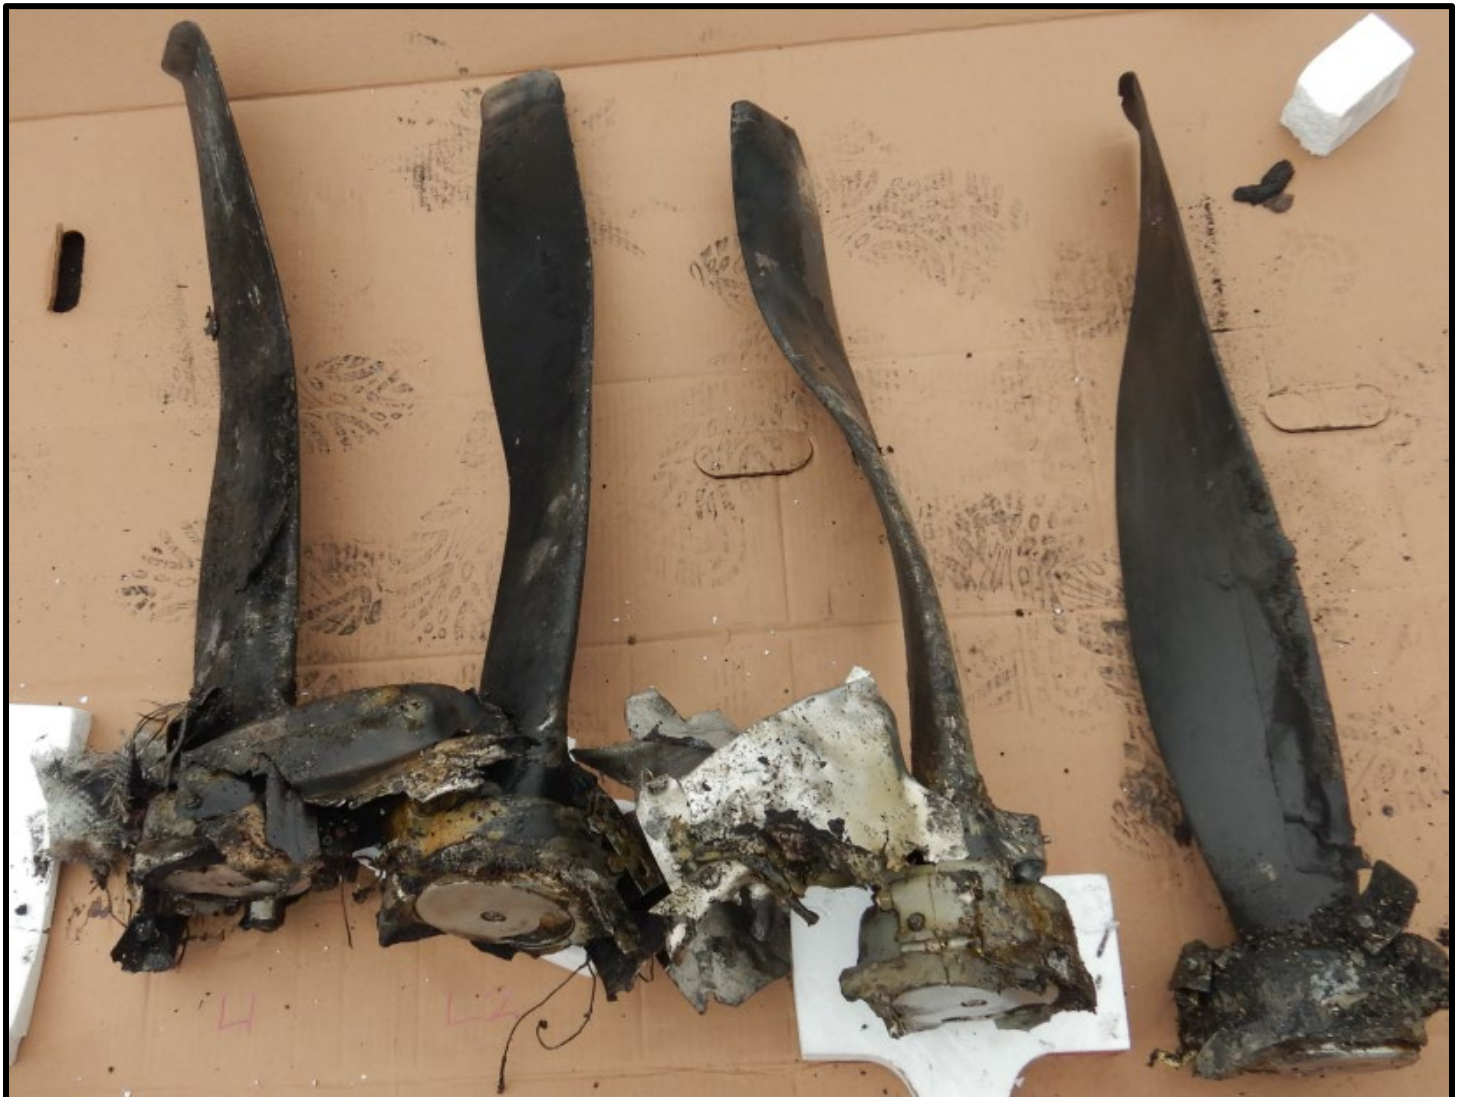
Figure 17: Left Propeller Blades

The propeller governor was separated from the crankcase; its respective control cable remained attached. The left propeller was found in the left-engine's impact crater. The propeller hub had been shattered, and all four "Q-tip" propeller blades were detached. All four blades exhibited chordwise scoring, leading edge chips, and were twisted and bent.

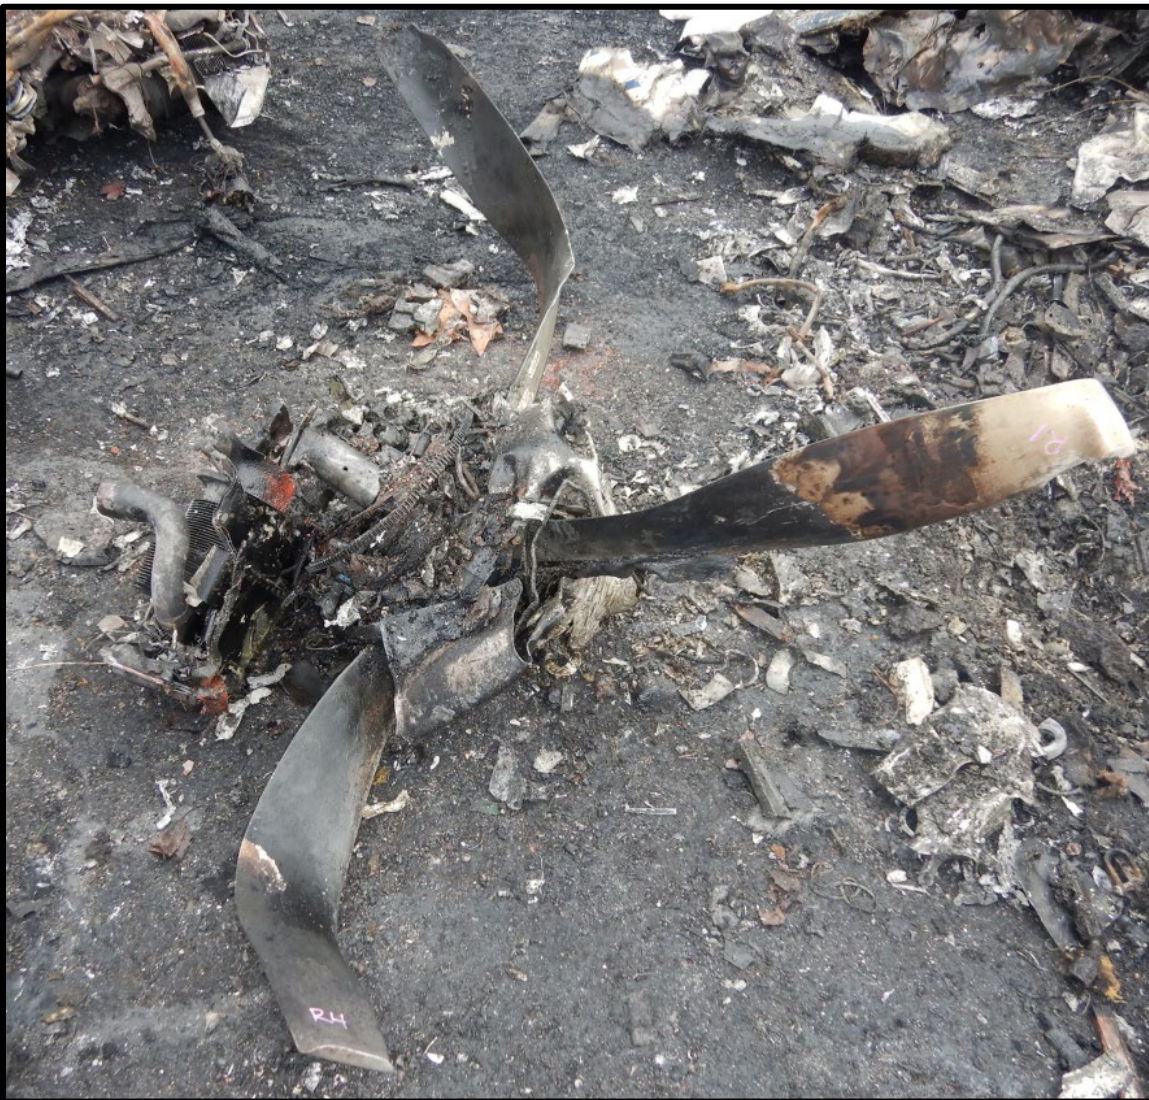
Figure 18: Right Propeller Blades

The right propeller sustained damage within the impact crater created by the right engine. The propeller hub was cracked, releasing one of the four “Q-tip” propeller blades. One propeller blade was impact separated at the shank. All four propeller blades sustained bending and twisting, displayed chordwise scraping, tip separation, and leading-edge chipping.

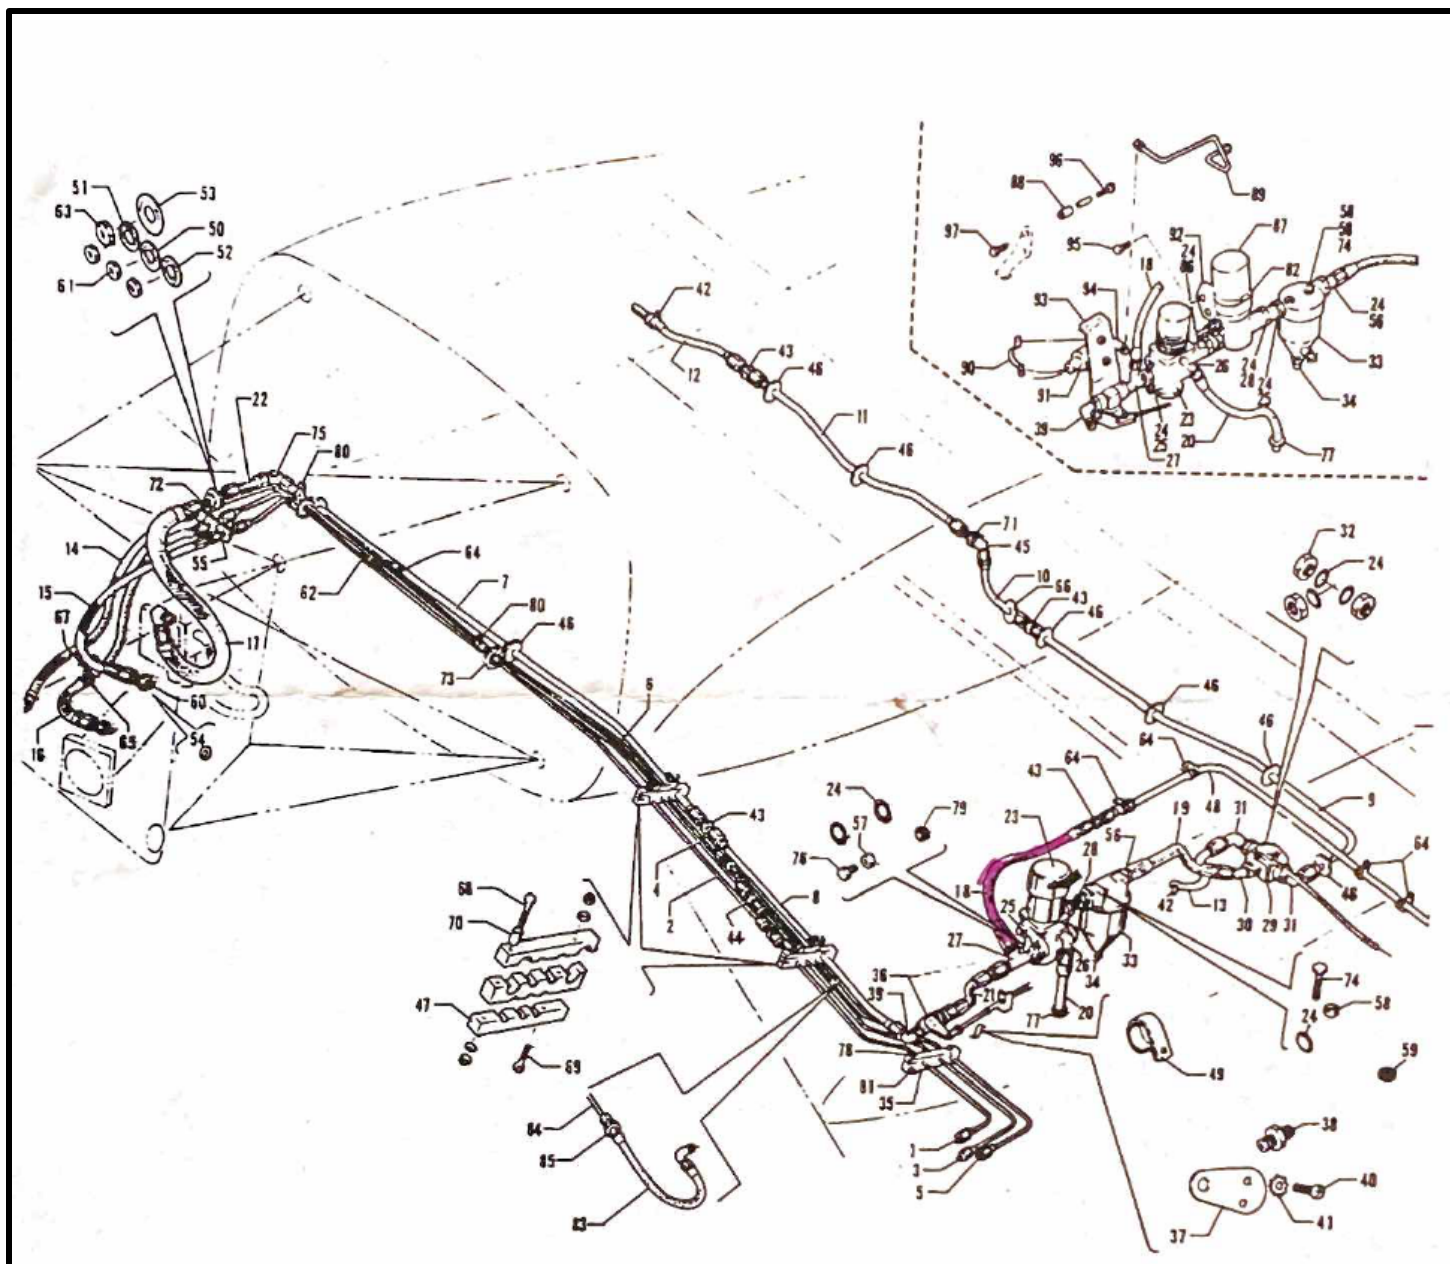
Figure 23: Fuel Line that was Replaced (No. 18 highlighted)

The last examination was recorded as being completed on December 04, 2021 at a tachometer time of 1,754.4 hours. The invoice stated that an auxiliary hose assembly was replaced the day before the accident following a leak.

Discrepancy: 3									
Problem:									
Fuel leak.									
Action Taken:									
Troubleshoot and found flexible fuel supply line in right wing root leaking. Replaced fuel line with new. Leak check good at this time. No further defects noted.									
Charges This Item:					4.22 Hours @ [REDACTED]				
Part Number	Description	Credit	Quantity	Units	List Price	Disc	Unit Price	Extended	
AE7010000H0180	Hose Assy		1.00	Each	[REDACTED]		[REDACTED]	\$	[REDACTED]
	Freight		1.00				[REDACTED]	\$	[REDACTED]
Total For This Discrepancy:								\$	[REDACTED]

- 1) Removed and replaced right wing fuel hose to aux pump with new hose as required in reference to PA-31-350 MM Section 9. Operations and leak check good.
