ZOE KELIHER
Sr. Air Safety Investigator
Office of Aviation Safety – Western Pacific Region

Subject: WPR23FA034

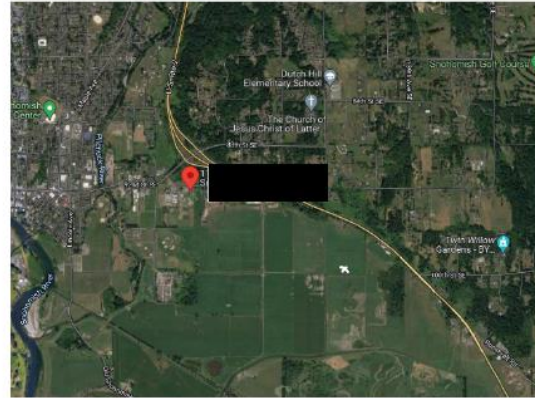
About 4000 feet NW of impact

Heard a strange, weird sound then I heard nothing. I looked up the sky and saw the plane. There was a white smoke, like the jet stream white cloud type of smoke came out of the plane.

It was descending like a corkscrew shape. I didn't know that it was an exercise or accident. I kept looking, but it didn't pull back up. Soon after, there was a dark fume from the ground, but I did not see the airplane's impact because of the tree line. I called 911.

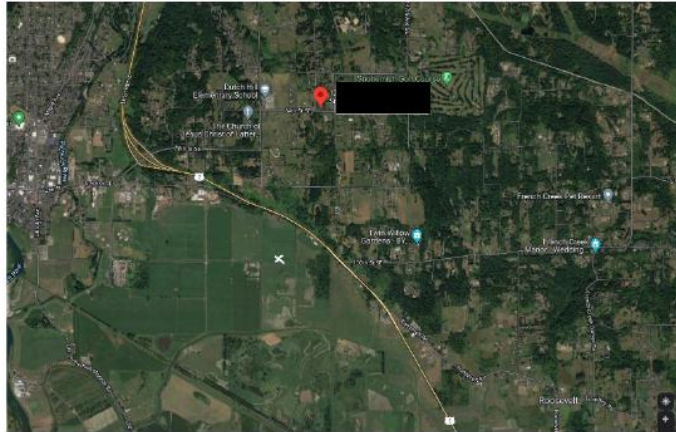
About 5000 ft North

I was outside of the house. It was an unusual loud pop sound. When I saw the airplane, a white smoke was trailing behind the plane. After the sound, the plane started climb, then black smoke came out of the windshield and engine cowling. I saw the left wing separated from the airplane then spiral to the ground slowly. Main body was much faster than the separated wing. I didn't see the impact due to the tree.

It was white smoke first, then climbed more higher and then black smoke. It was 10:10 am and called 911 at 10:15.

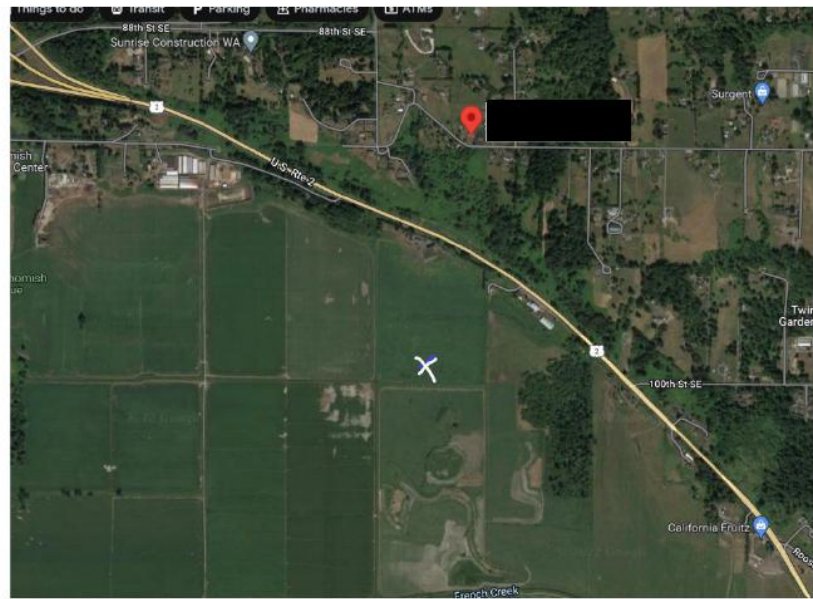
2000 ft North

I was outside of my house working. I heard sudden, very unusual sound. It was like a roaring of engine, accelerating that I never heard before. As I looked up the sky, the airplane was falling; one wing was separated already. First, I thought that the wing was going to land on us. It was that close. The airplane was literally falling from the sky. I did not see the impact due to the trees. But I saw one piece of the airplane, rectangular in shape, blue-colored, followed by the airplane.
