**NATIONAL TRANSPORTATION SAFETY BOARD  
OFFICE OF AVIATION SAFETY  
WASHINGTON, D.C. 20594**

**POWERPLANTS GROUP CHAIRMAN'S FACTUAL REPORT**

NTSB ID: DCA2020MA059

Location: Calabasas, California  
Date: January 26, 2020  
Time: 0947 Pacific Standard Time (PST)  
Aircraft: Sikorsky S76B, N72EX, operated by Island Express Helicopters

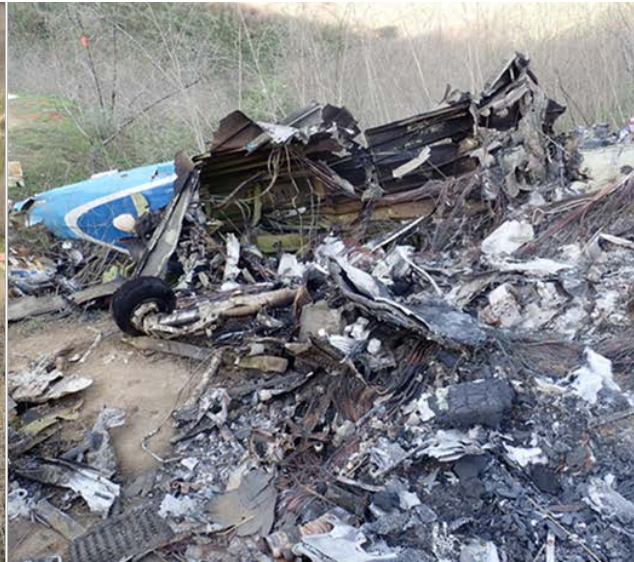
Figure 3. Main wreckage site

The engines were found approximately 153 feet from the initial point of impact, in the main wreckage area. See Figure 2. The main wreckage was substantially destroyed by fire. See Figure 3.

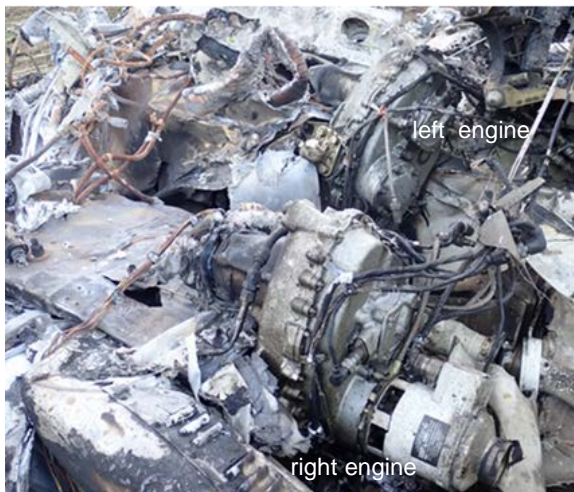
Figure 4. View of engines as found

The engines were inverted and engine deck material limited inspection. Both engine RGBs appeared intact. The viewable gas generator and exhaust cases showed no evidence of uncontainment. See Figure 4. The accessory gearbox (AGB) casings, the AGB-mounted accessory housings, and the inlet cases of both engines were thermally consumed.<sup>3</sup> See Figure 5.

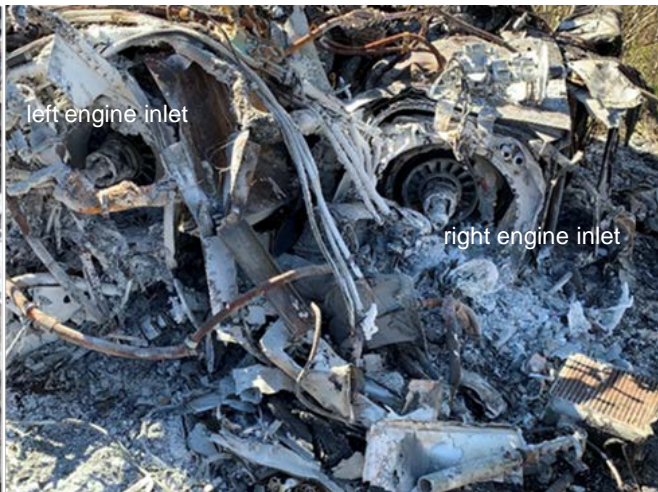
Figure 5. AGB and inlet cases destroyed, exposed inlets

<sup>3</sup> The AGB cases are magnesium castings. The engine inlet case and the gearbox-mounted accessory housings are aluminum castings.

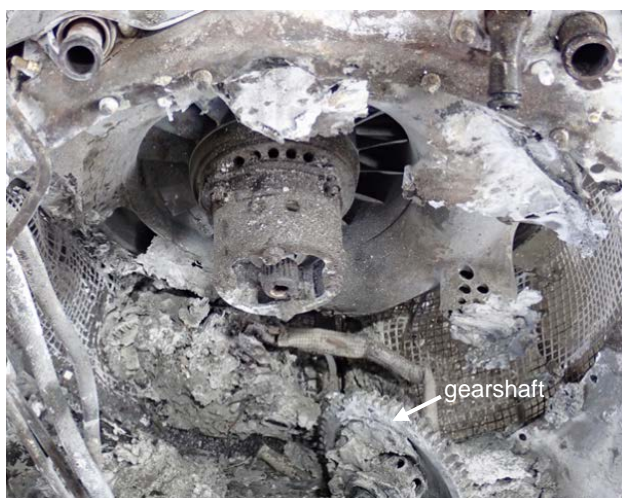
Figure 6. Left engine inlet

The left engine gas generator rotor was seized. Inspection of compressor components through the inlet found no obvious damage. Internal AGB and AGB-mounted accessory components were found

in the debris just forward of the compressor inlet. See Figure 6.

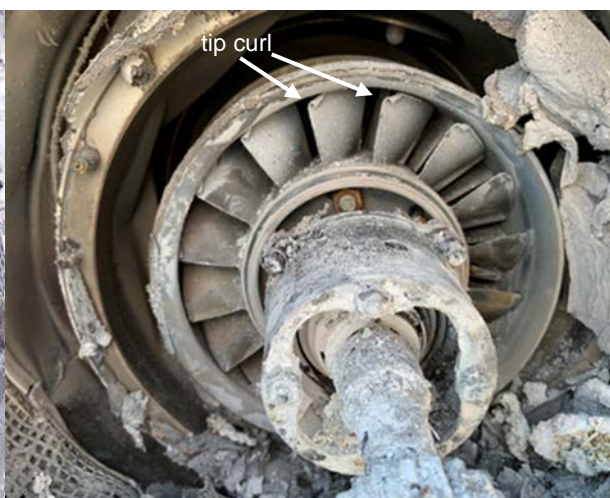
Figure 7. Right engine inlet

The right engine gas generator rotor was seized. All of the S1 compressor rotor blade tips were curled in the direction opposite of rotation. See Figure 7. Visible compressor components appeared otherwise undamaged. Internal AGB and AGB-mounted accessory internal components were found in debris just forward of the compressor inlet.

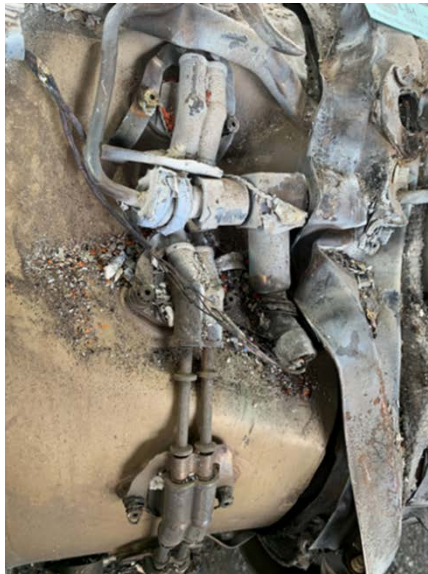
Figure 11. Dent in gas generator case

There was a large dent in the gas generator case at the flow divider (6 o'clock<sup>7</sup>). See Figure 11. There was a circumferential fracture along a seam weld between 5 and 11 o'clock, just forward of the large dent. See Figure 12.

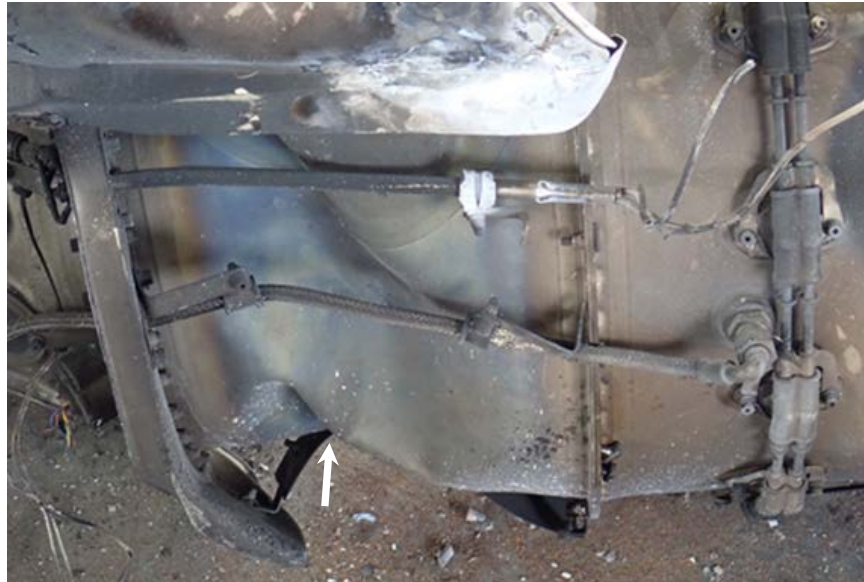
Figure 13. Exhaust duct distortion

The exhaust duct was bent and displaced upward at its forward flange. See Figure 13.

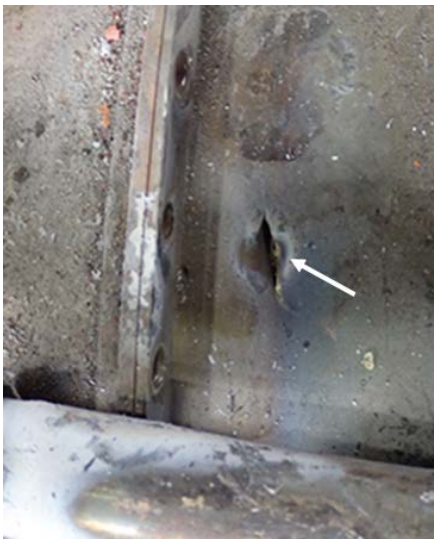
Figure 14. Exhaust duct penetration

There was an approximately 0.5-inch case penetration near the C flange at 6 o'clock. See Figure 14.

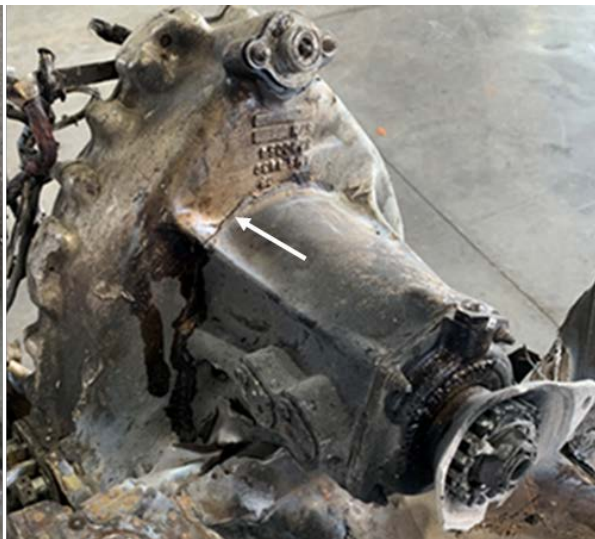
Figure 15. RGB casting fracture

The RGB casting was fractured at the base of the output shaft detail. See Figure 15.

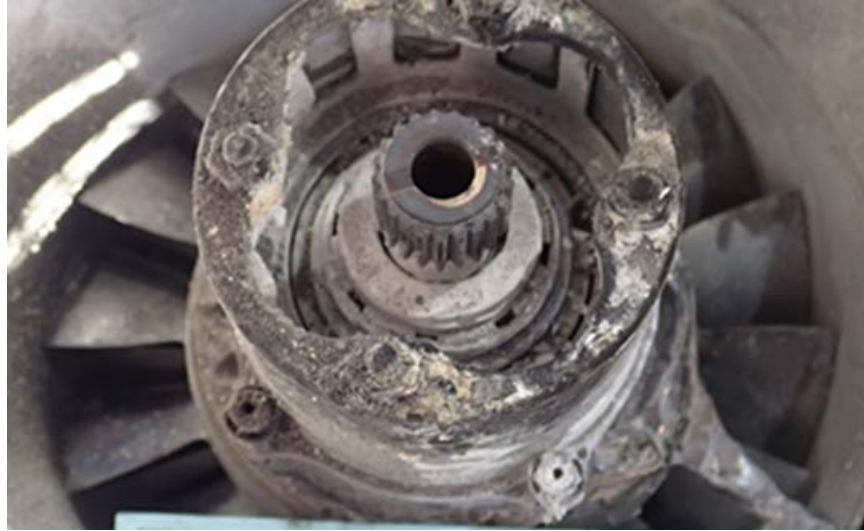
Figure 18. S1 compressor and front support bearing

The No. 1 bearing and stator air seal were thermally damaged and heavily contaminated with fire debris. See Figure 18. The bearing was seized. The S1 and second stage (S2) compressor airfoils were intact. The compressor was not disassembled.

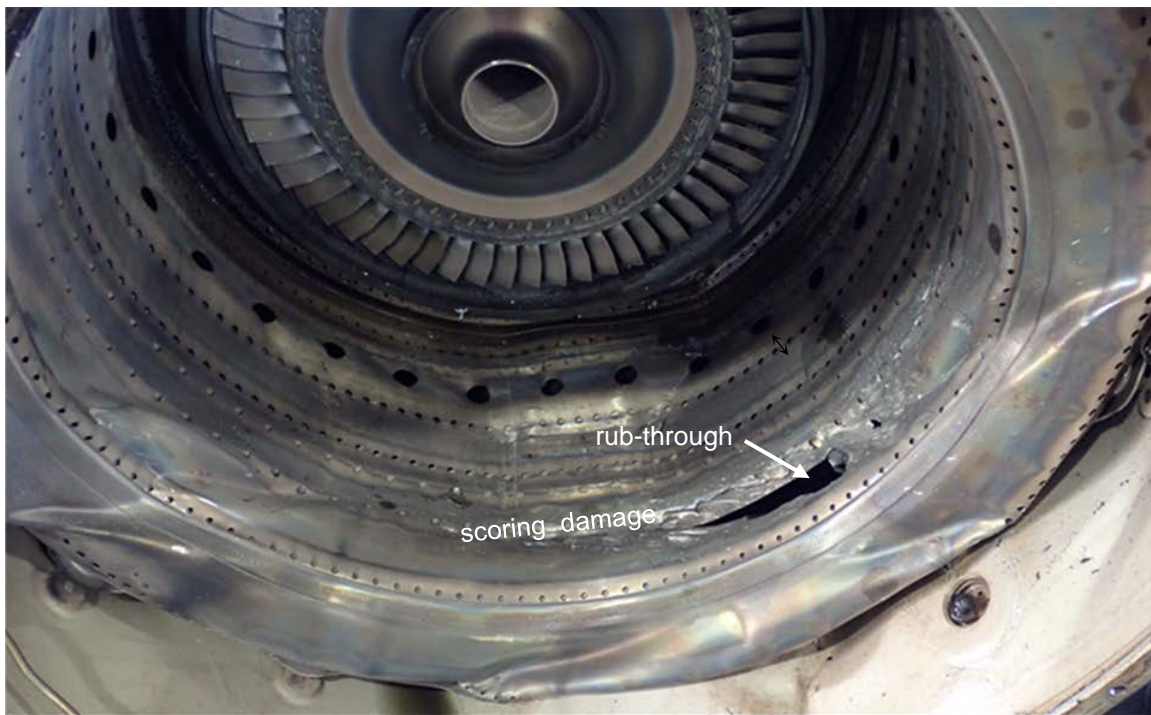
Figure 19. Combustor liner distortion, scoring and metal deposited on shroud segments and blade TEs

The combustion liner was crushed and distorted between 5 and 9 o'clock; this damage was in line with the damage to the gas generator case and with the power turbine plane of rotation. There was heavy scoring between 6 and 7 o'clock, with rub-through up to 1.1 inches axially through the liner wall. See Figure 19.

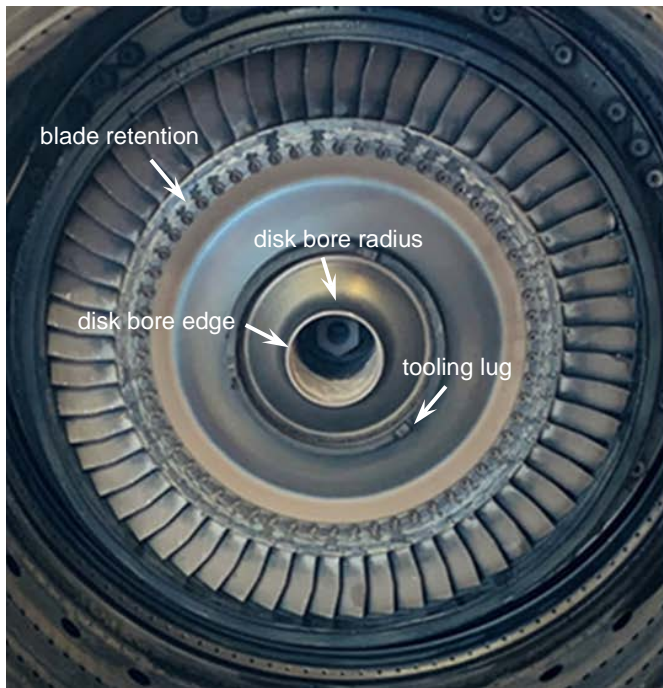
Figure 20. Compressor turbine downstream face showing 360° scoring

The compressor turbine downstream face<sup>9</sup> was scored 360° in the blade fir tree root/retention rivet (blade retention) area.<sup>10</sup> There was circumferential scoring at the disk bore radius and along the bore edge, and at the tooling lugs. See Figure 20. Metal deposits (metallization) was observed on the blade trailing edges (TEs) and on the visible sections of the compressor turbine shroud segments.<sup>11</sup> The shroud segments appeared intact. See Figure 21.

<sup>10</sup> Such scoring occurs when contact between stationary and rotating components occurs during operation, when operating clearances are lost.

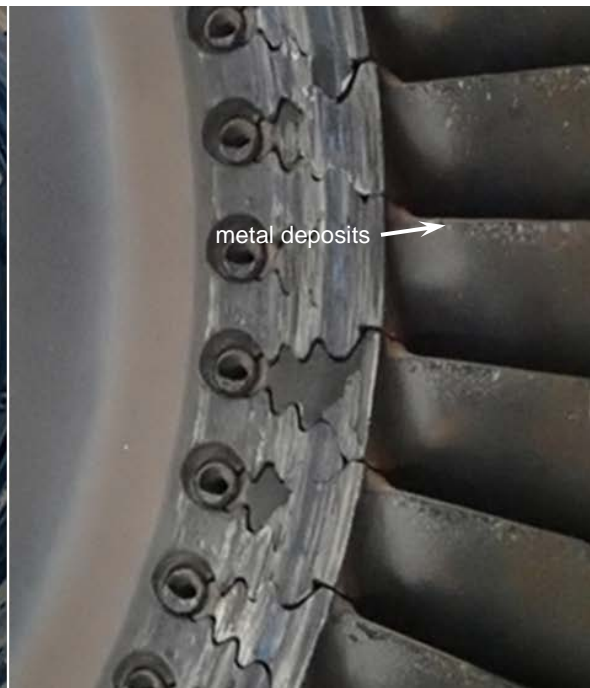
Figure 21. Detail of scoring along blade retention

<sup>11</sup> Metallization is an indication that engine combustion was occurring as metal particles were produced.

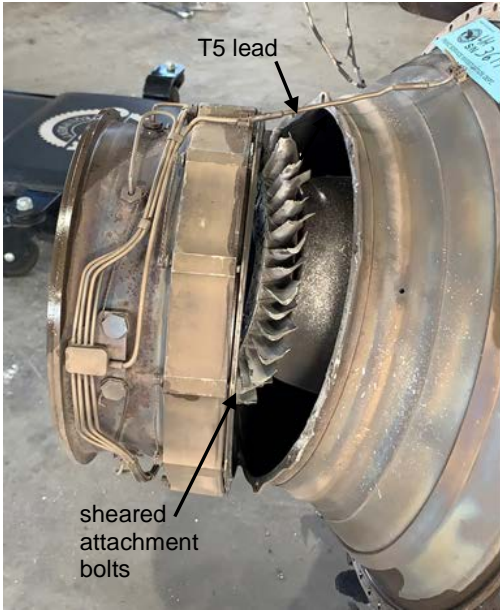
Figure 22. Power turbine stator housing

The power turbine stator housing-to-exhaust duct flange retention bolts were sheared. The housing remained attached to the exhaust duct by the interturbine temperature (T5) busbar lead. See Figure 22.

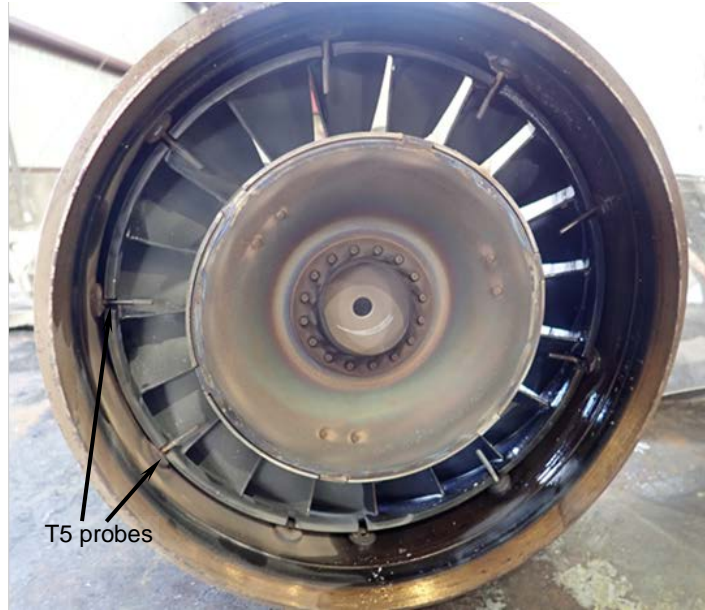
Figure 23. Power turbine vane ring and baffle assembly

The T5 harness was locally distorted. The power turbine vane ring and baffle assembly had shifted position in the power turbine stator housing. Several T5 probes were bent. See Figure 23.

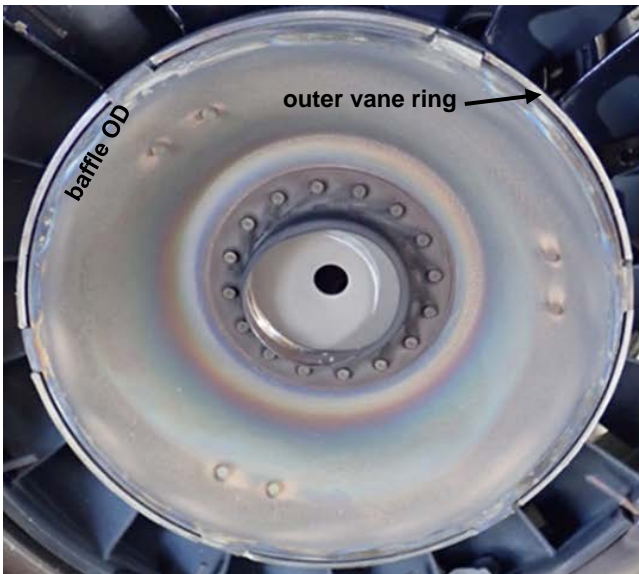
Figure 24. Rotational damage to power turbine vane and baffle assembly upstream face

The power turbine vane ring and baffle assembly upstream face displayed 360° scoring and local thermal discoloration at the baffle outer diameter (OD). The vane inner ring edge was also scored. See Figure 24. Part of the inner baffle lip was distorted upward and was scored in two locations. There were two arcs of scoring contact on the inner baffle face. See Figure 25.

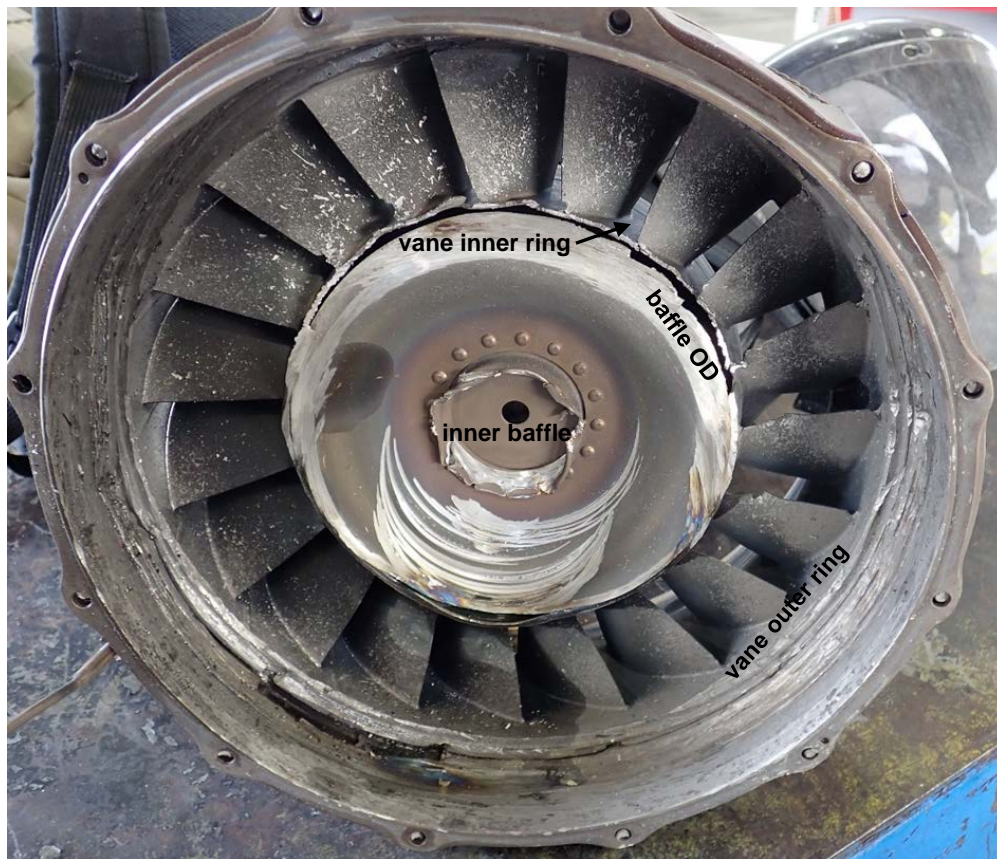
Figure 26. Power turbine vane ring and baffle assembly downstream face

along the baffle OD and adjacent outer vane ring edge. This scoring signature spanned more of the baffle face (up to 0.6 inch) between 10 and 3 o'clock; the baffle was separated from the vane inner ring in this area. The baffle was also separated, and heat discolored, at 6 o'clock. The inner baffle lip was torn and was splayed outward between 3 and 10 o'clock, and inward between 10 and 12 o'clock. See Figure 26.

There were a series of circumferentially oriented marks on the baffle face between 3 and 9 o'clock. See Figures 26 and 27.

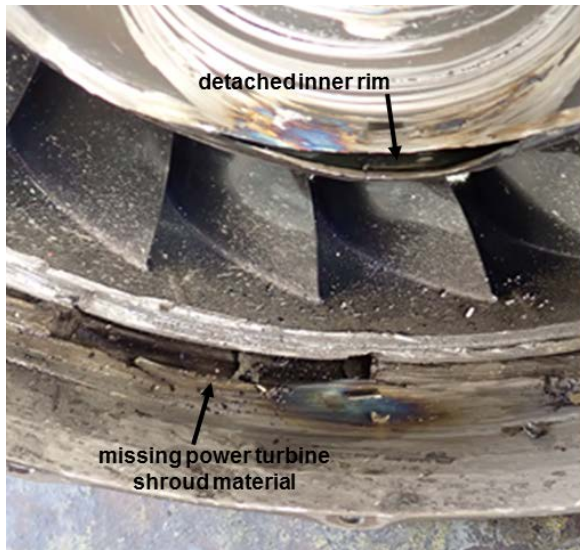
Figure 27. Detail, downstream power turbine vane ring and baffle assembly

The power turbine shroud was heavily rubbed; the knife edges were obliterated in some areas, and the shroud material was missing between 7 and 8 o'clock. See Figure 27. The vane TEs displayed tearing and gouging damage. Metallization was present on all vanes. See Figure 28.

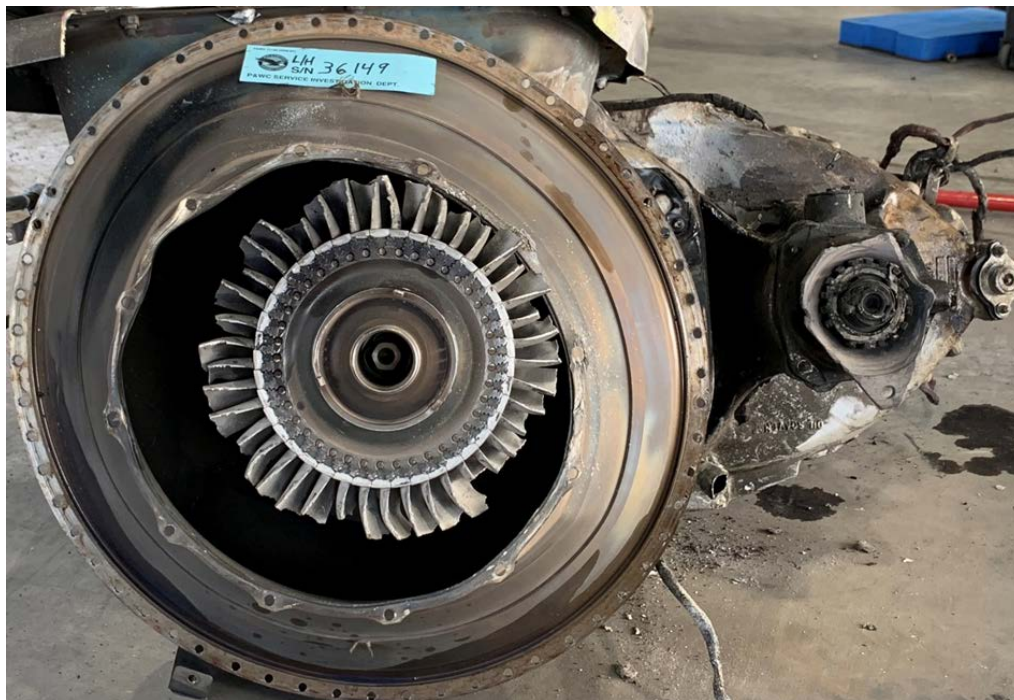
Figure 29. Power turbine with power turbine stator housing removed

All the power turbine blade tip shrouds were liberated. The above-platform lengths of the remaining blade airfoils measured approximately 0.4 to 1.4 inches above the platform. See Figure 29.

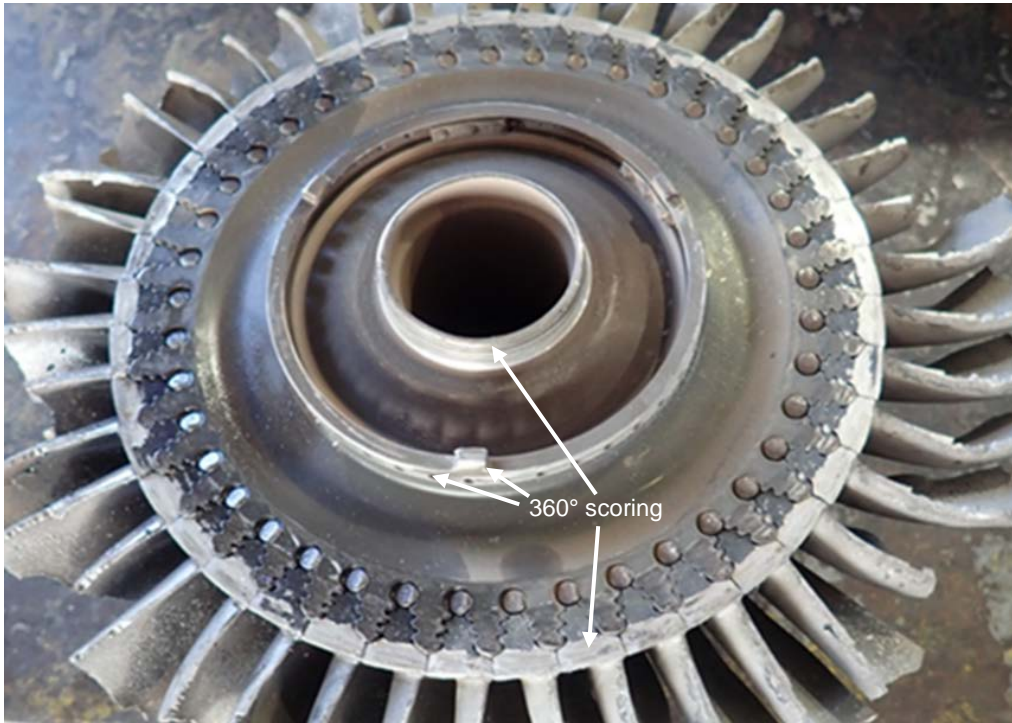
Figure 30. Power turbine upstream face showing circumferential contact damage

The power turbine upstream face was scored 360° along the disk outboard of the fir tree roots and at the center bore, balance ring and tooling lugs. See Figures 30 and 31.

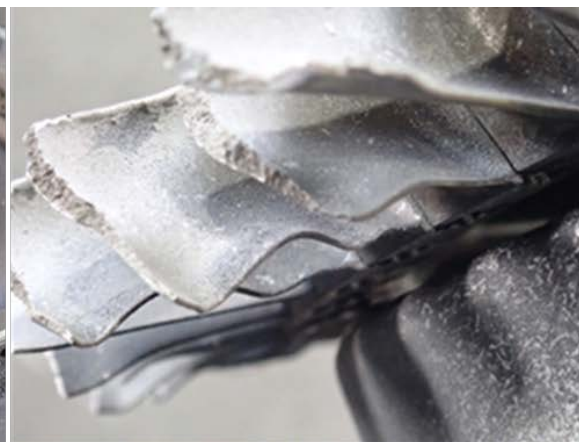
Figure 32. Power turbine airfoil bending

Undamaged areas of airfoil fracture surfaces were rough and uneven, consistent with overload. Some of the airfoil fracture surfaces were rubbed. The fracture surface of the tallest remaining airfoil exhibited thermal discoloration. The TEs of some airfoils displayed bending with a wavy appearance. See Figure 32.

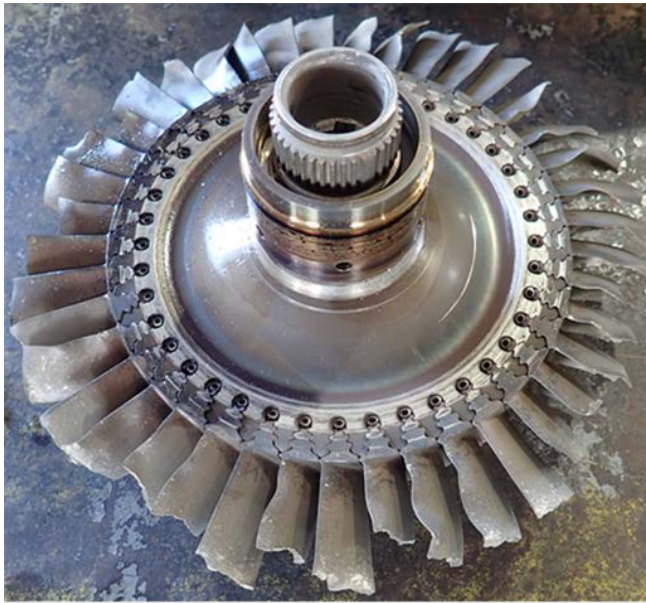
Figure 33. Power turbine downstream face showing heavy rotational scoring and aftward blade displacement

The downstream face of the power turbine was scored 360° along the base of the fir trees roots,

across the rivets diameter and on the disk face inboard of the rivets. Most of the blades were displaced aft. See Figures 34 and 35.

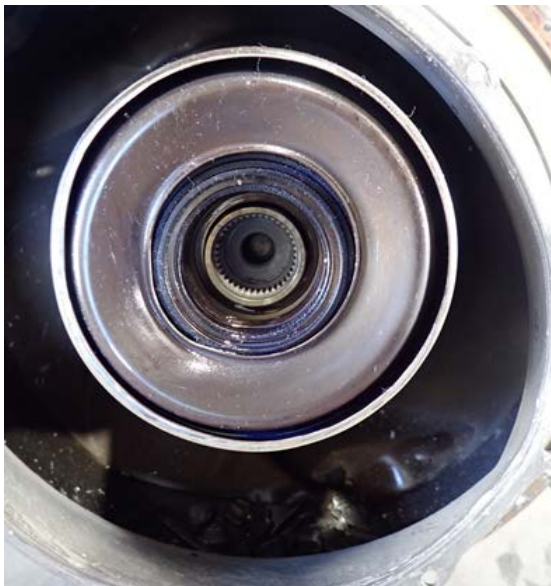
Figure 35. Exhaust duct rotational damage

The exhaust duct inner forward cone lip displayed rotational scoring. The No. 3 bearing cover inner lip was bent aft. See Figure 35. Impact marks were observed on the exhaust duct inside surfaces. Blade fragments were lying inside the duct at 6 o'clock. See Figure 36.

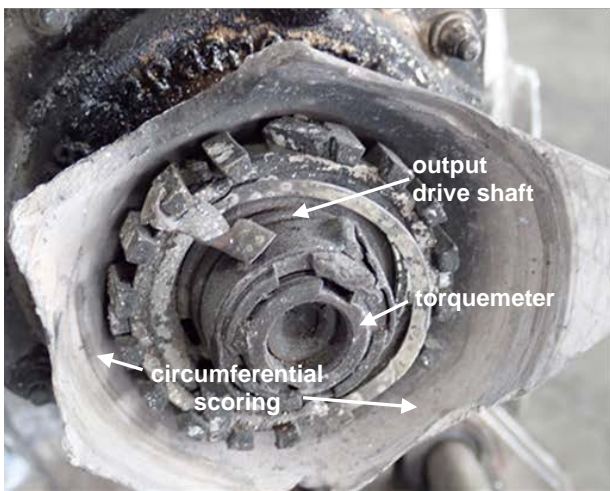
Figure 37. Circumferential scoring on the (airframe) flexible drive shaft coupling

Two of the three airframe coupling drive lobes were fractured off. Circumferential scoring was observed on the coupling surface. See Figure 37.

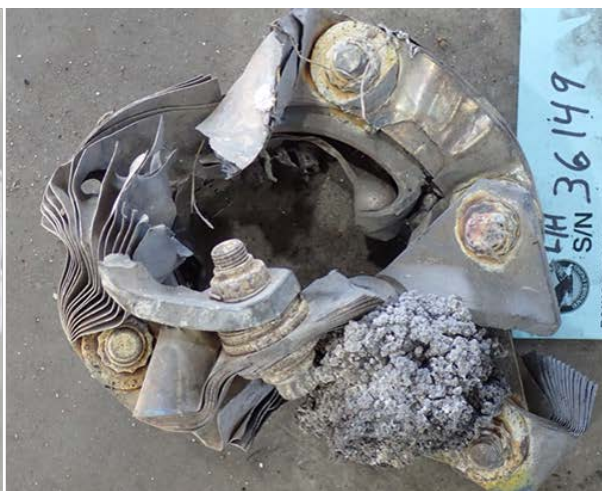
Figure 38. Section of airframe flexible drive shaft

The mating piece of the airframe flexible coupling was found nearby. It was distorted. See Figure 38.

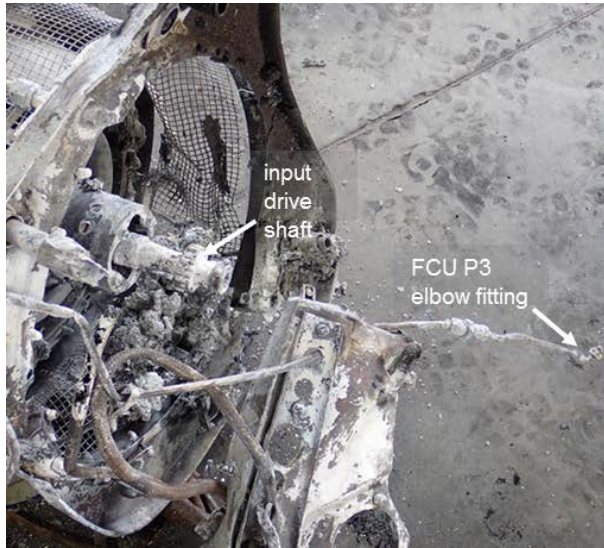
Figure 43. Compressor inlet with AGB and inlet case structure missing

Thermal destruction of the AGB and inlet case structure had displaced the compressor inlet screen and exposed the No. 1 bearing flexible housing. The inlet screen was distorted and coated with fire debris. See Figure 43.

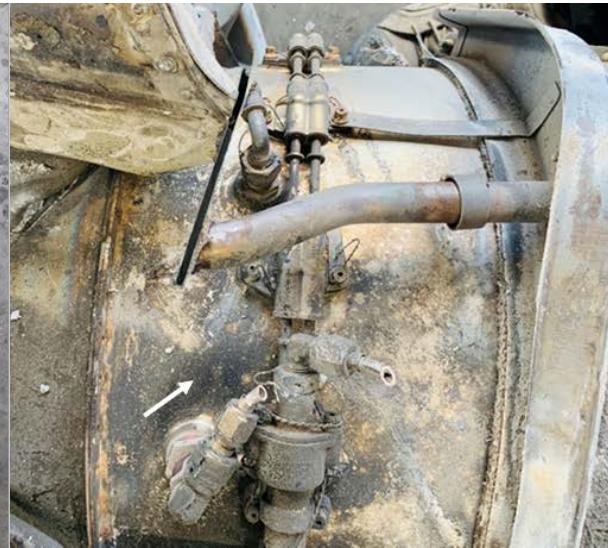
Figure 44. Dented gas generator case

The gas generator case exhibited multiple dents adjacent to the fuel nozzles between 4 and 8 o'clock. See Figure 44.

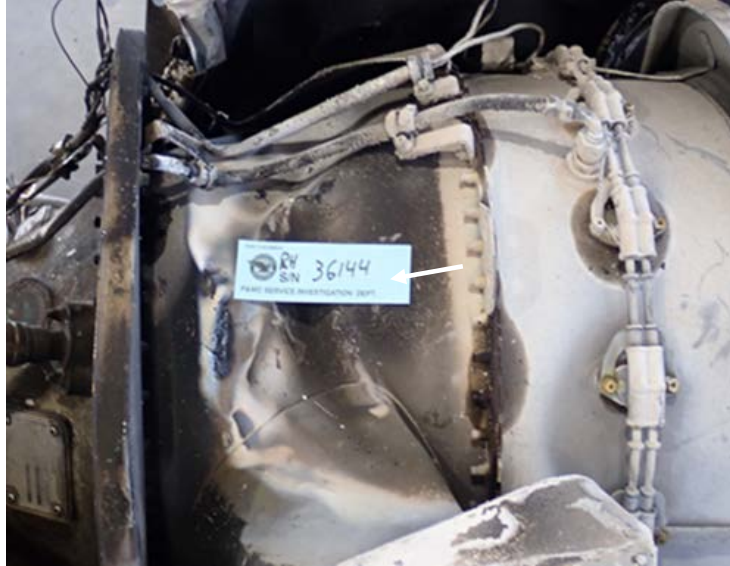
Figure 45. Exhaust duct compression damage

The exhaust duct was compressively deformed 360°. See Figure 45.

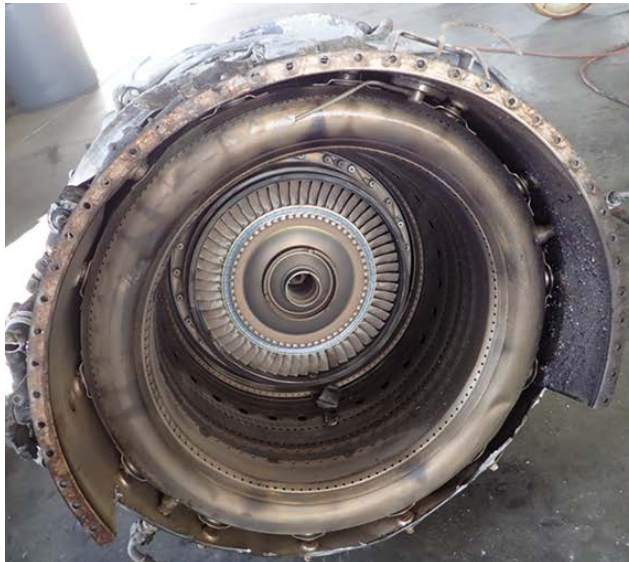
Figure 46. Compressor turbine and combustor after C flange separation

The exhaust stack exit port was severely distorted and was deformed over part of the C flange. The gas generator case was sectioned in this area to facilitate engine disassembly. The engine was separated at the C flange. Metal fragments were found lying on the inside surface of the PT housing and the combustion liner at 6 o'clock. See Figures 46 and 47.

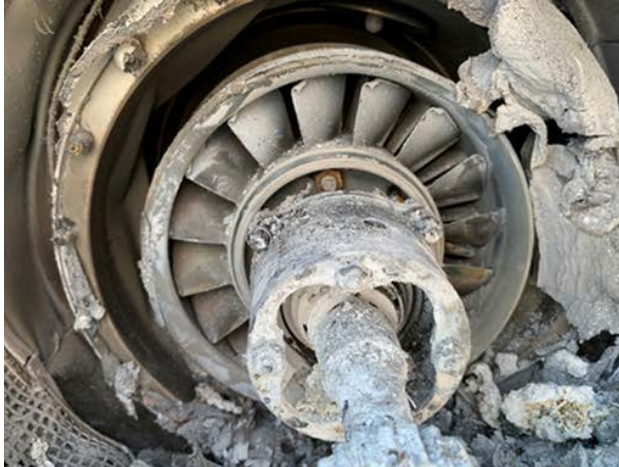
Figure 48. Compressor inlet showing No. 1 bearing package

The No. 1 bearing and stator air seal were thermally damaged and heavily contaminated with fire debris. See Figure 48. The bearing was seized. The S1 compressor blade tips were all curled in the direction opposite of rotation. See Figure 49. The S2 airfoils were intact.

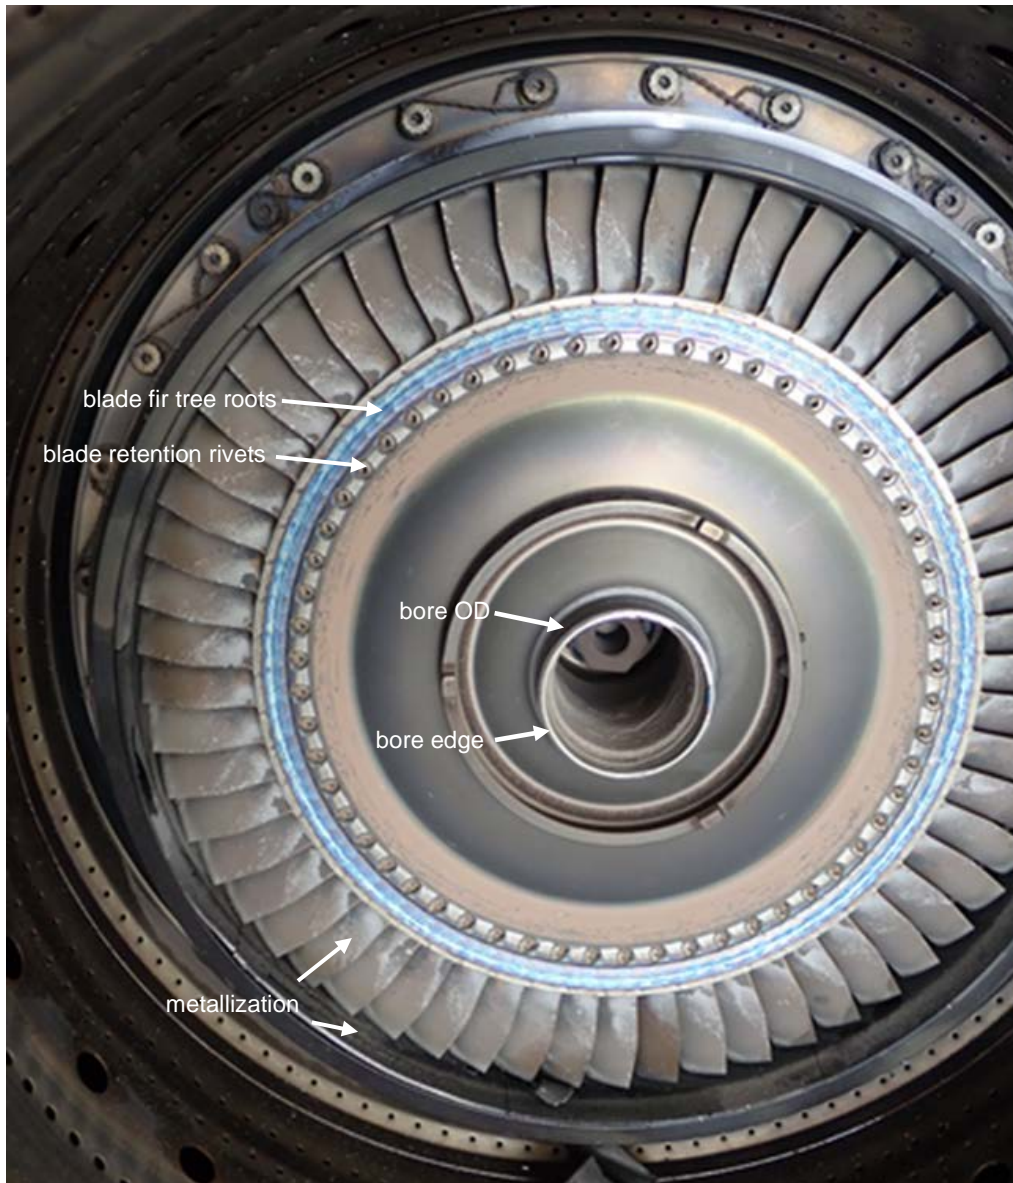
Figure 50. Compressor turbine downstream face showing rub 360° scoring

The compressor turbine downstream face was scored 360° along the fir tree roots, blade retention rivets, and at the bore outer surface and edge. There was heat discoloration along the fir tree roots and rivets. The compressor turbine shroud segments appeared intact and their viewable areas were coated with metal. Metallization was also observed on the compressor turbine blade TEs. See Figure 50.

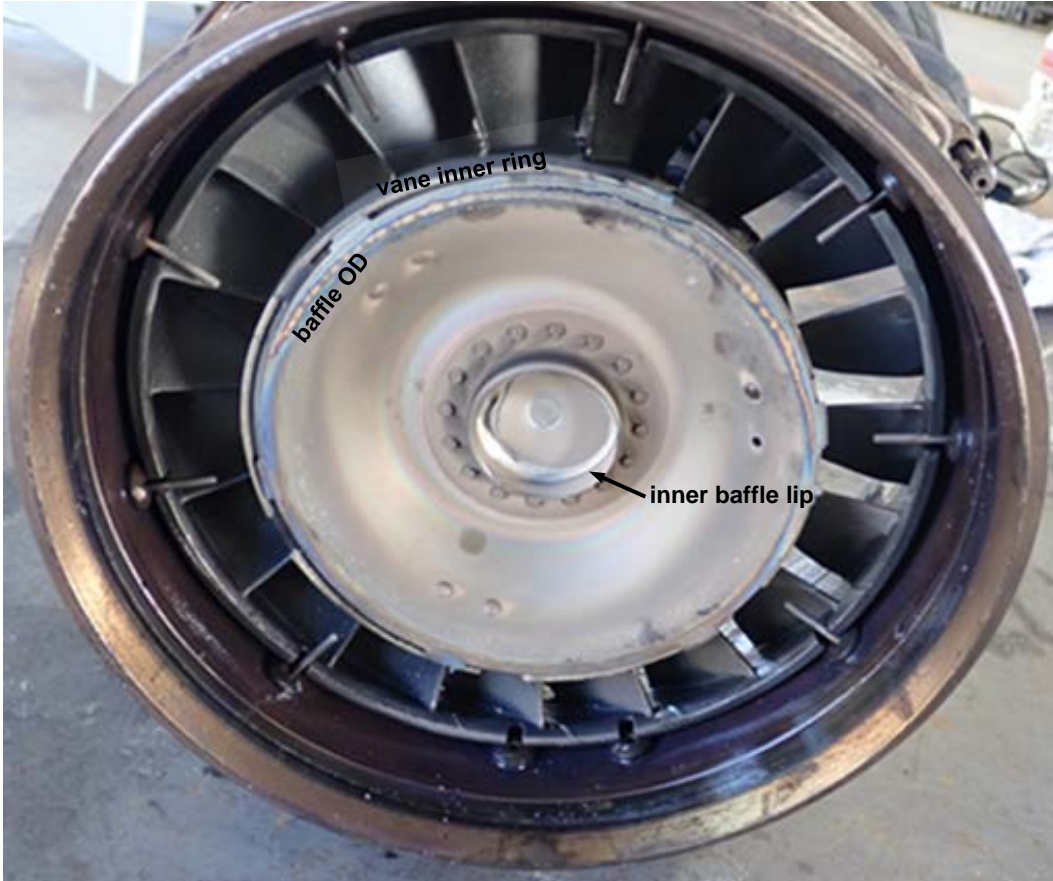
Figure 51. Upstream face of power turbine vane ring and baffle assembly showing rotational damage

The upstream face of the power turbine vane ring and baffle assembly displayed 360° scoring along the vane inner ring and baffle OD, and on the inner and outer baffle lip surfaces. There was heavy heat discoloration along the baffle OD, and it was separated from the vane inner ring in several areas. See Figure 51.

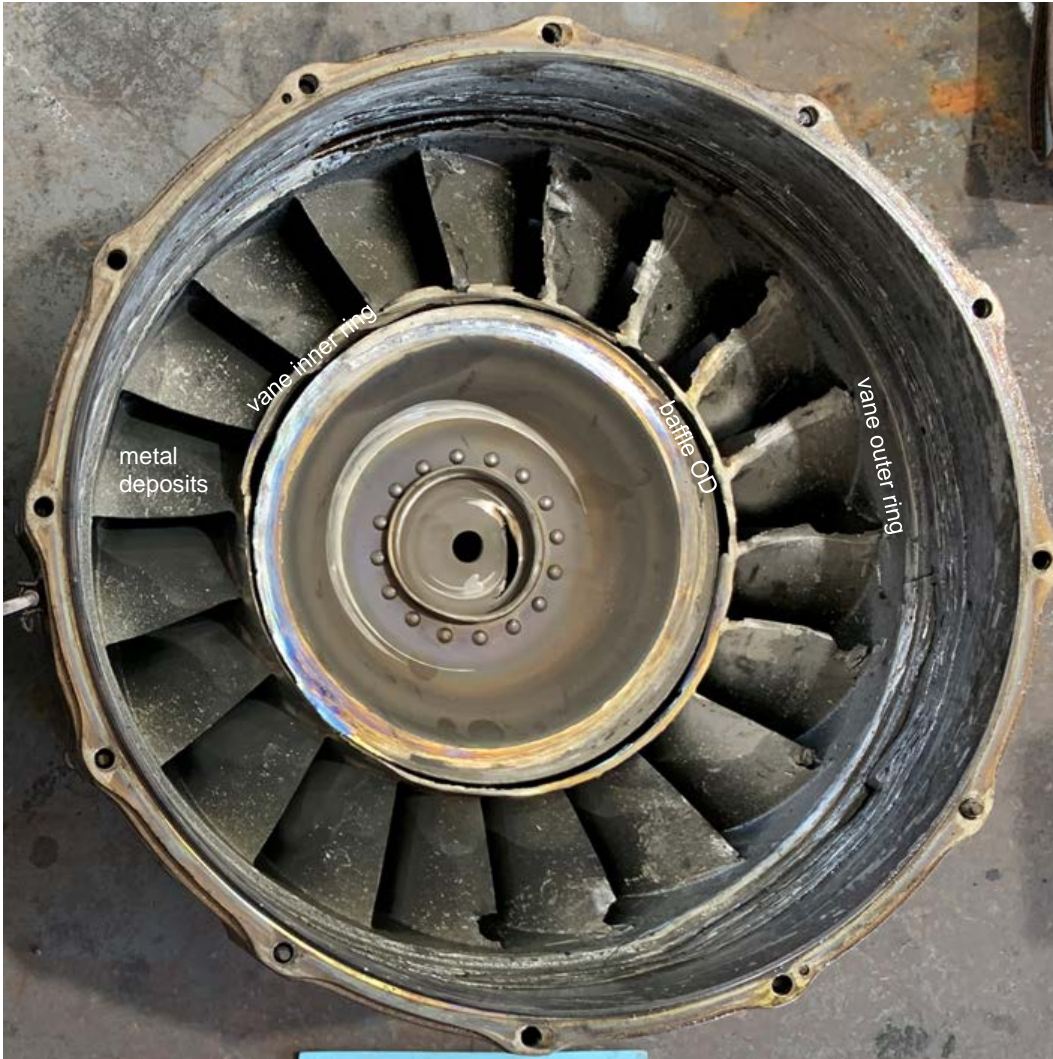
Figure 52. Downstream face of power turbine vane ring and baffle assembly, showing rotational damage

The downstream face of the power turbine vane ring and baffle assembly displayed 360° scoring along the inner vane ring edge and the baffle OD. There was heavy heat discoloration along the baffle OD, and it was partially separated from the inner vane ring. There were arcs of scoring on the baffle face between 6 and 2 o'clock and on the inner baffle face between 12 and 7 o'clock, where the material was penetrated between 2 and 5 o'clock. The vanes between 12 and 6 o'clock were missing chunks of TE material. Six of the vanes and the vane outer ring edge in this area were heavily rubbed and battered. The power turbine shroud was also battered, and the knife edges were obliterated. There were heavy metal deposits on the vane TEs. The air path showed some isolated impact marks. See Figure 52.

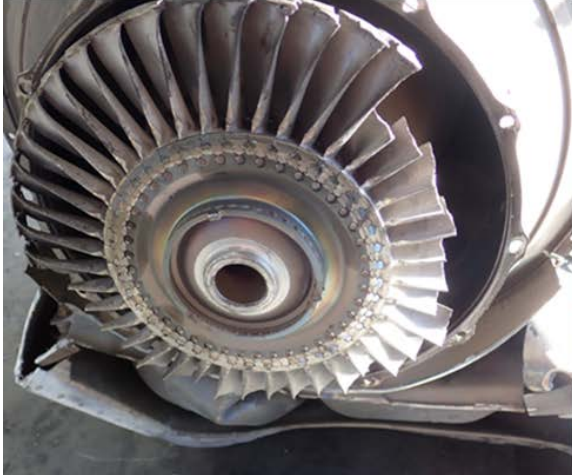
Figure 53. Power turbine with power turbine vane ring and baffle assembly removed

Following separation, the PT rotor turned freely by hand and continuity to the output shaft was established. The bolt bore edge was severely scored 360°, with metal displacement into the bore, decreasing the bore diameter in this area. The tooling lugs all showed local scuff/rub marks. See Figure 53. The power turbine upstream face was heavily rubbed 360° outboard of the blade retention rivets and there was heavy rub along the blade leading edges (LEs) adjacent to the platform. See Figure 54.

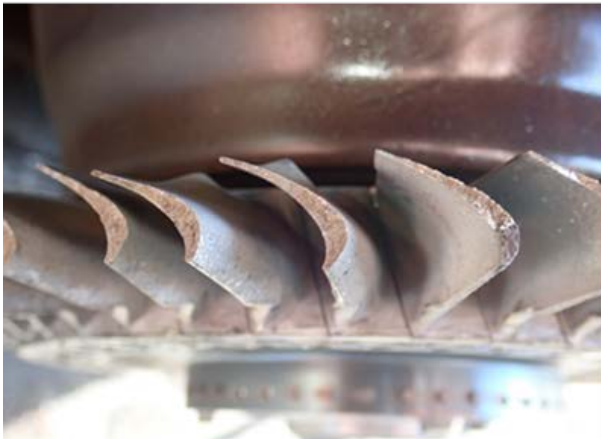
Figure 55. Power turbine blade fracture surfaces

Twenty-five blades were fractured. The remaining blade stubs were 1.0 to 1.6 inches long. The airfoil fracture surfaces were rough and uneven, consistent with overload. See Figure 55. The 16 remaining blades were intact; their shrouds exhibited heavy tip rub, and some of the shroud material was missing. See Figure 56.

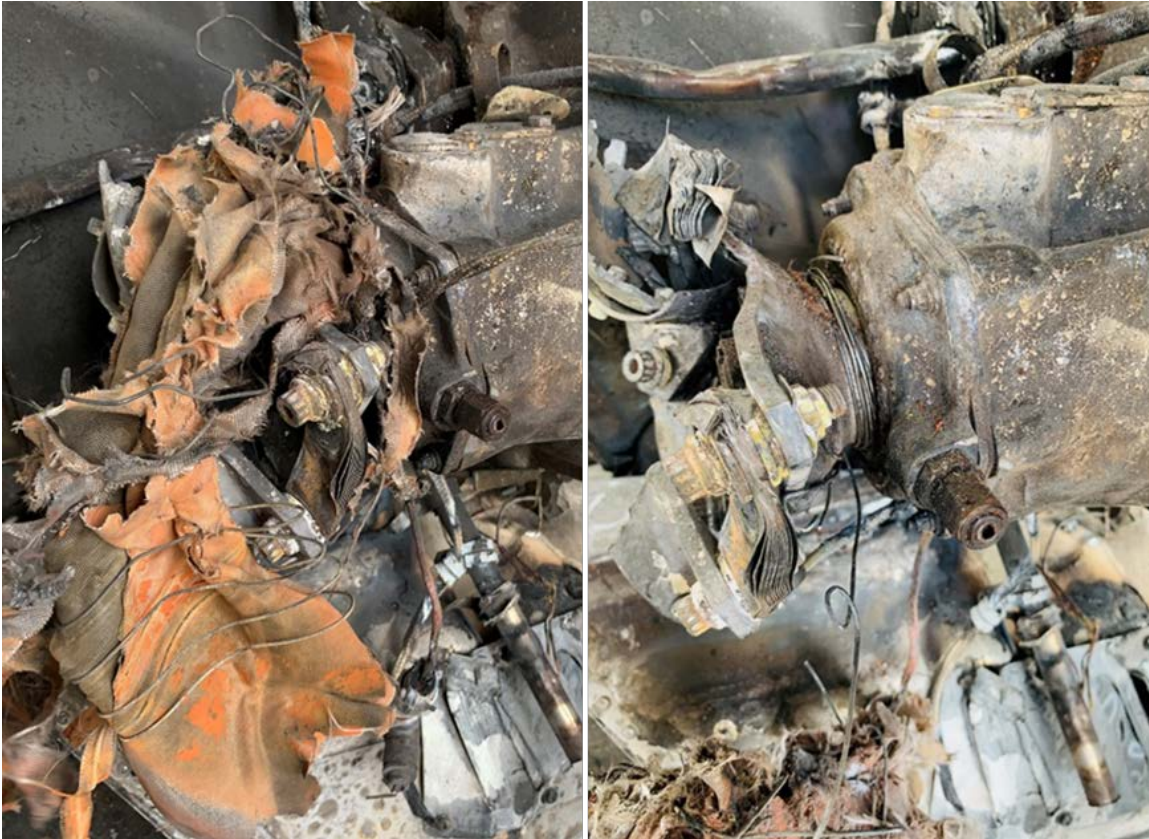
Figure 57. Engine output shaft with hose material    Figure 58. Wire wrapped around engine output shaft

EEC cooling hose material was attached at the RGB in the output shaft area.<sup>12</sup> See Figure 57.

Structural wire from the cooling hose was found wrapped around the output shaft. See Figure 58.

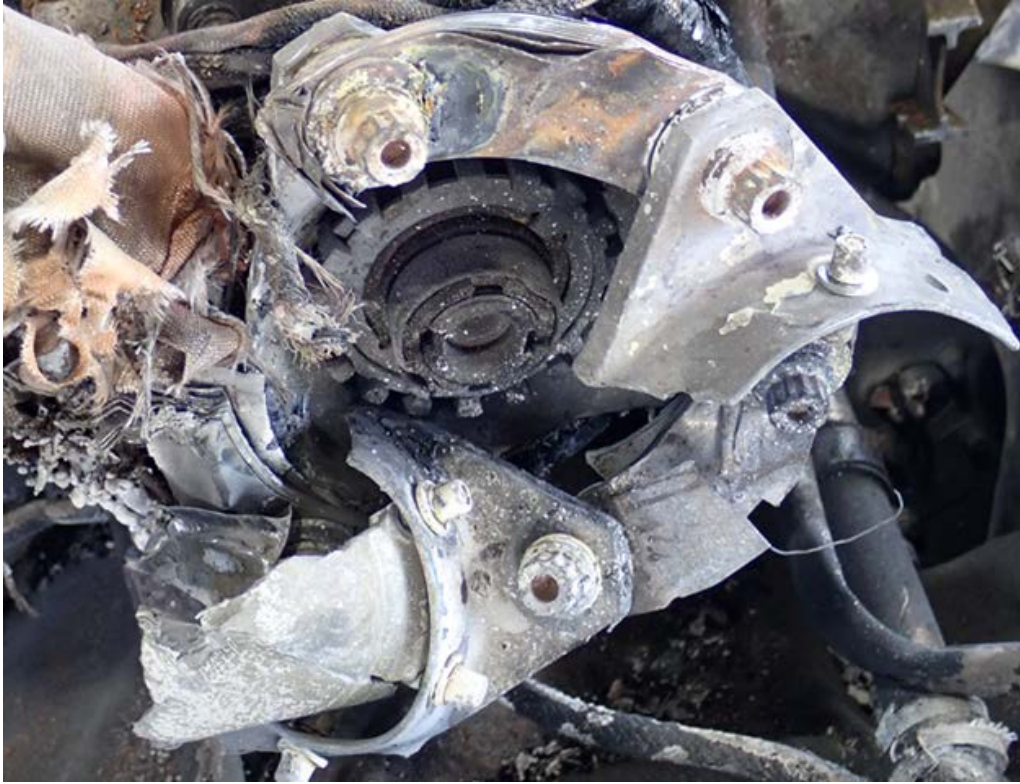
Figure 59. Distorted airframe coupling attached at engine output shaft

The airframe-supplied engine output coupling was attached to the engine. See Figure 59.
