National Transportation Safety Board

WPR22FA004

ACCIDENT SITE, AIRFRAME, AND ENGINE EXAMINATION

Location: Santee, California
Date: October 11, 2021
Time: 1214 Pacific daylight time
Airplane: N7022G, Cessna 340A

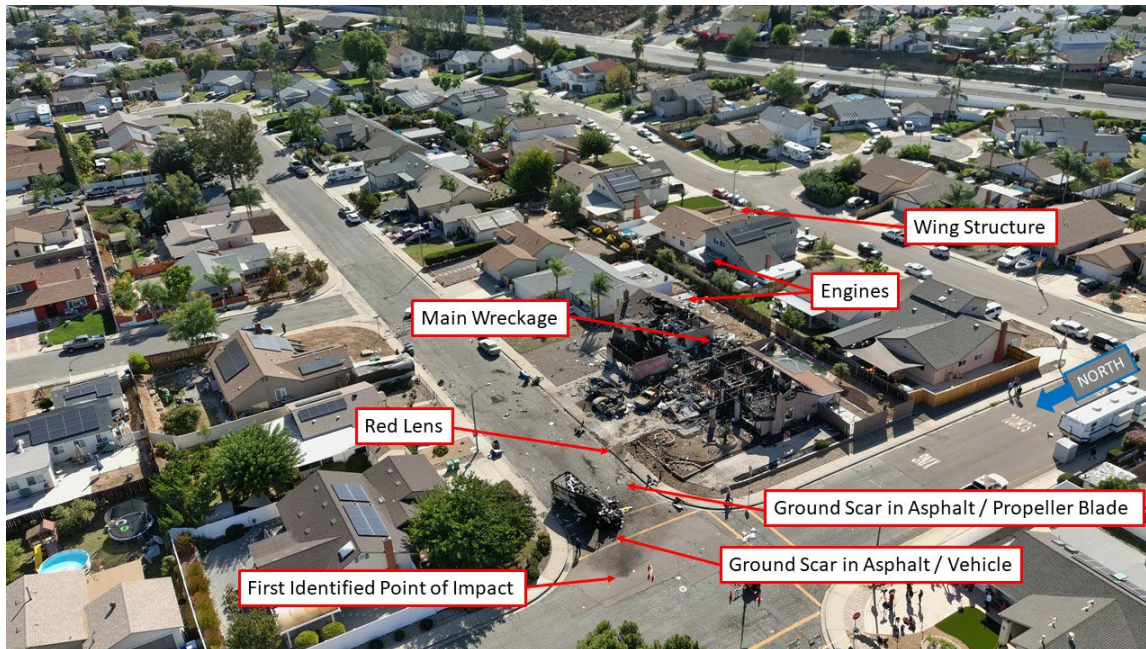
Examination of the accident site revealed that the airplane impacted a residential street on a heading of about 113° magnetic heading. The debris path, which consisted of various airplane, vehicle, and residential structure debris was about 475 ft long and 400 ft wide, oriented on a heading of about 132°. Numerous residential structures exhibited impact related damage and or fire damage.

Figure 1: Annotations of wreckage locations. Aerial photo provided by San Diego County Sheriff.

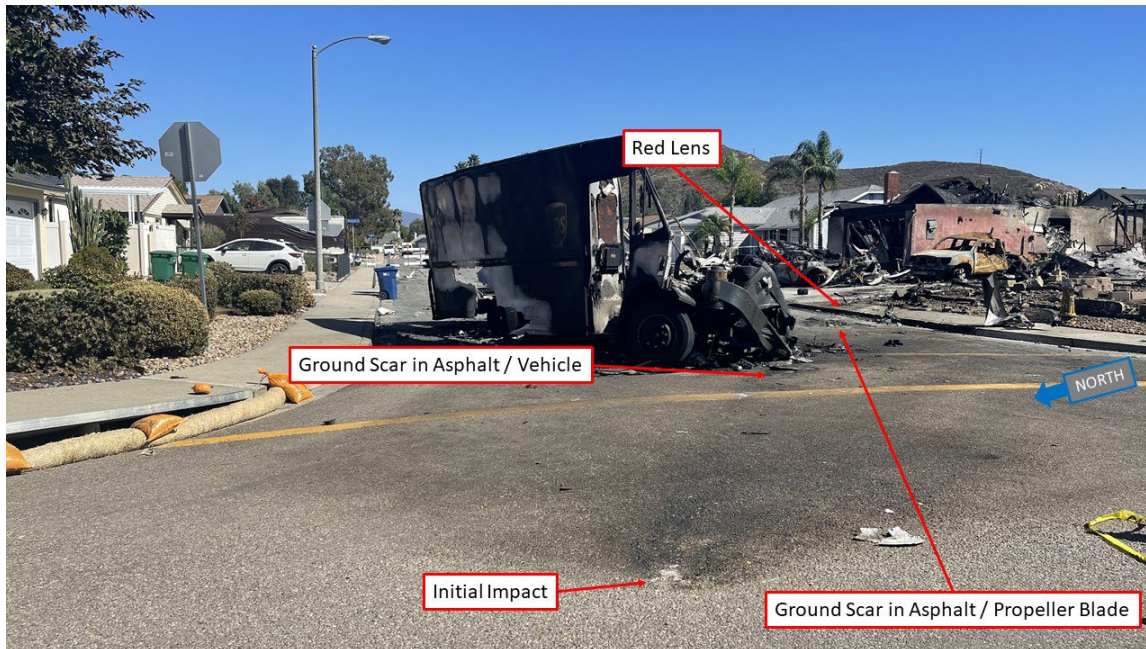
The first identified point of contact (FIPC) was a gouge in the asphalt road about 10 inches long and 5 inches wide. Scrape marks extended from about 18 ft from the FIPC to a second gouge in the asphalt, which was about 2 ft wide and 3 ft long, along with a damaged vehicle. Adjacent to the second scrape mark and vehicle, was an additional gouge in the asphalt, about 2 ft long and 4 inches wide. Additional scrape marks extended 28 ft to a large impact crater within the asphalt, which was about 4 ft wide, 3 ft long, and about 6 inches deep, and contained a portion of propeller blade. Additional scratch marks extended another 12 ft to portions of red lens, consistent with the left wing navigation lens.

Figure 2: Initial impact area.

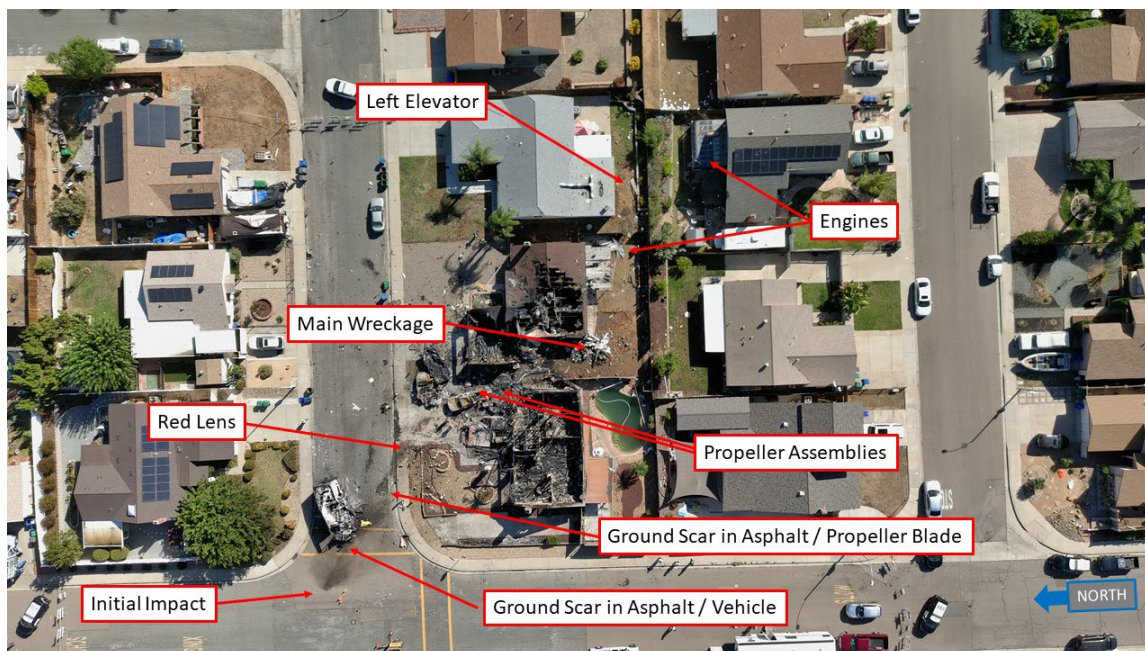
The left and right propeller assemblies were located about 110 and 115 ft from the FIPC. The main wreckage, which consisted of both wings, fuselage structure, and empennage was located about 166 ft from the FIPC. The left elevator was located about 233 ft from the FIPC.

One engine was located about 199 ft from the FIPC and a second engine was about 250 ft from the FIPC. Portions of wing structure were located about 355 ft from the FIPC. Additional light debris consisting of a vacuum pump and metal fragments were located about 475 ft from the FIPC.

Figure 3: Annotations of wreckage locations. Aerial photo provided by San Diego County Sheriff.

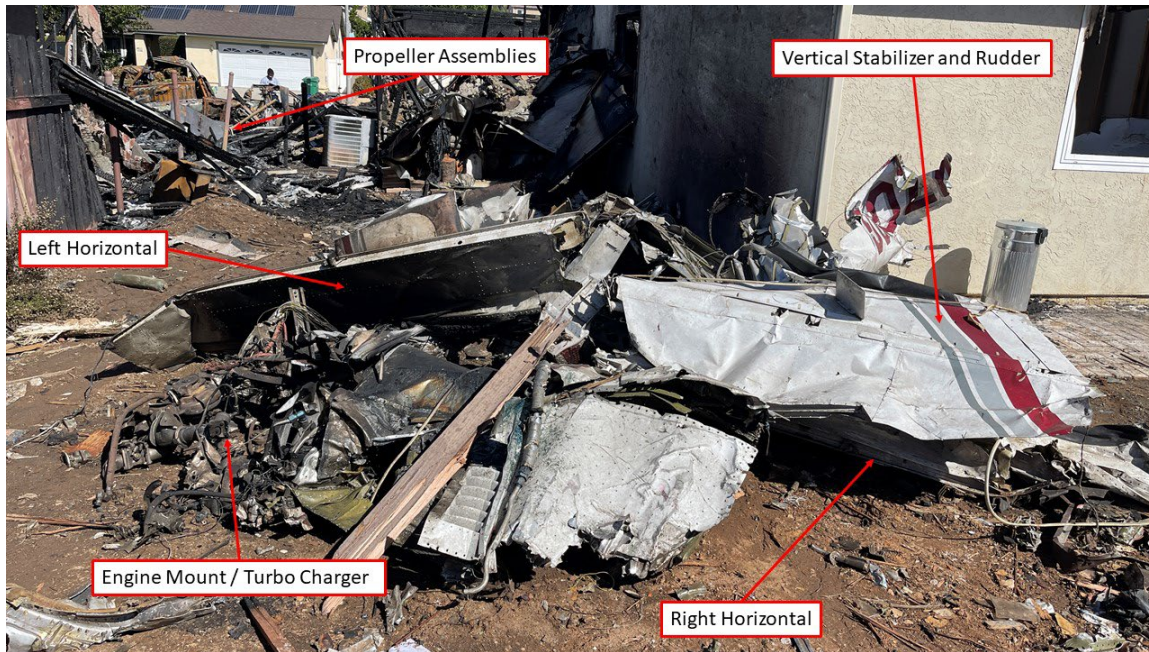
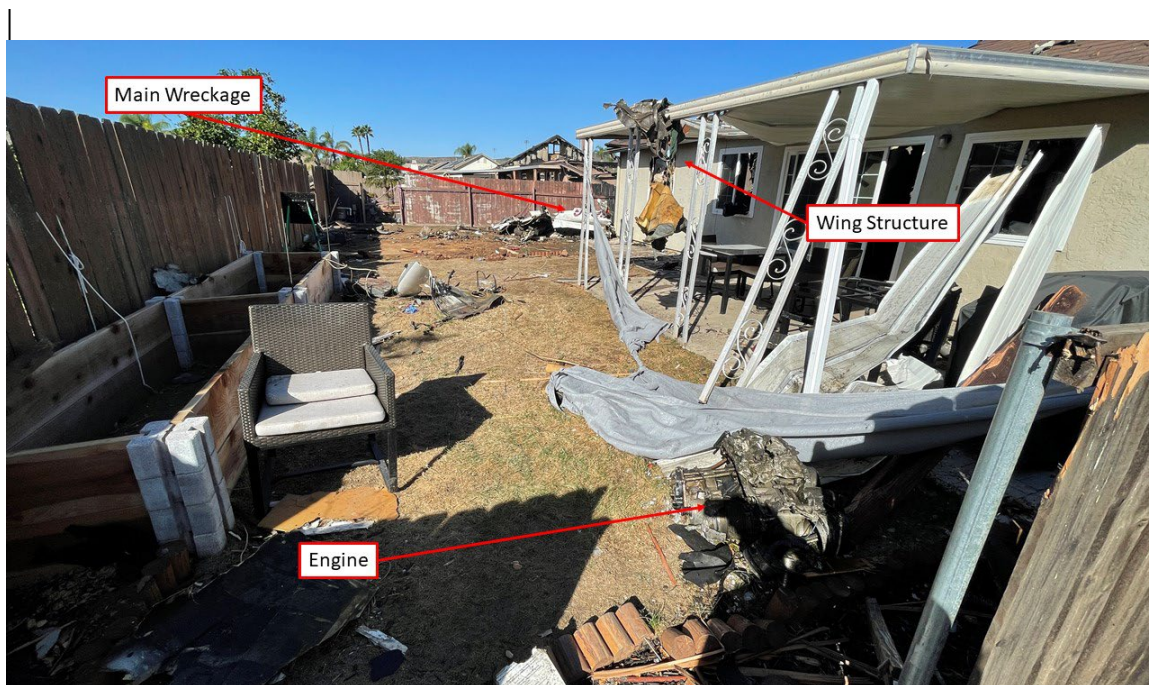
Examination of the main wreckage revealed that the fuselage and wings were located within the main wreckage and exhibited extensive fire damage and fragmentation throughout. Both engines were separated from their respective mounts. The empennage exhibited extensive crushing throughout. The left horizontal stabilizer was impact damaged and the left elevator was separated and located adjacent to the main wreckage within the debris path. The right horizontal stabilizer was impact damaged and was torn open from the leading edge aft about 30 to 40 inches from the outboard tip. The right elevator was separated. The outboard approximate 50 inches of the right elevator was located within the debris area. however, the inboard portion of the right elevator and trim tab were not located. The vertical stabilizer and rudder remained attached to the empennage structure and exhibited impact damage.

Figure 4: Main wreckage area.

Figure 5: Main wreckage area.

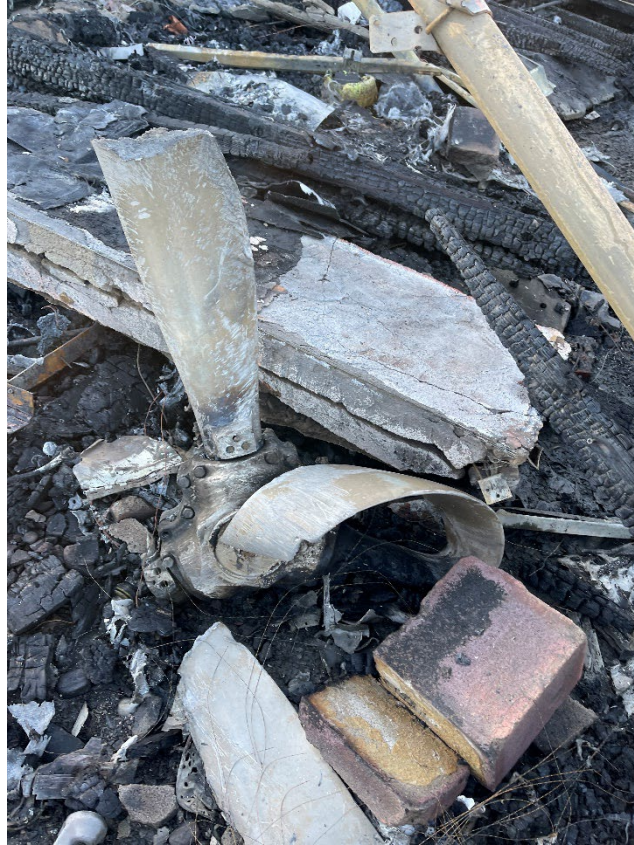
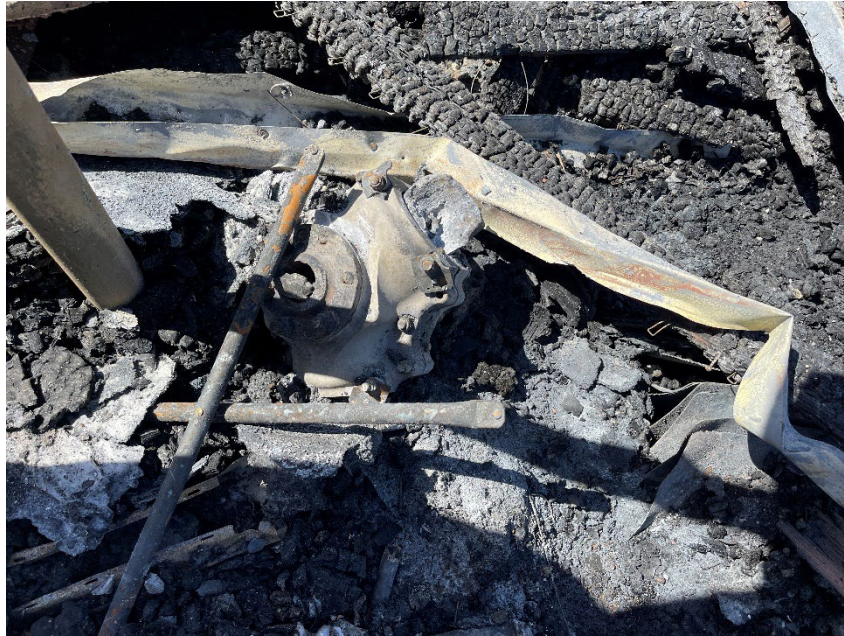
Both propeller assemblies were separated from the engines and exhibited varying degrees of propeller blade separation. Fragments of the propeller blades were located throughout the wreckage debris path. All recovered fragments exhibited chordwise striations, gouges, and polishing along the cambered side of the blade.

Figure 6: Propeller assembly.

Figure 7: Propeller assembly.

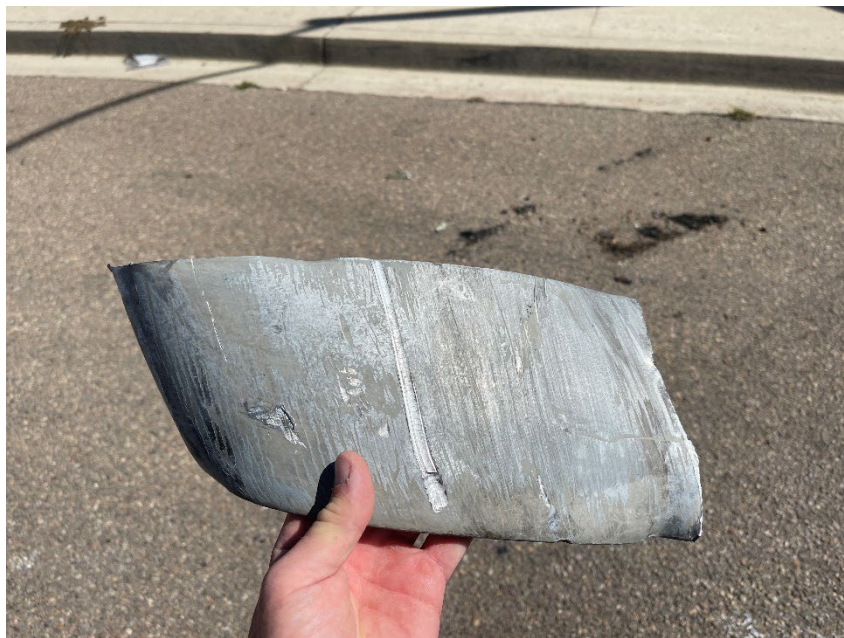
Figure 8: Recovered propeller blade fragment.

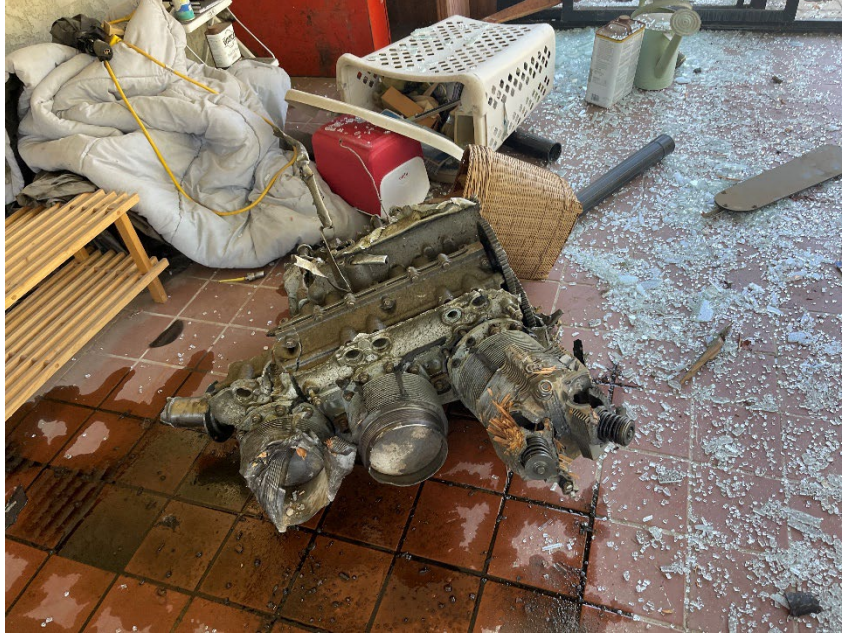
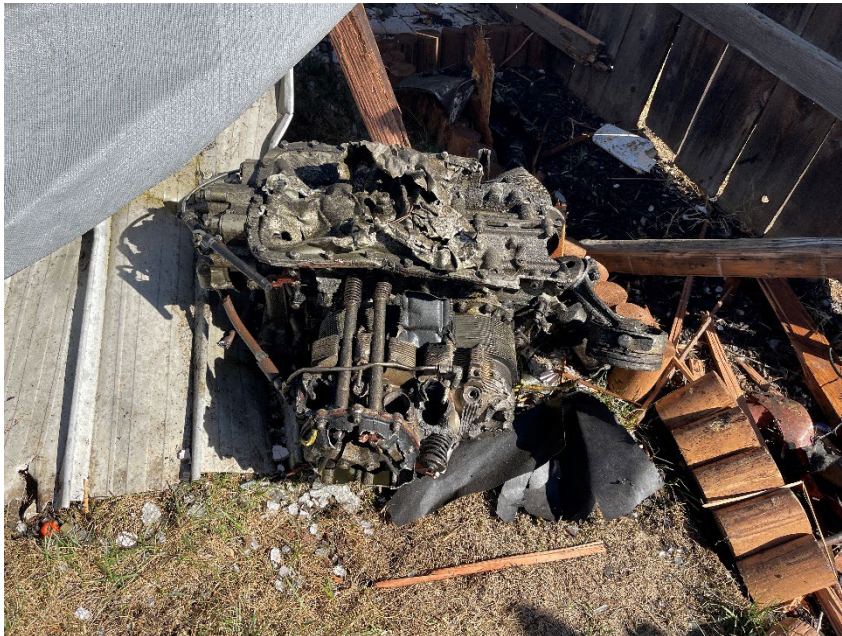
Both engines were heavily impact damaged, with engine accessories separated, and varying degrees of cylinder damage. Both engine crankcases exhibited impact damage to the forward area of the crankcase, exposing internal engine components. The engine turbochargers were fragmented into multiple sections and located throughout the wreckage debris area.

Figure 9: Engine.

Figure 10: Engine
