**NATIONAL TRANSPORTATION SAFETY BOARD**  
Vehicle Recorder Division  
Washington, DC 20594

## **Image/Video Study**

Location: Chamberlain, South Dakota  
Date: November 30, 2019  
Aircraft: Pilatus PC-12/47E, N56KJ  
Operator: Private  
NTSB Number: CEN20FA022

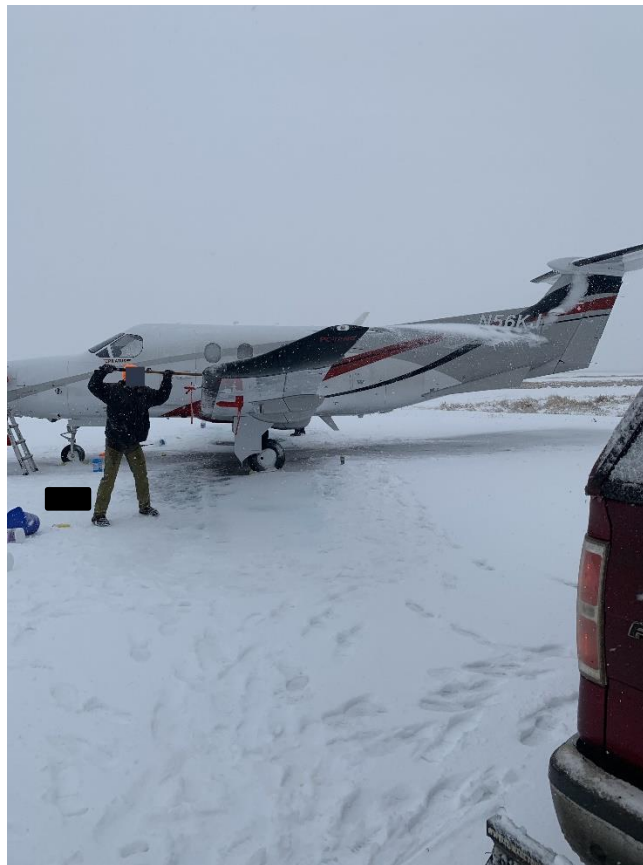
#### IMG\_7372.jpg – 11:02:49 A.M.

Figure 1 is an original unaltered photo of the aircraft at 11:02:49 A.M. The aircraft is on the ramp and a person is using a tool to deice the left wing. There is a ladder visible near the nose of the aircraft.

Figure 1. A photo taken at 11:02:49 A.M.

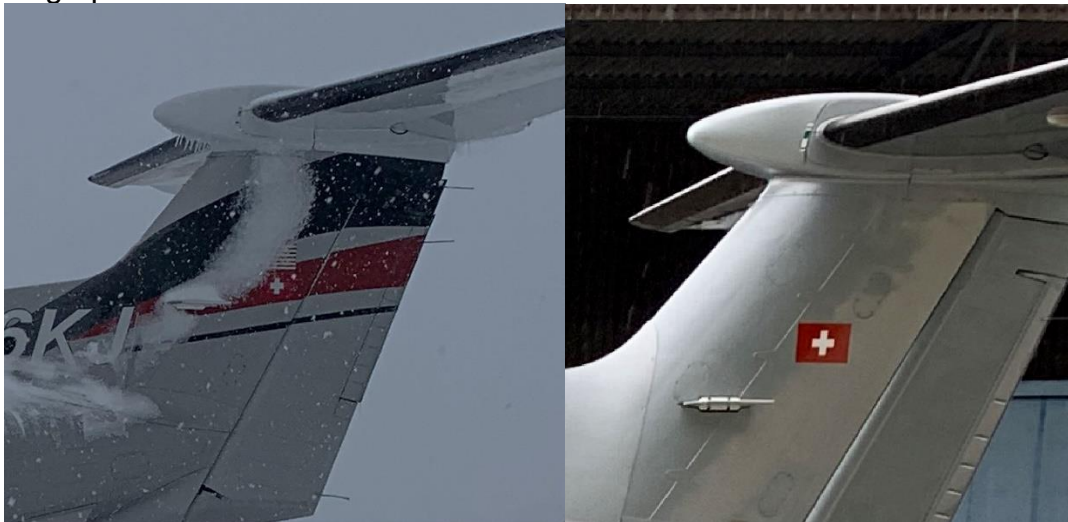
Figure 2 is a comparison between IMG\_7372.jpg zoomed in to show the aircraft's horizontal stab area. This photo has been cropped and the brightness and contrast has been adjusted. The photo on the right is that of an exemplar PC-12 taken at a similar angle by engineers at a Pilatus facility in Europe. An iPhone XR was used and the focal length was matched the represent the focal length shown in the metadata of the original photo. This focal length corresponded with the iPhone XR's widest setting. The comparison shows accumulated precipitation build-up above the leading edge of the horizontal stab. It also shows accumulated precipitation had built up on the vertical stab and icicles were present on the horizontal stab bullet fairing. There is visible moisture falling present in the photograph.

**Figure 2. A comparison between IMG\_7373.jpg and a photo of an exemplar PC-12 taken from a similar angle.**

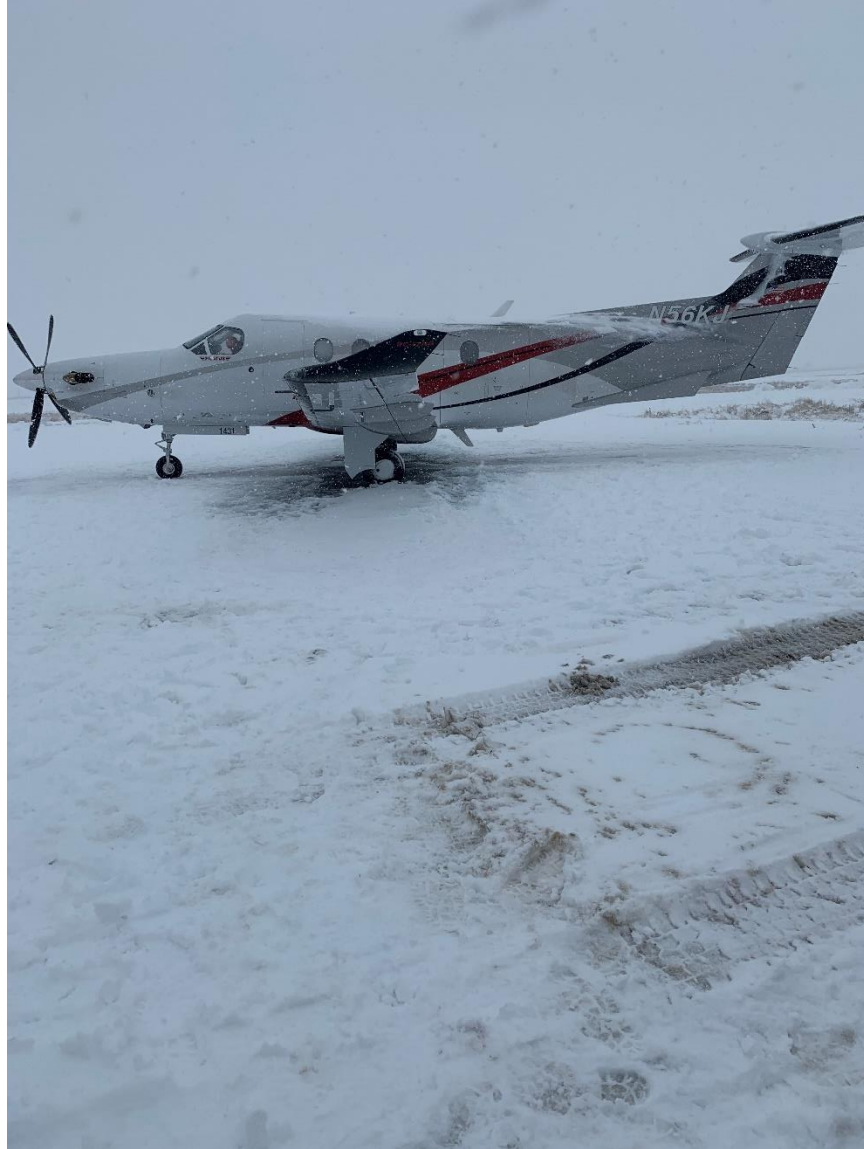
### **IMG\_7377.jpg – 12:21:40 P.M.**

Figure 3 is an original unaltered photo of the aircraft at 12:21:40 P.M. The ladder that was visible previously near the nose is no longer in the image frame. There is an individual present in the cockpit.

**Figure 3. A photo taken at 12:21:40 P.M.**

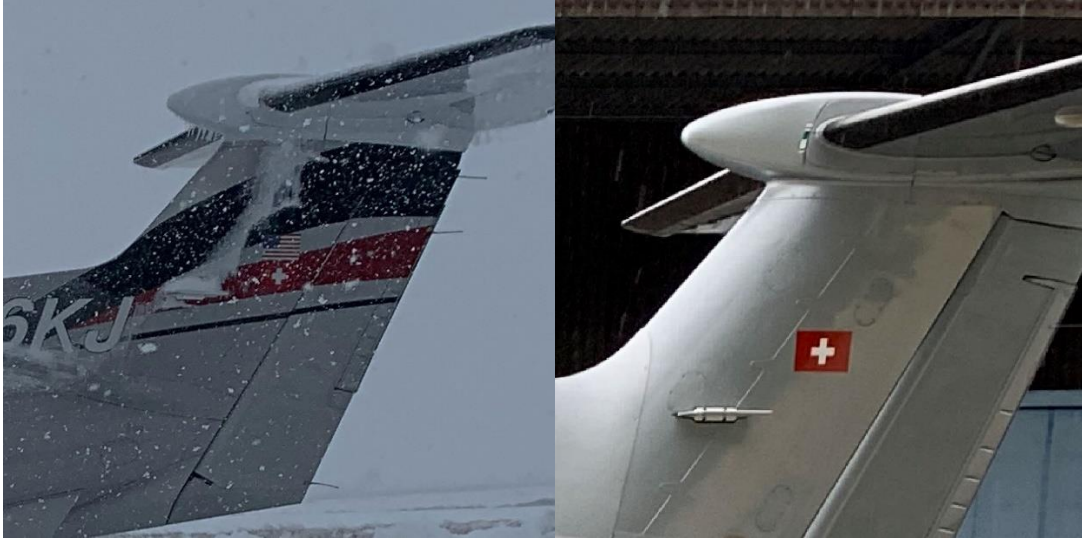
Figure 4 is a comparison between IMG\_7377.jpg zoomed in to show the aircraft's horizontal stab area. This photo has been cropped and the brightness and contrast has been adjusted. The photo on the right is that of an exemplar PC-12 taken at a similar angle by engineers at a Pilatus facility in Europe. An iPhone XR was used and the focal length was matched the represent the focal length shown in the metadata of the original photo. This focal length corresponded with the iPhone XR's widest setting. The photo on the left shows accumulated precipitation forward of the horizontal stab's leading edge. The comparison shows accumulated precipitation build-up above the leading edge of the horizontal stab. It also shows accumulated precipitation build-up on the vertical stab and icicles were present on the horizontal stab bullet fairing. There is more visible moisture present falling when compared to the photograph taken at 11:02:39 A.M.

Figure 4. A comparison between IMG\_7377.jpg and a photo of an exemplar PC-12 taken from a similar angle.

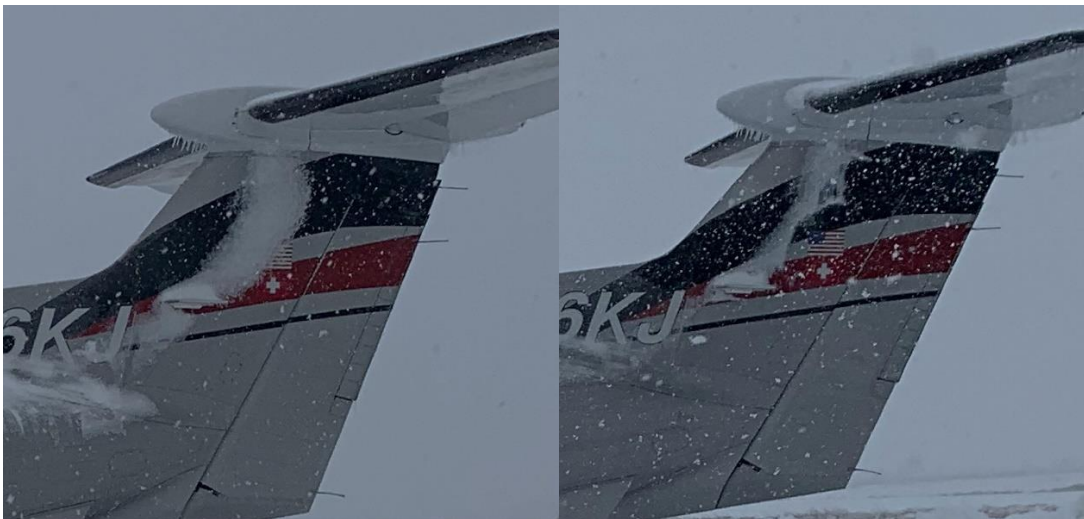
Figure 5 is a comparison of IMG\_7372.jpg taken at 11:02:49 A.M. and IMG\_7377.jpg taken at 12:21:40 P.M. The amount of time between these two photos was 1 hour 18 minutes and 51 seconds. Each of these photos have been cropped and the brightness and contrast adjusted to similar levels. In IMG\_7377.jpg there is additional accumulated precipitation when compared to IMG\_7372.jpg. Additionally, there is more visible moisture present falling in IMG\_7377.jpg when compared to IMG\_7372.jpg.

Figure 5. A comparison between IMG\_7372.jpg (left) and IMG\_7377.jpg (right)

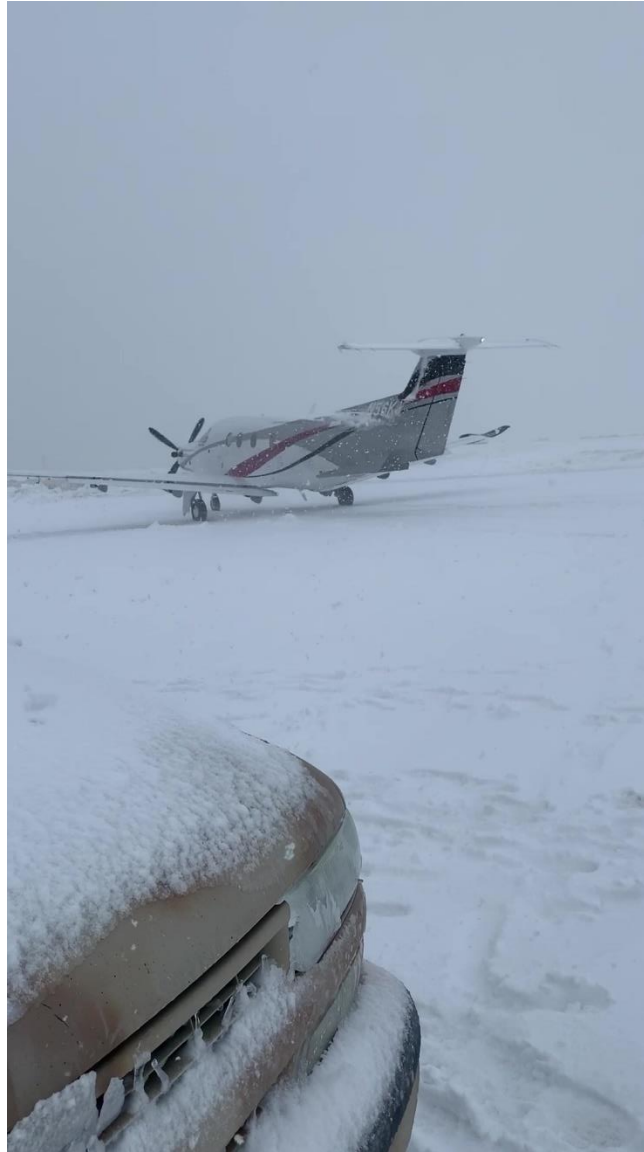
## IMG\_7378.mov

Figure 6 is an unaltered still image export from IMG\_7378.mov. The video file shows the accident aircraft taxiing for takeoff.

Figure 6. An exported still image from IMG\_7378.mov.

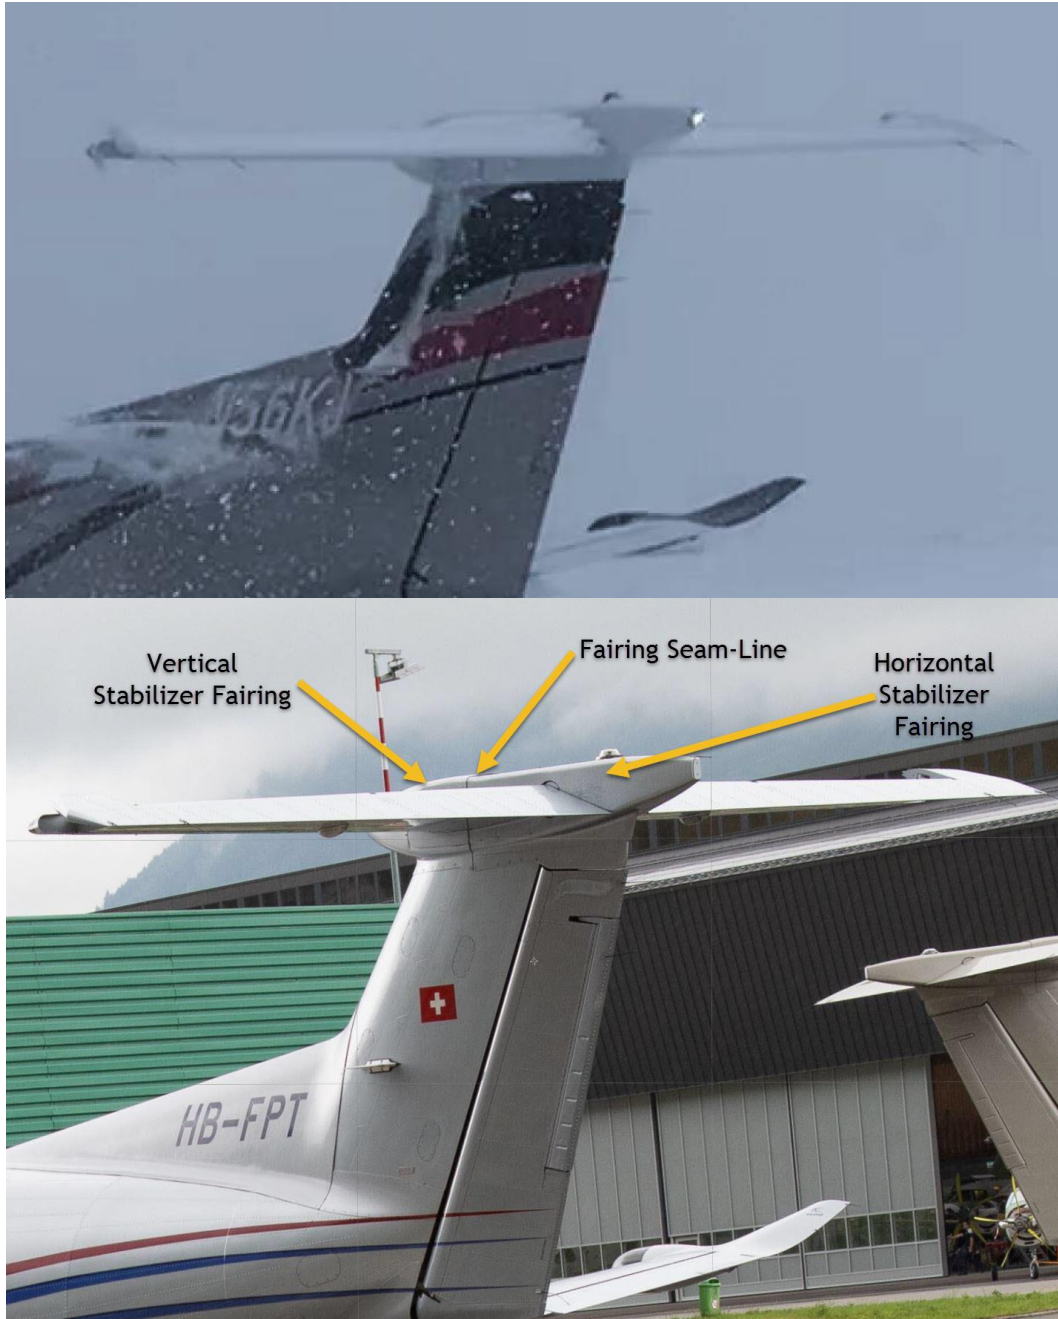
Figure 7 is a comparison between IMG\_7378.mov zoomed in to show the aircraft's horizontal stab area. The photo on the right is that of an exemplar PC-12 taken at a similar angle taken at a Pilatus facility in Europe. The focal length of the original video still could not be determined. A Canon SLR was used to replicate the original still image export as closely as possible. A ladder was used to replicate the eye height of the original recording. Pilatus engineers reported that the elevator control surface will typically rest in a full nose down position when no input to the controls are made and that the elevator control surface deflection observed in the original

still export from the original witness video corresponded with a full nose down elevator deflection. Figure 7 shows the original still export cropped and zoomed (top) in comparison to the exemplar photo taken at the Pilatus facility (bottom). The exemplar photo taken at the Pilatus facility is annotated to show the vertical stabilizer fairing, the horizontal stabilizer fairing and the seam-line between the two fairings.

Figure 7. A comparison between a still image from IMG\_7378.mov (top) and a photo of an exemplar PC-12 (bottom) taken from a similar angle.

The exemplar photo at the bottom of figure 7 shows the free area above the horizontal stab in relation to the amount of vertical stabilizer fairing, the horizontal stabilizer fairing and the seam-line between the two fairings that is visible. In the photo of the accident aircraft at the top of figure 7, accumulated precipitation is visible on the top surface of the horizontal stab. The accumulated precipitation obscures some of the free area seen on the exemplar photo when related to surface area visible on the vertical stabilizer fairing, the horizontal stabilizer fairing and the seam-line between the two fairings.
