NATIONAL TRANSPORTATION SAFETY BOARD
Vehicle Recorder Division

Cockpit Voice Recorder

Specialist's Factual Report
By Christopher Babcock

Location: Kake, Alaska
Date: January 29, 2019
Aircraft: Hawker Beechcraft B200 Super King Air, Registration N13LY
Operator: Guardian Flight LLC
NTSB Number: ANC19FA012

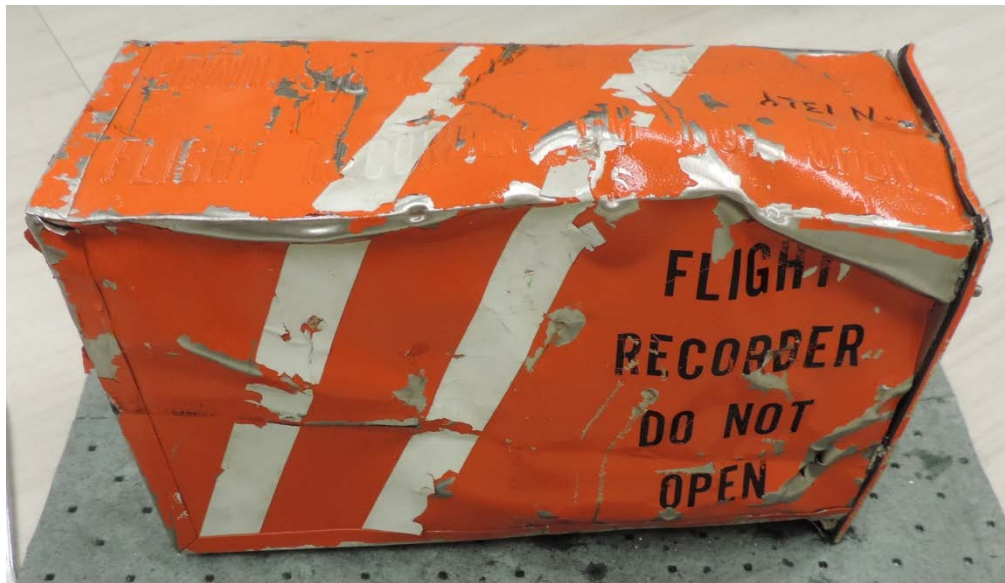
Upon arrival at the laboratory, the recorder was submerged in distilled water. The recorder exhibited impact damage (Figure 1). The recorder was opened, and the crash protected memory unit was extracted and thoroughly rinsed and soaked in deionized water to more effectively remove salt deposits on the unit (Figure 2). After soaking, the unit was dried in a vacuum oven.

Figure 1. Condition of CVR, as received.

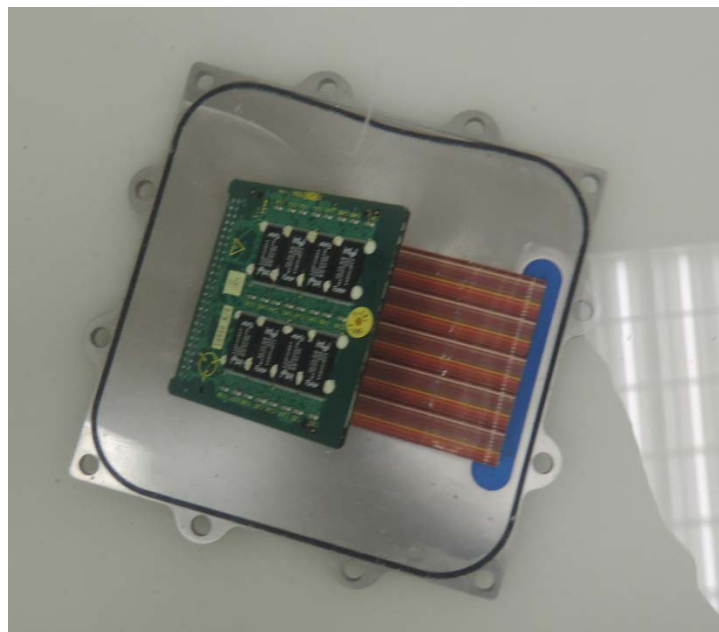
Figure 2. Memory board soaking in deionized water.

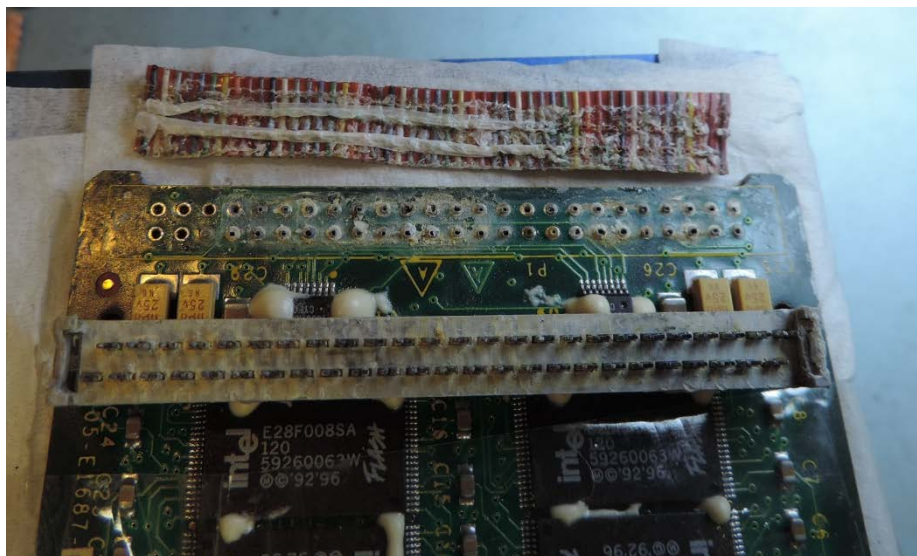
The first attempt to download the audio using the manufacturer's procedures and a laboratory surrogate recorder were not successful. Removal of the connector connecting the ribbon cable and memory board revealed substantial corrosion (Figure 3) causing the solder joints to degrade. The memory board was cleaned, and a new connector was soldered in place and connected to the ribbon cable. The connector on the other end of the ribbon cable was replaced as well (Figure 4). The second attempt to download the audio was successful.

Figure 3. Corrosion found under connector.

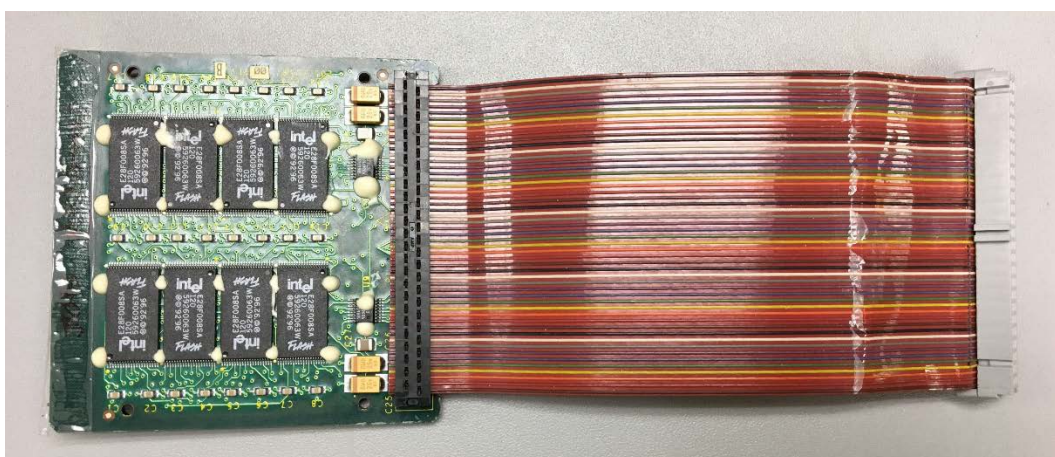
Figure 4. Repaired memory board and connectors.
