NATIONAL TRANSPORTATION SAFETY BOARD

Specialist's Factual Report
By Christopher Babcock

Location: Yukon, Oklahoma
Date: March 18, 2019
Aircraft: Israel Aerospace Industries Westwind 1124
Registration: N4MH
Operator: Sundance Airport FBO LLC
NTSB Number: CEN19FA104

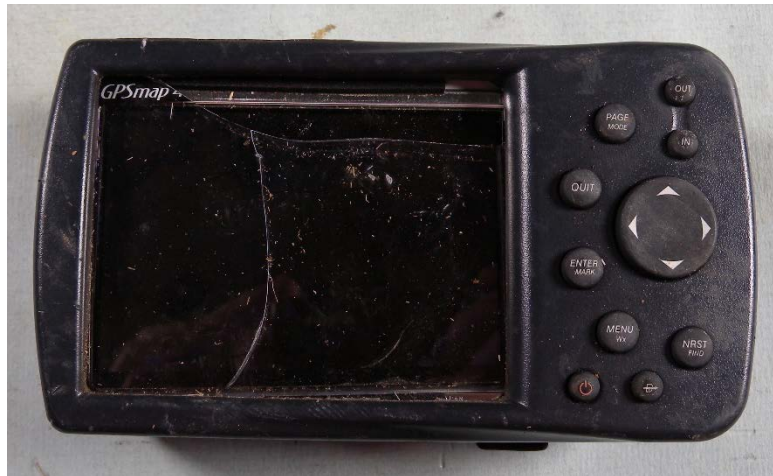
The GPS exhibited some signs of impact damage including a broken screen. Data was extracted normally through the manufacturer's software.

Figure 1. Garmin GPSMAP 496, as received.

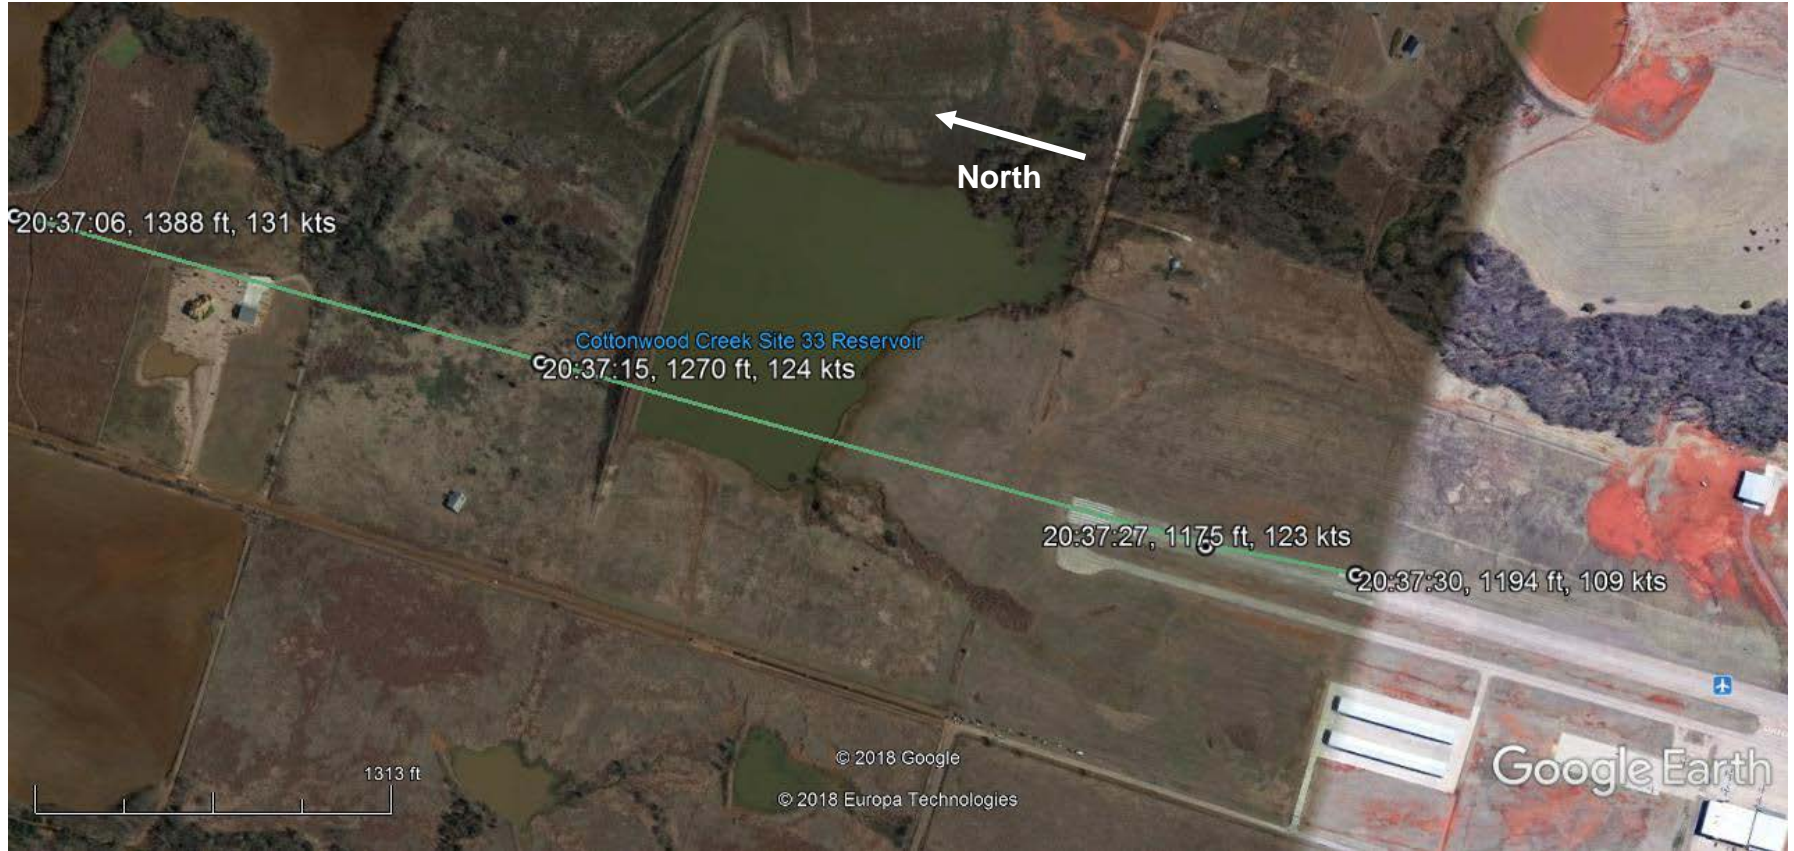
Figure 2 is a graphical overlay generated using Google Earth for end of the accident flight. The weather and lighting conditions in Google Earth are not necessarily the weather and lighting conditions present at the time of the recording.

The last recorded parameter was as at 2037:30 UTC on March 18, 2019, with a GPS altitude of 1194 feet above Mean Sea Level (MSL) and a ground speed of 109 knots. Due to data buffering on the GPS unit, the data recording may have ended before the accident event.

Figure 2. Google Earth overlay showing end of accident flight.
