Dear Mr. Weeks: Subject: Howard DGA-15P Airplane

SERVICE BULLETIN NO. 3

SUBJECT: Possible Fuel System Failure and Placarding of Fuel System.

Subject: Howard DGA-15P - Malfunctioning of Fuel System

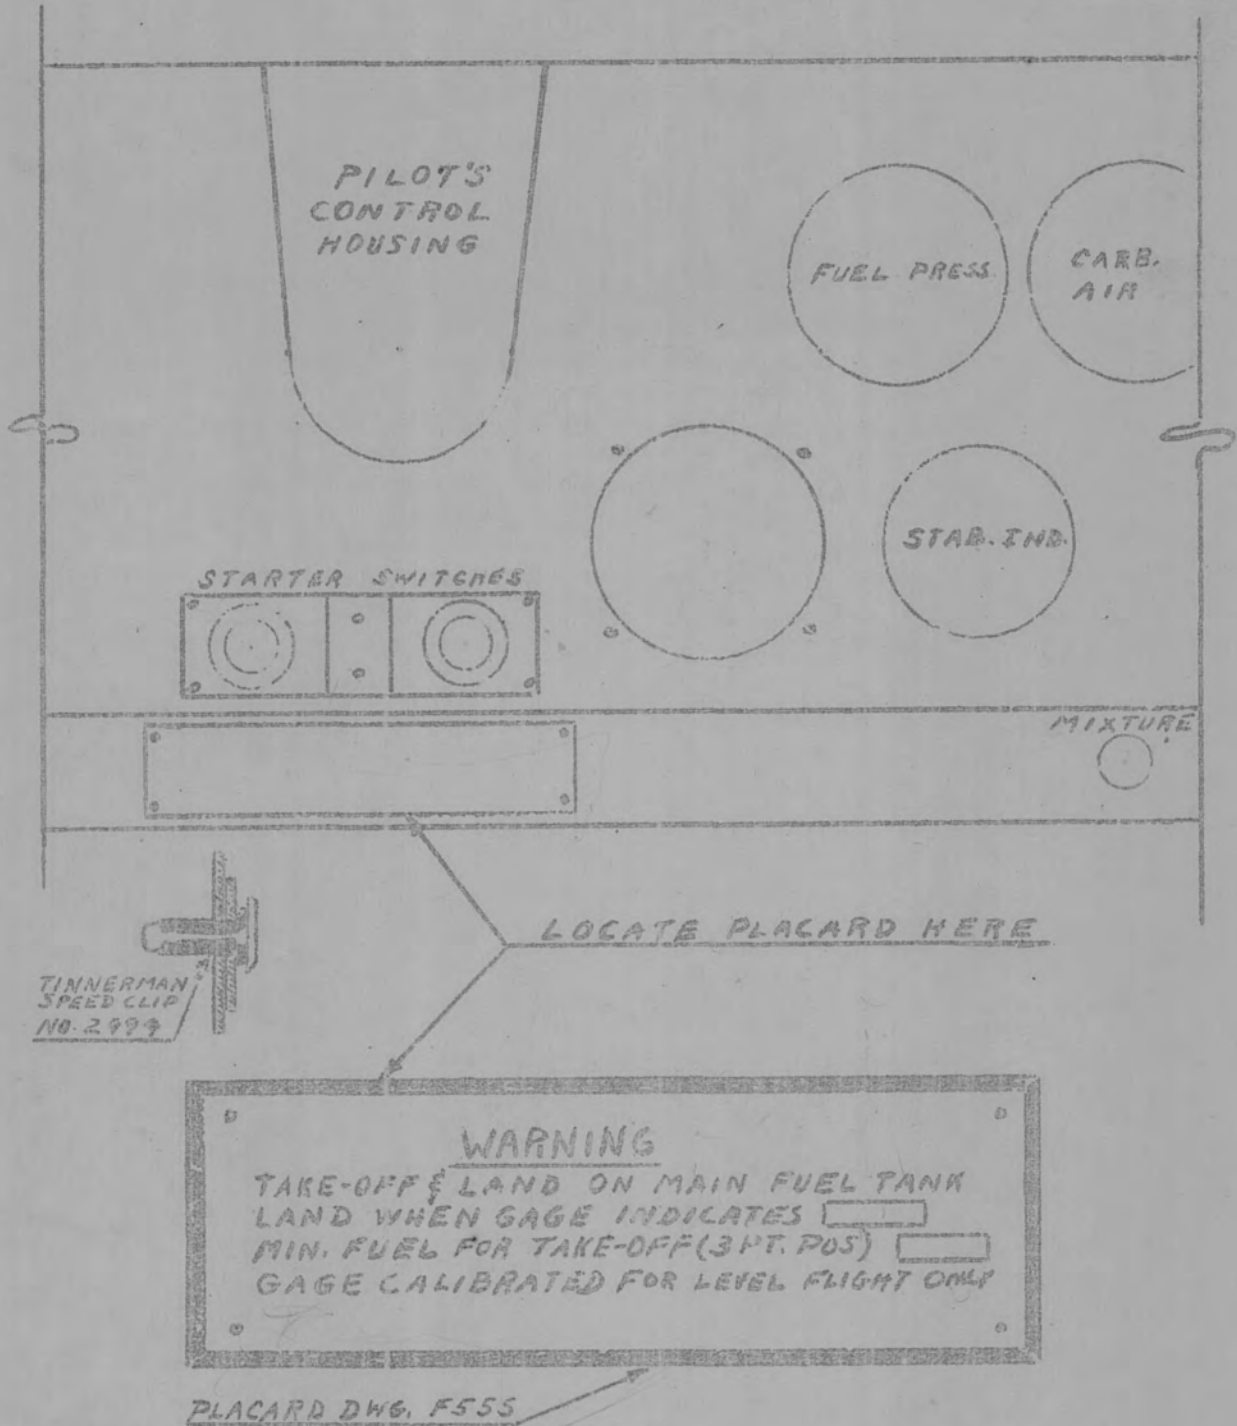
FIG NO 1

Tests conducted indicate that under certain low fuel conditions, the engine ~~may~~ ~~be~~ ~~able~~ ~~to~~ ~~cut-out~~ ~~at~~ ~~an~~ ~~indicated~~ ~~take-off~~ ~~and~~ ~~climb~~ ~~condition.~~ *best angle of climb condition.*

Each airplane should be checked to determine the fuel gauge indications when the airplane is in a level flight position and also in a 3 point position, with 18 gallons of fuel in the main tank. The indicated readings should be stamped in the blank spaces provided on the placard shown on Figure No. 1.

1. With the airplane in a 3 point position, on level ground, drain the main tank and refill accurately with 18 gallons of fuel. *front end* Observe the fuel gauge reading and stamp the indicated reading in the blank space provided on the placard (Min. Fuel for Take-off       ) as shown on Figure No. 1.

With the airplane in level flight position and with 18 gallons of fuel in the main tank, observe the fuel gauge reading. Stamp the indicated reading in the blank space provided on the placard (Min. Fuel for Take-off (3 Pt. Pos.)       ) as shown on Figure No. 1.

3. The placard shall be installed in full view of the Pilot in the position shown on Figure No. 1. Drill four #14 (.086) holes using the placard as a template. Secure the placard by means of four #2994 Tinnerman Speed Clips in the manner shown on Figure No. 1.

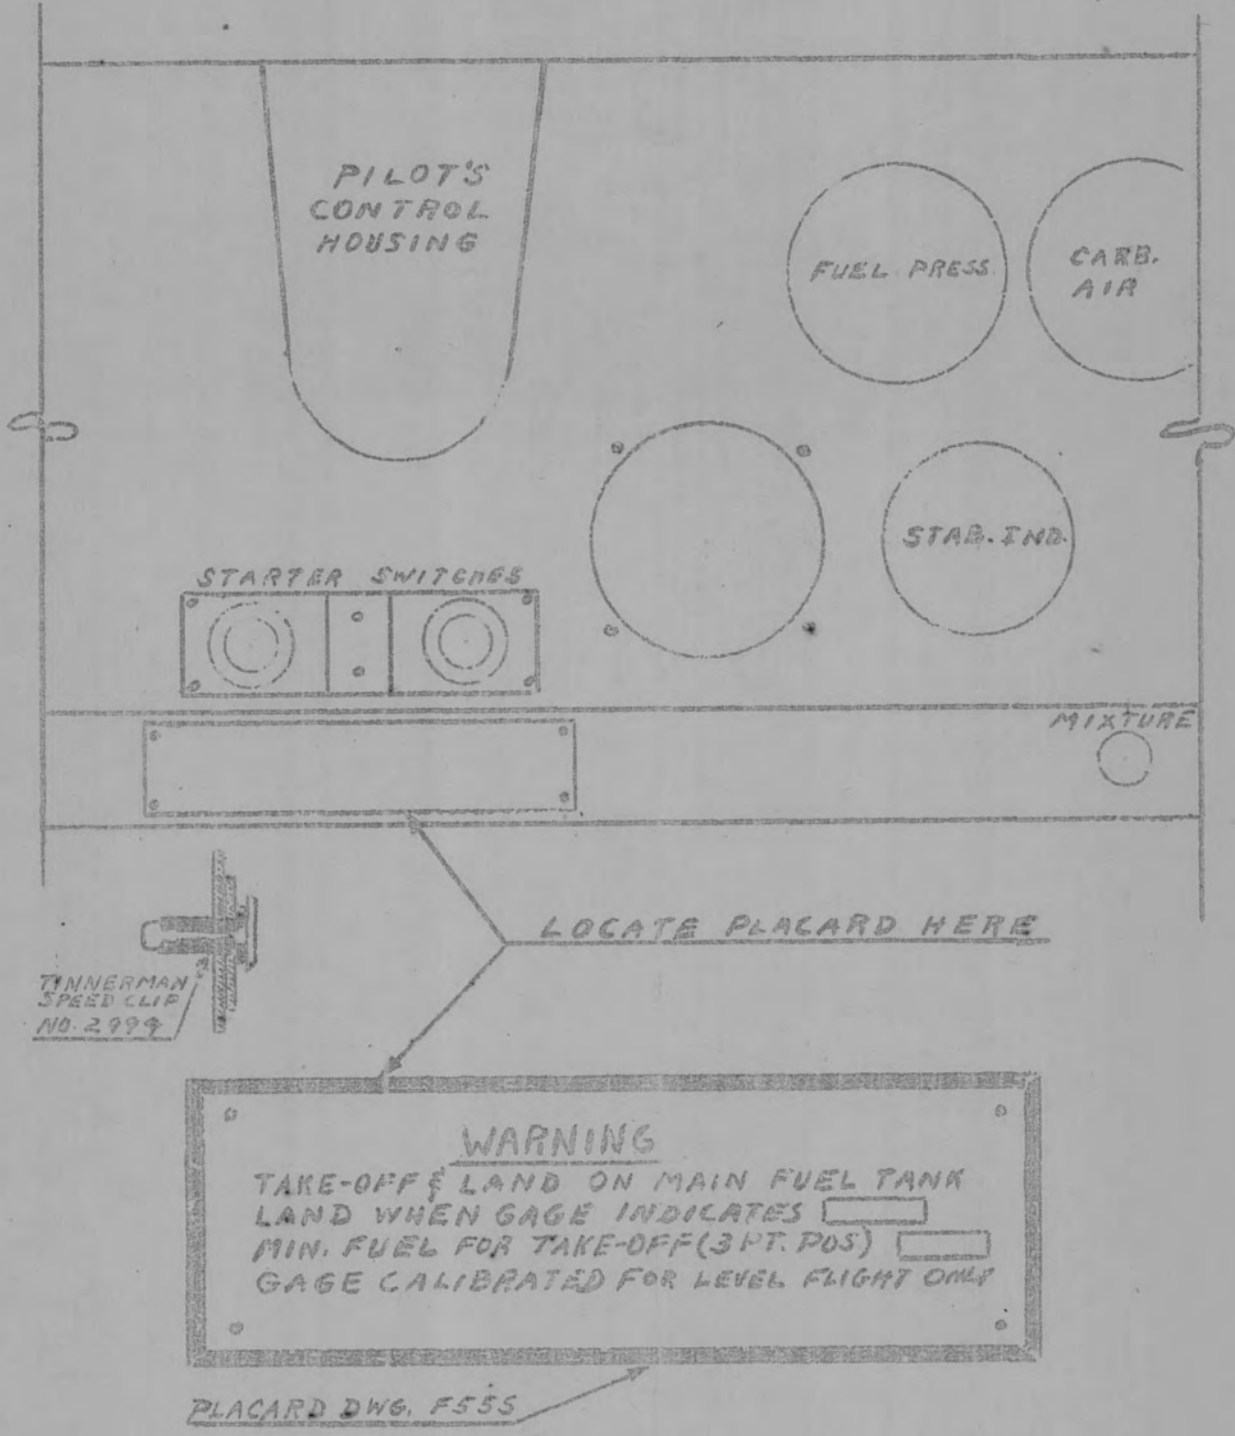
FIG NO 1

Tests conducted indicate that under certain low fuel conditions, the engine may have the tendency to cut-out following a simulated take-off from a semi-stalled condition.

Each airplane should be checked to determine the fuel gauge indications when the airplane is in a level flight position and also in a 3 point position, with 18 gallons of fuel in the main tank. The indicated readings should be stamped in the blank spaces provided on the placard shown on Figure No. 1.

1. With the airplane in a 3 point position, on level ground, drain the main tank and refill accurately with 18 gallons of fuel. Observe the fuel gauge reading and stamp the indicated reading in the blank space provided on the placard (Min. Fuel for Take-off \_\_\_\_\_) as shown on Figure No. 1.

With the airplane in level flight position and with 18 gallons of fuel in the main tank, observe the fuel gauge reading. Stamp the indicated reading in the blank space provided on the placard (Min. Fuel for Take-off (3 Pt. Pos.) \_\_\_\_\_) as shown on Figure No. 1.

3. The placard shall be installed in full view of the Pilot in the position shown on Figure No. 1. Drill four #44 (.086) holes using the placard as a template. Secure the placard by means of four #2994 Tinnerman Speed Clips in the manner shown on Figure No. 1.

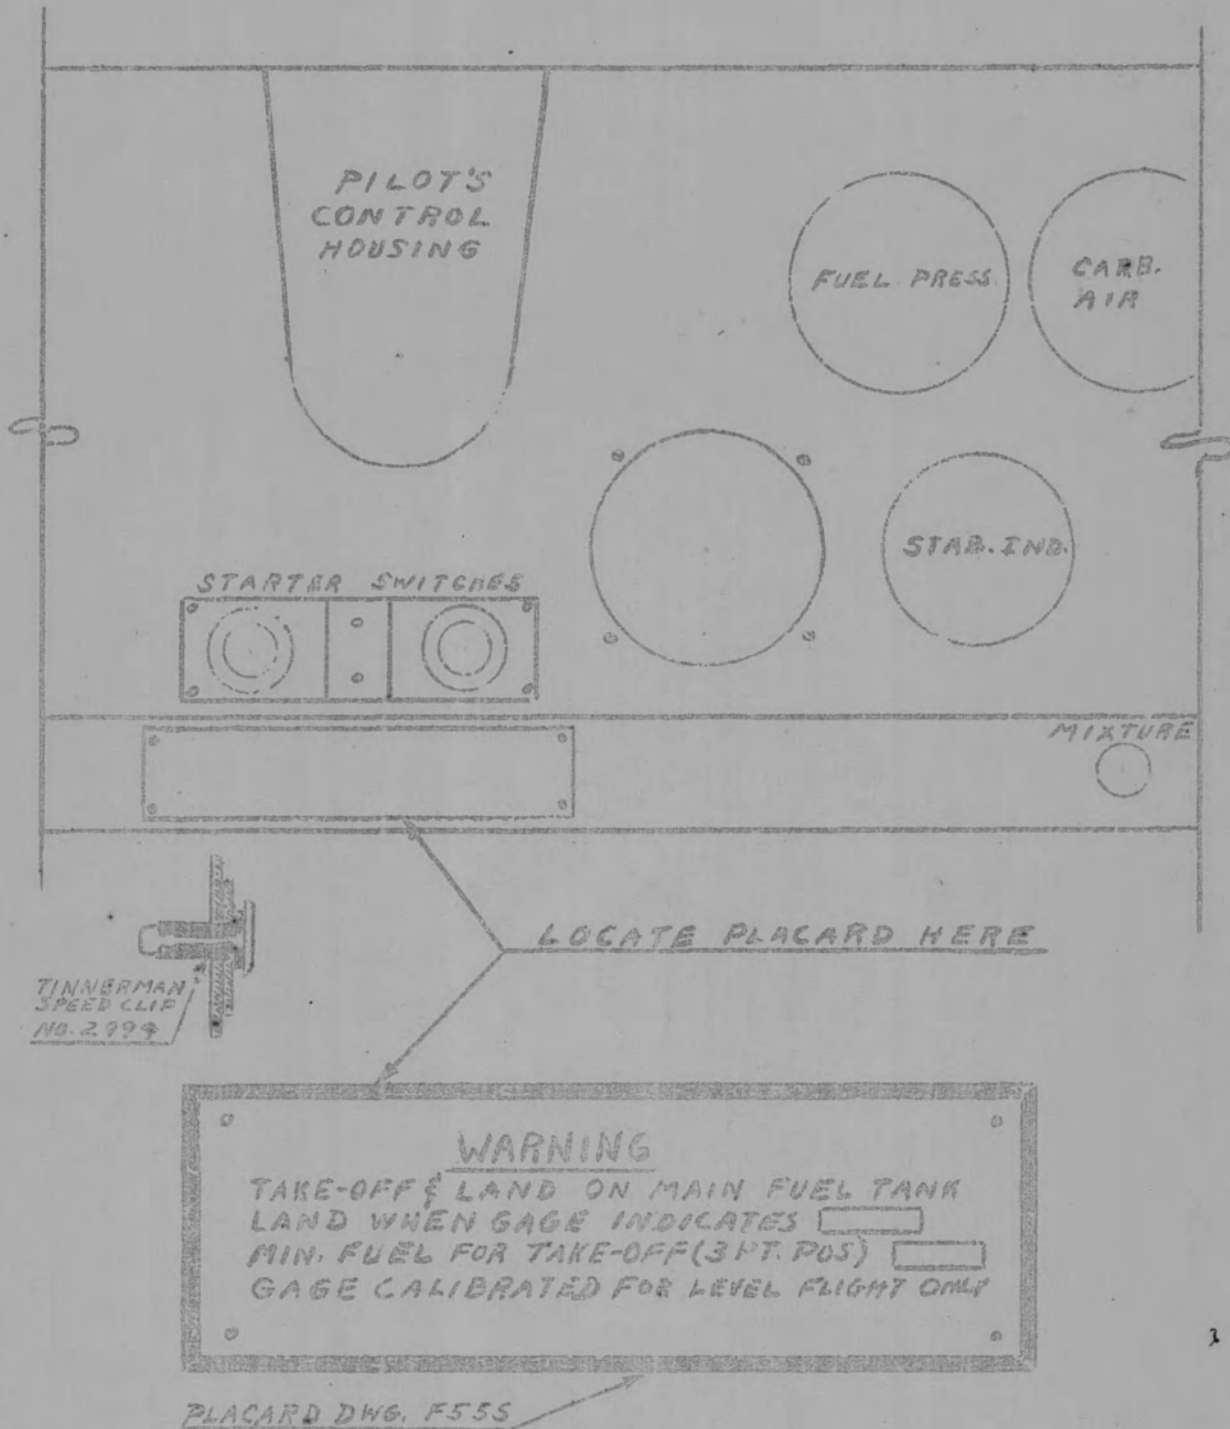
FIG NO 1

Tests conducted indicate that under certain low fuel conditions, the engine may have the tendency to cut-out following a simulated take-off from a semi-stalled condition.

Each airplane should be checked to determine the fuel gauge indications when the airplane is in a level flight position and also in a 3 point position, with 18 gallons of fuel in the main tank. The indicated readings should be stamped in the blank spaces provided on the placard shown on Figure No. 1.

1. With the airplane in a 3 point position, on level ground, drain the main tank and refill accurately with 18 gallons of fuel. Observe the fuel gauge reading and stamp the indicated reading in the blank space provided on the placard (Min. Fuel for Take-off \_\_\_\_\_) as shown on Figure No. 1.

With the airplane in level flight position and with 18 gallons of fuel in the main tank, observe the fuel gauge reading. Stamp the indicated reading in the blank space provided on the placard (Min. Fuel for Take-off (3 Pt. Pos.) \_\_\_\_\_) as shown on Figure No. 1.

3. The placard shall be installed in full view of the Pilot in the position shown on Figure No. 1. Drill four #14 (.086) holes using the placard as a template. Secure the placard by means of four #2994 Tinnerman Speed Clips in the manner shown on Figure No. 1.

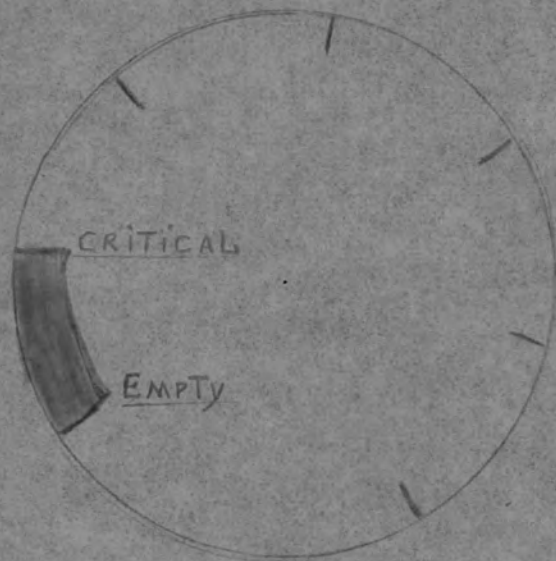
Fuel Gauge Dial

(1) Re-calibrate the fuel gauge for each tank with particular attention given to the marking at various levels below the  $1/2$  full level of the tank. The fuel gauge should not indicate gasoline in the tank, with the airplane in any normal flight attitude, when the tank is empty; however, it may indicate empty when there is usable gasoline in the tank.

(2) Determine the gasoline level necessary in each tank to assure normal engine operations during simulated take-off and climb at the best angle of climb on each tank.

(3) Mark the dial of each fuel tank gauge as shown on the enclosed sketch and place a placard beneath the gauges as follows:

"Do not take-off with gasoline supply in critical range"
