MEMORANDUM

Date: January 13, 2020
Subject: FAA Examination of N4112K
NTSB Accident Number: ANC20LA013

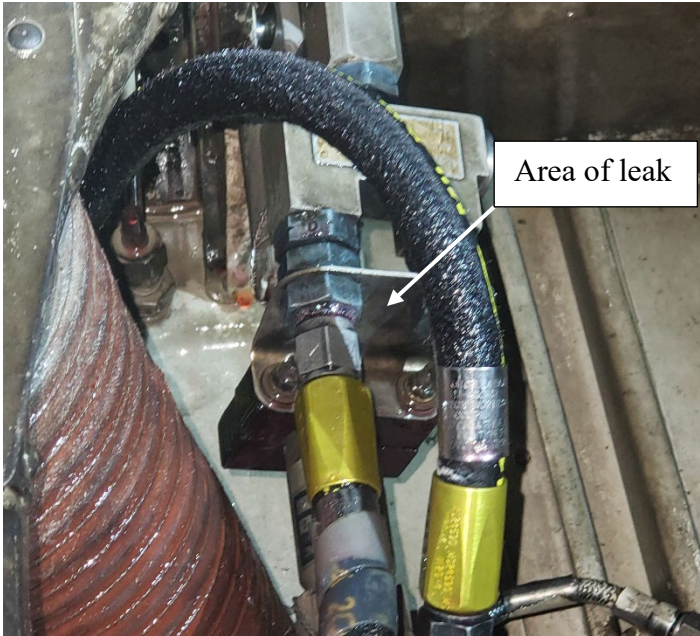
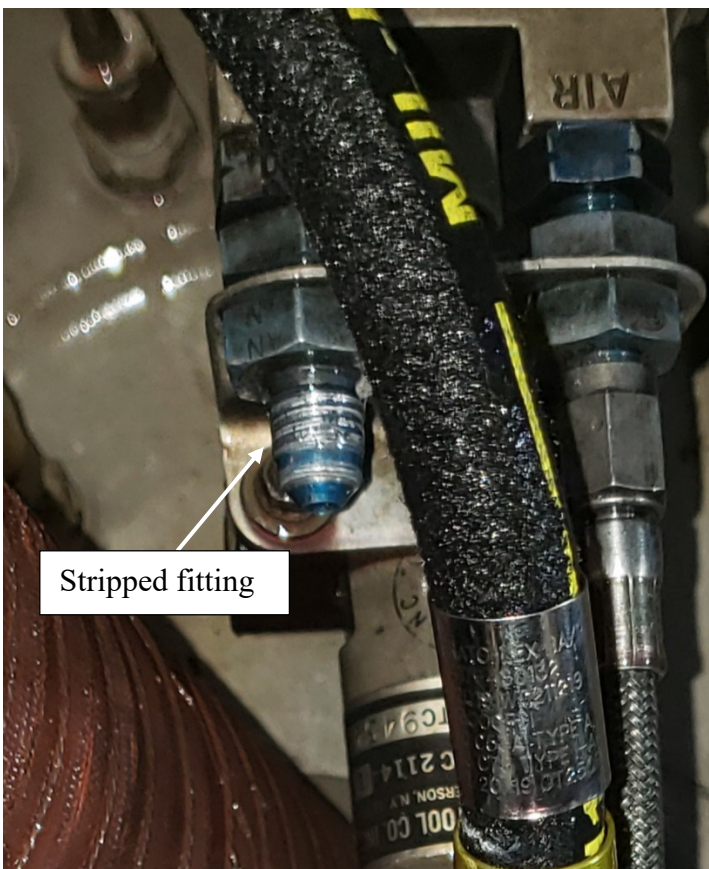
Upon arrival I visually inspected right main landing gear, all appeared normal, checked hydraulic reservoir and found it to be empty. Looked at all landing gear and belly of ACFT for hydraulic leaks and noticed fluid near the right wing root, the ACFT was then placed on jacks and the hydraulic mule attached and the system was pressurized. Hydraulic fluid began spraying from the right main gear unlock actuator . Pressure was then removed and the actuator and line were removed for inspection, the line was found serviceable but a fitting on the actuator was found stripped causing the leak, the fitting was appropriate for the application but had failed for unknown reasons. The open fittings were then capped and the gear cycled, all functions appeared normal. It is believed the gear would not come down due to depletion of hydraulic fluid due to the leaking fitting.

Inspector Chalstrom returned to the airplane a few days later to examine the emergency landing gear system. The company had already removed the right shuttle valve and the mechanic stated that there was water inside the valve when it was disassembled. The inner bore of the cylinder had corrosion inside and the valve would not move. It was likely that the cold temperatures would have caused the water in the valve to freeze, which would have prevented the air in the emergency system from activating the right landing gear when activated.
