National Transportation Safety Board

DCA23LA192

VIDEO FILE

Specialist's Factual Report

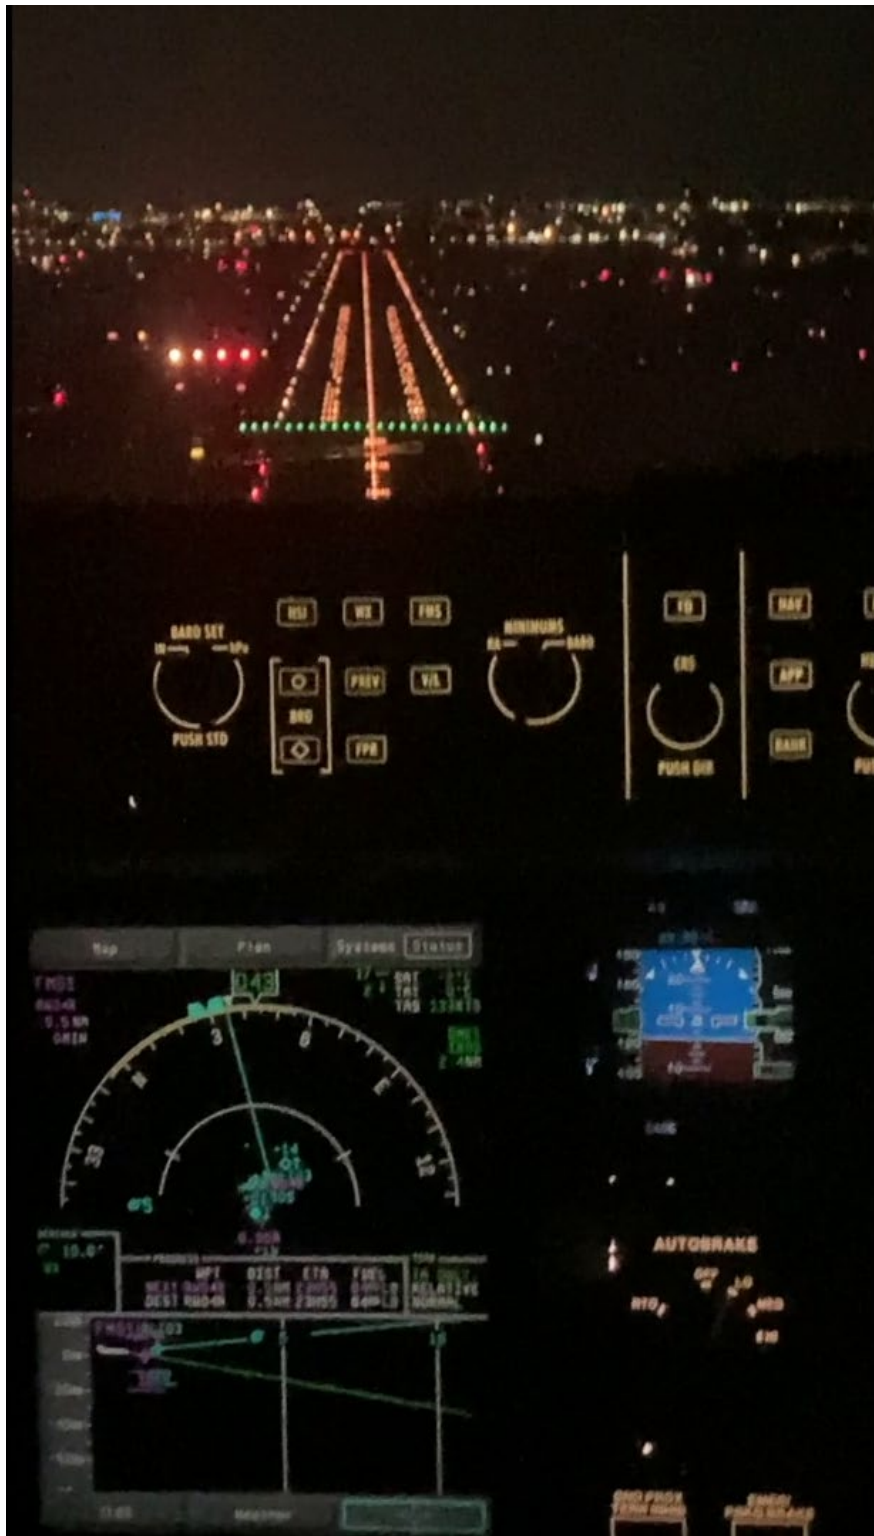
1:06.6	An automated "approaching minimums" callout was noted.
1:12.5	An automated "minimums" callout was noted. (Figure 1)
1:23.3	The green threshold lights disappeared beneath the glareshield.

Figure 1. Screen capture at "minimums" automated callout.

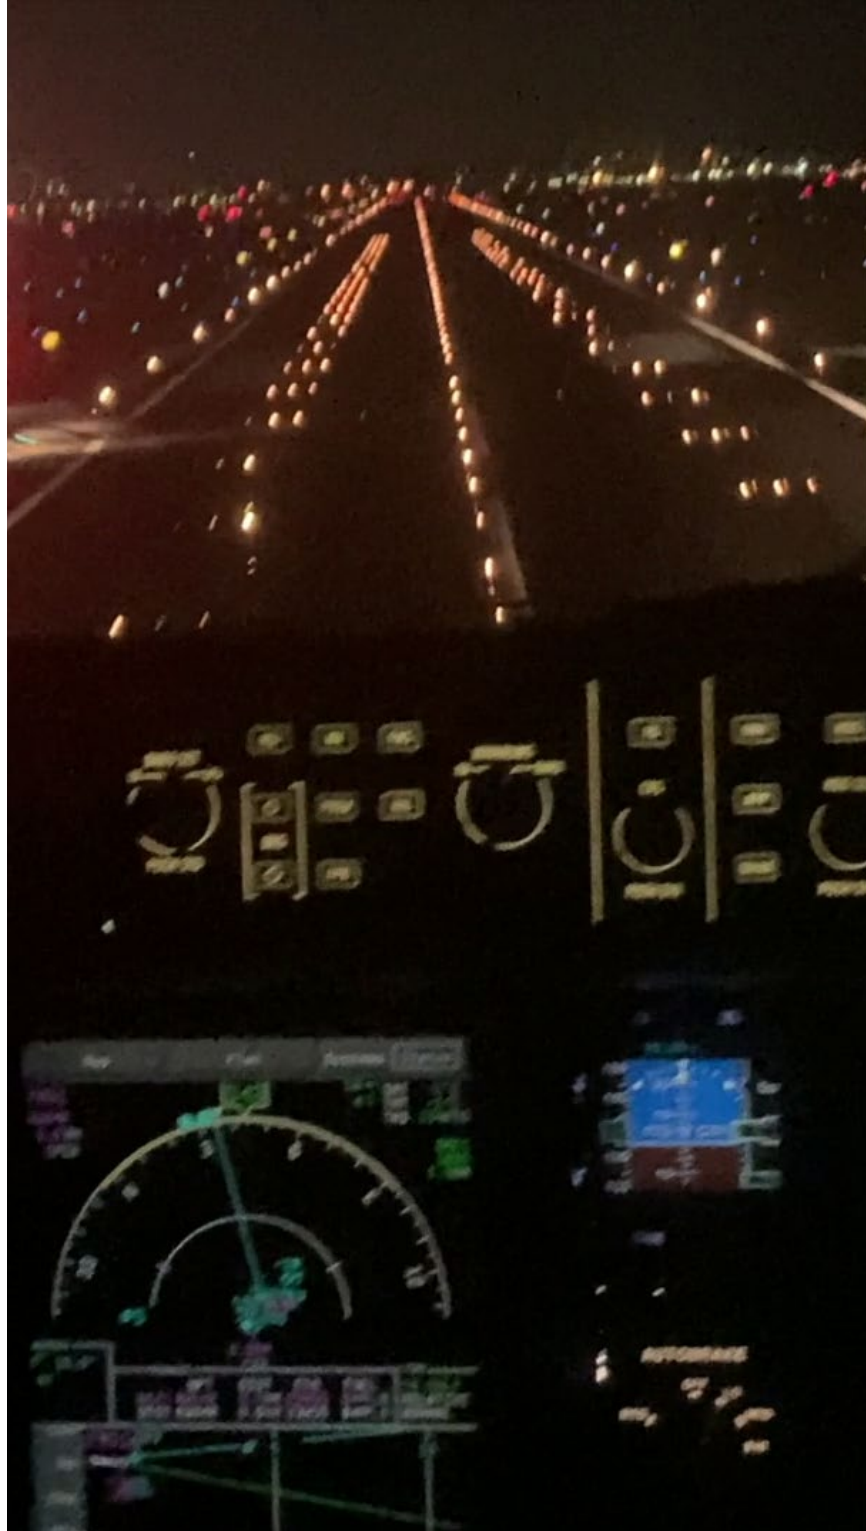
1:24.3	An automated "fifty" callout was noted.
1:25.6	An automated "forty" callout was noted.
1:26.7	An automated "thirty" callout was noted.
1:26.7	The nose of Lear 60 was noted crossing the left edge of the runway just ahead of the runway aiming point markers (Figure 2).

Figure 2. Nose of Lear 60 crossing the left edge of the runway at 1:26.7 elapsed time.

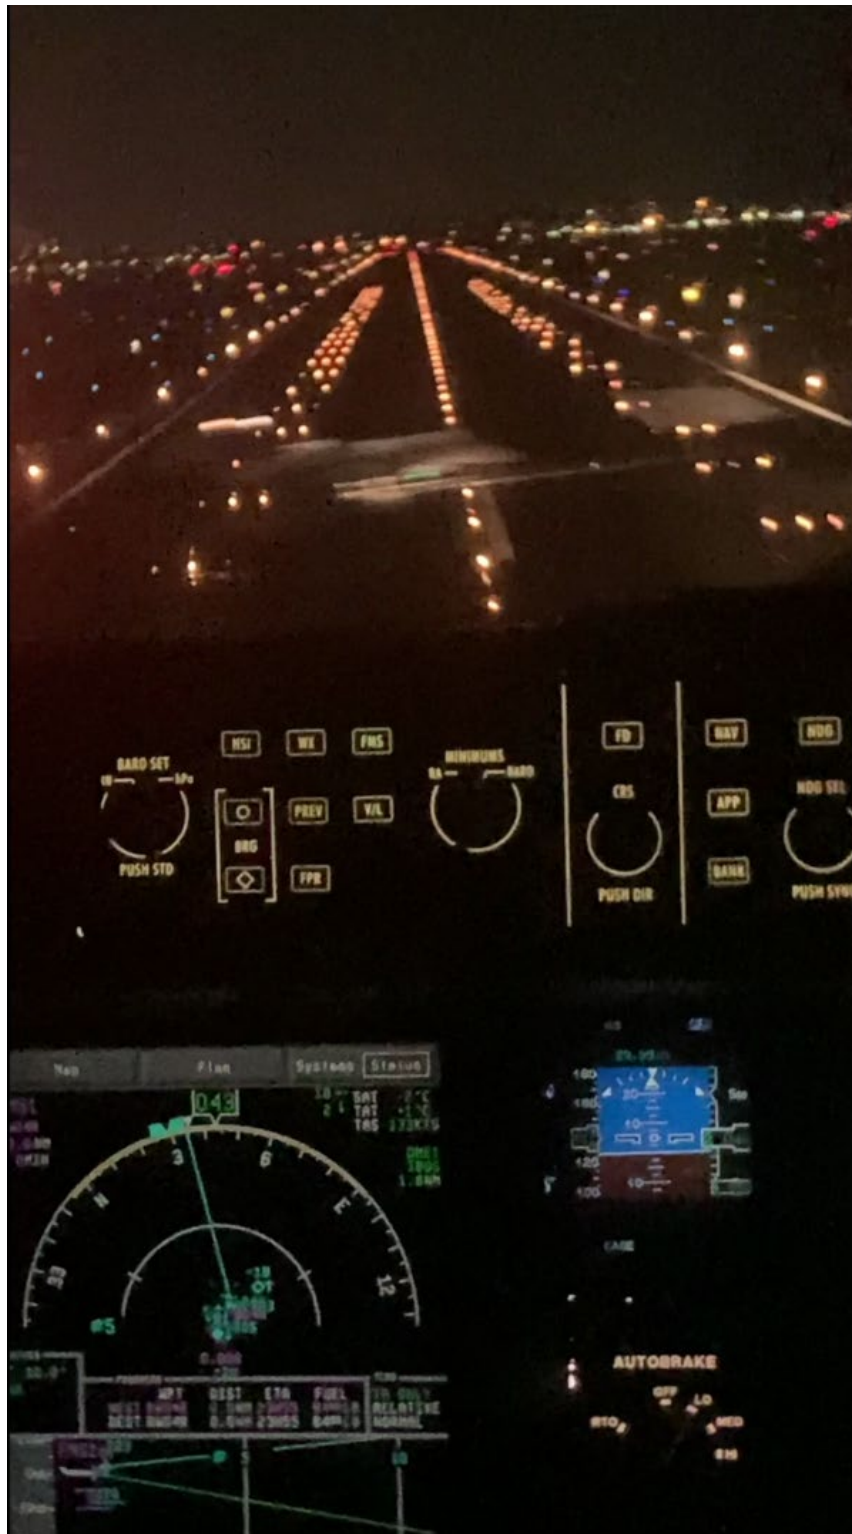
1:27.4	The nose landing gear of the Lear 60 crossed the centerline of the runway (Figure 3).
1:27.8	An automated "twenty" callout was noted.
1:28.2	The tail of Lear 60 crossed the right side of the runway and exited the camera frame.

Figure 3. Lear 60 nose landing gear crossing runway centerline at 1:27.4 elapsed time.
