NATIONAL TRANSPORTATION SAFETY BOARD

ON SCENE OBSERVATIONS

WPR19FA154

Location: Grover, Utah
Date: May 24, 2019
Aircraft: Cirrus SR22, Registration N809SR, Serial #2129
NTSB IIC: Samantha Link

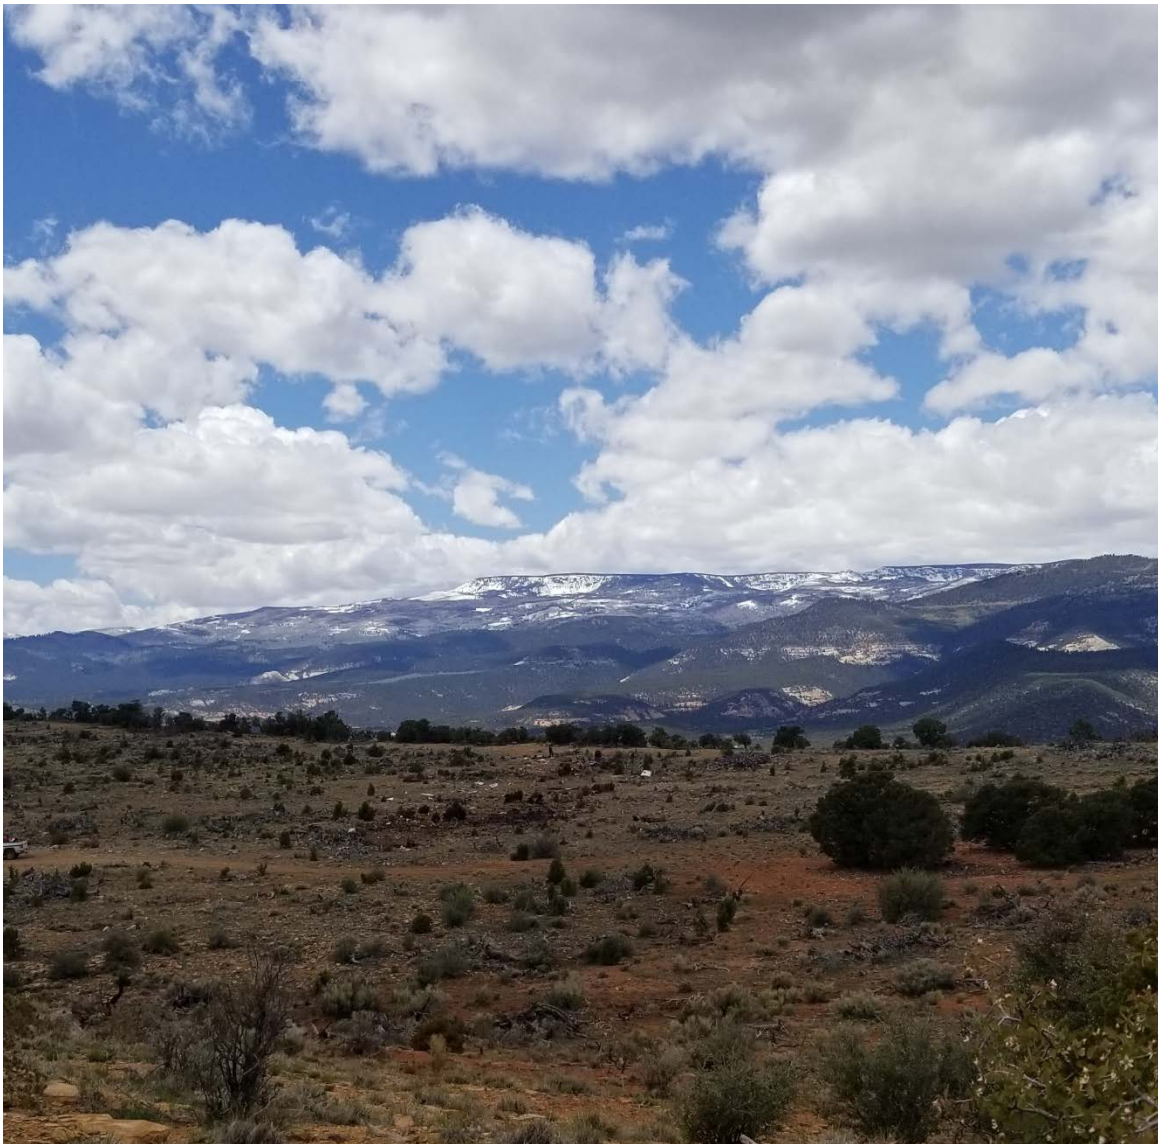
Figure 1: Accident Site from the Ridge Above

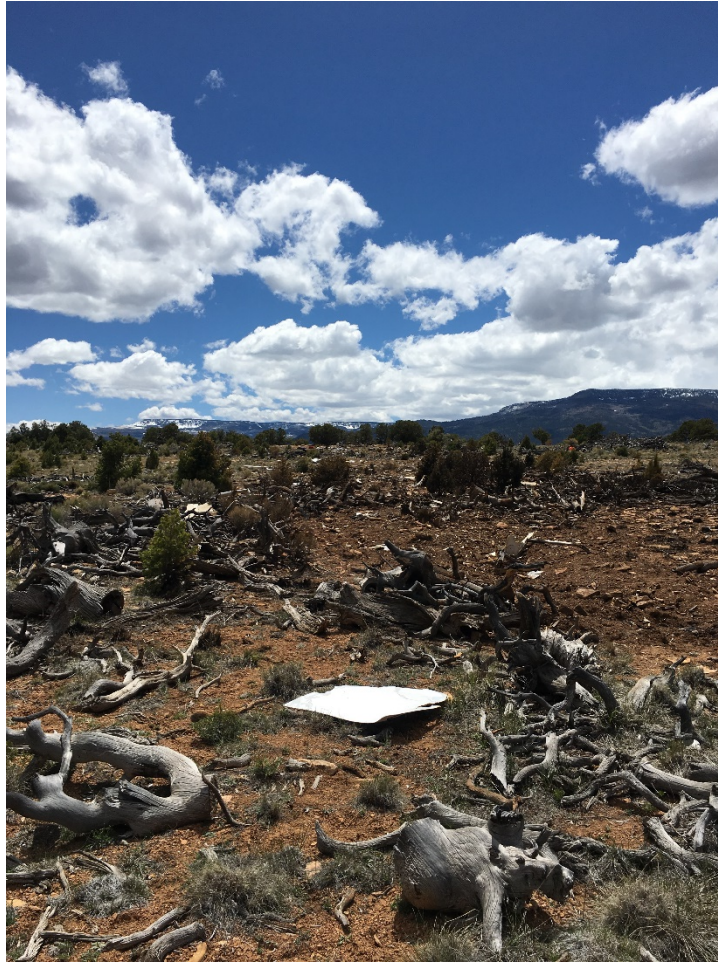
Figure 2: Debris Path from First Piece of Debris

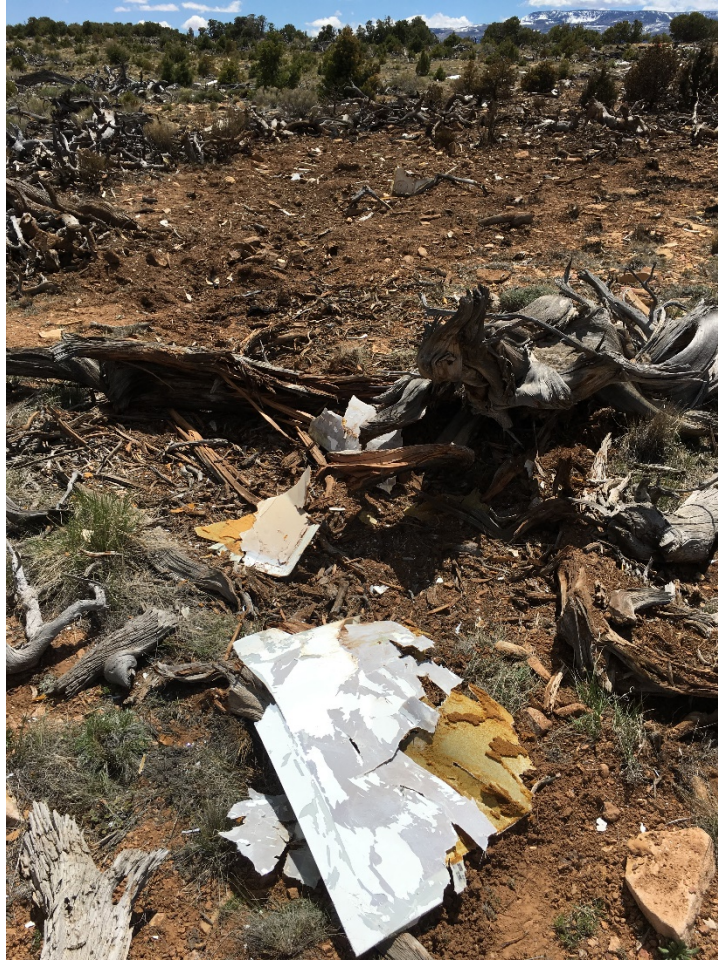
Figure 3: Initial Impact Crater

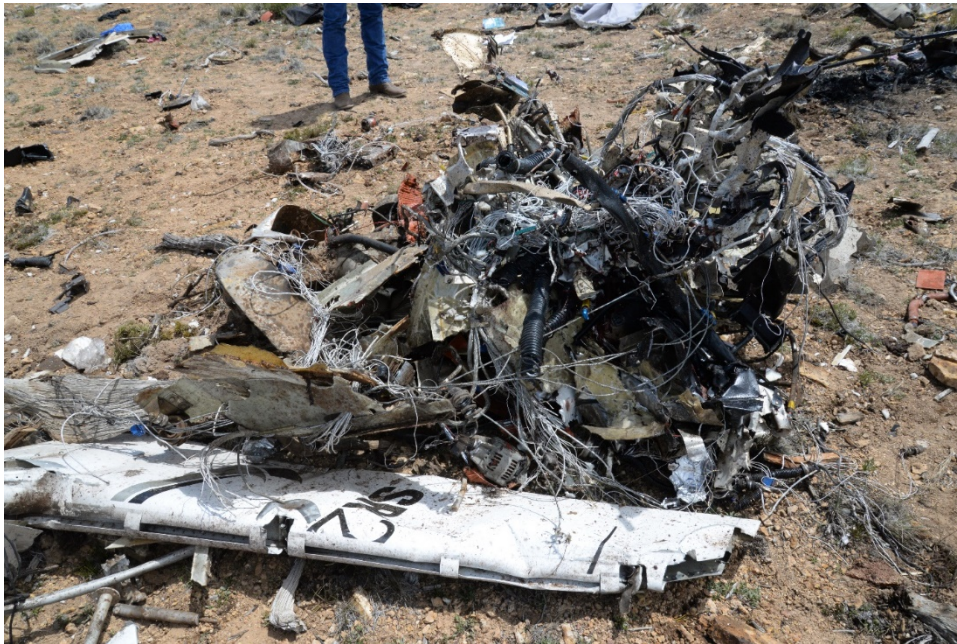
Figure 4: Engine, Firewall, and Rudder

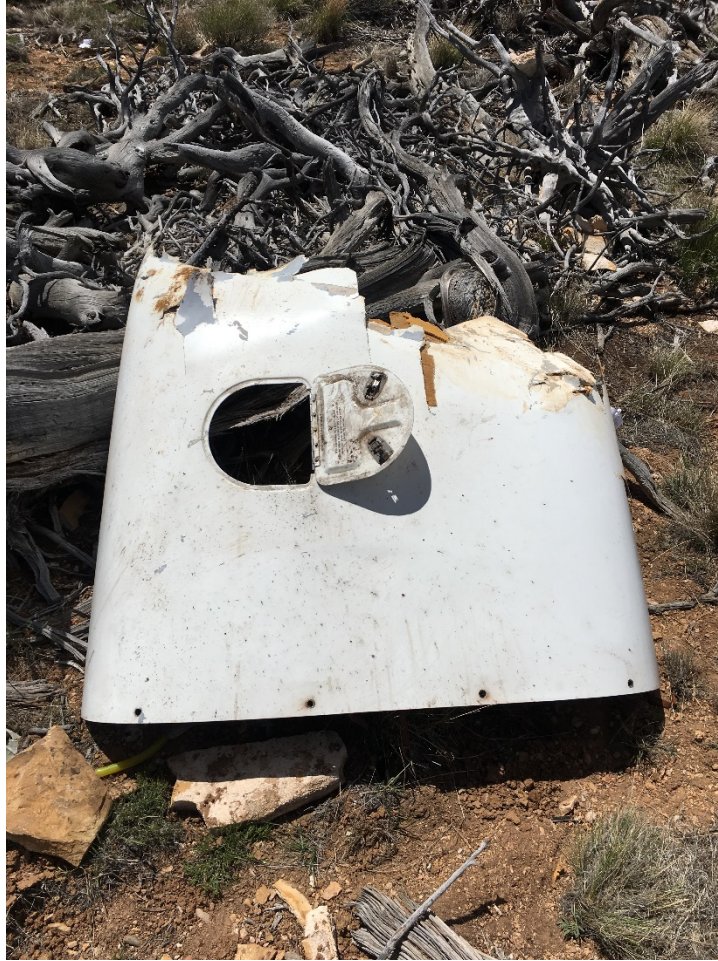
- The pin was not present
- The engine cowling was found fracture separated.
 - Fragments of the engine cowling were found both at the beginning and the end of the debris field.

- The top forward portion of the engine cowling was fractured diagonally to the right.
- The left wing was fracture separated into several pieces and scattered throughout the debris field

Figure 5: Upper Cowling

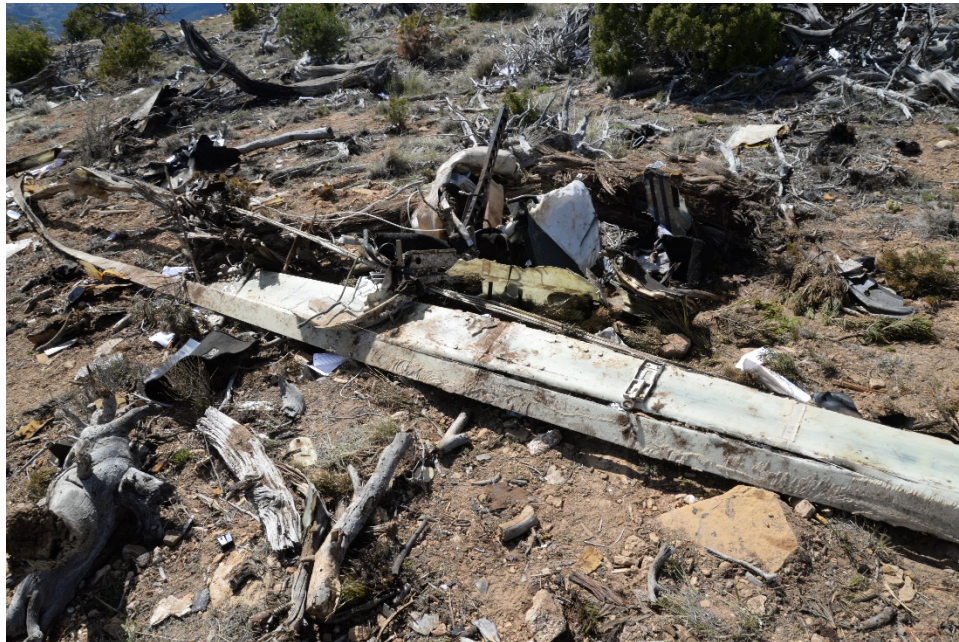
Figure 6: The Wing Spar

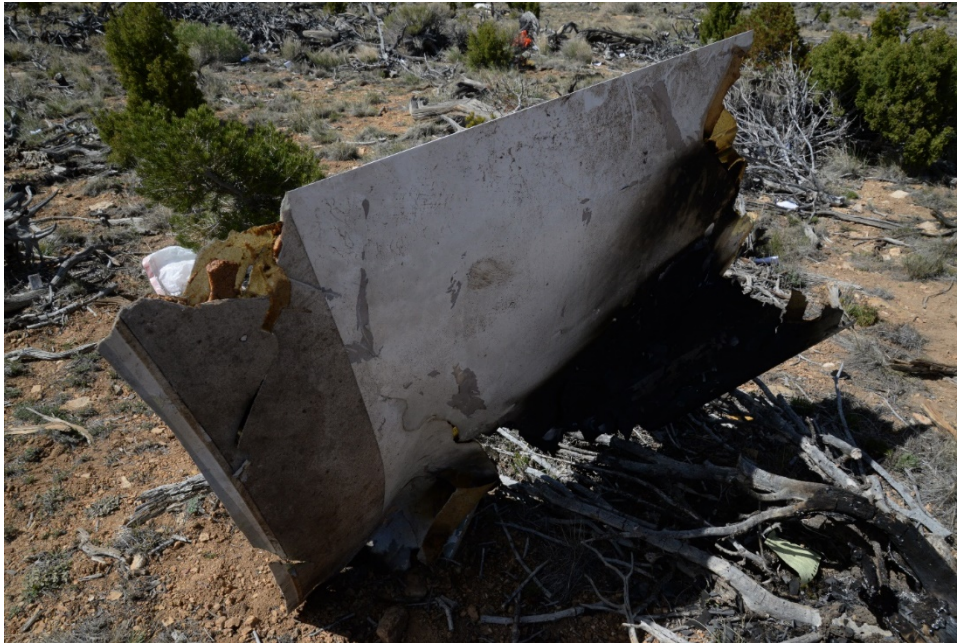
- The fractures were along its span as well as upper and lower wing skins.
 - The left aileron was fracture separated into two pieces
 - The left flap was mostly whole and exhibited crush damage throughout.

Figure 7: Inboard Left Wing

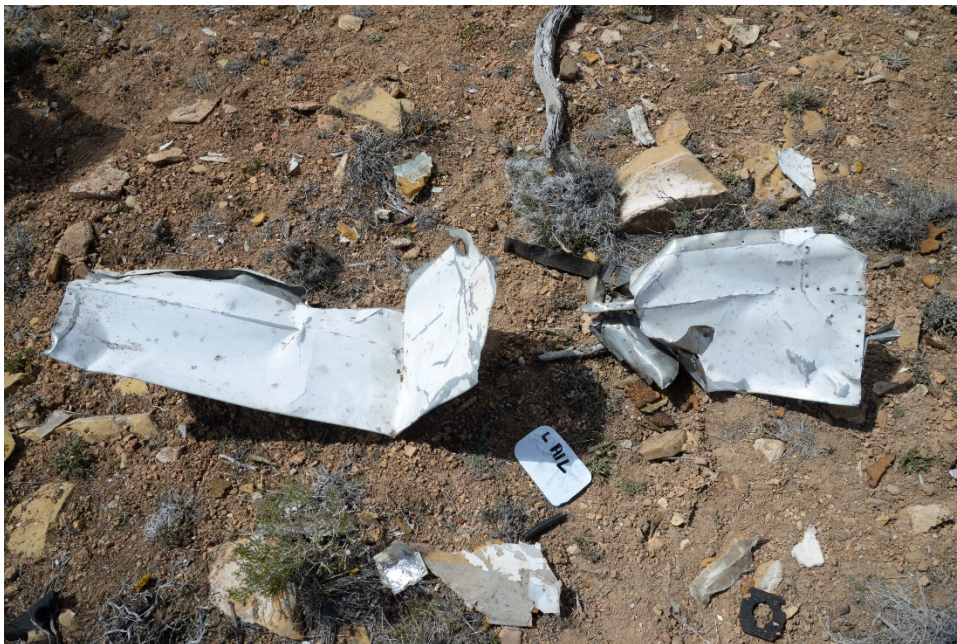
Figure 8: Left Aileron

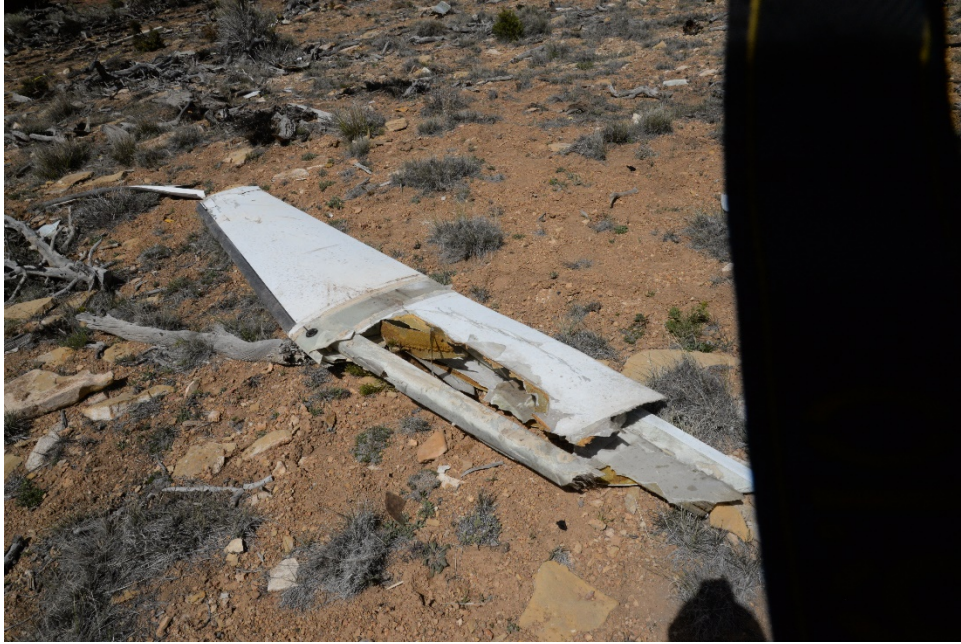
- The horizontal stabilizer was mostly whole
 - The right side was fracture separated about midspan
 - The elevators exhibited heavy impact related damage

Figure 9: Horizontal Stabilizer

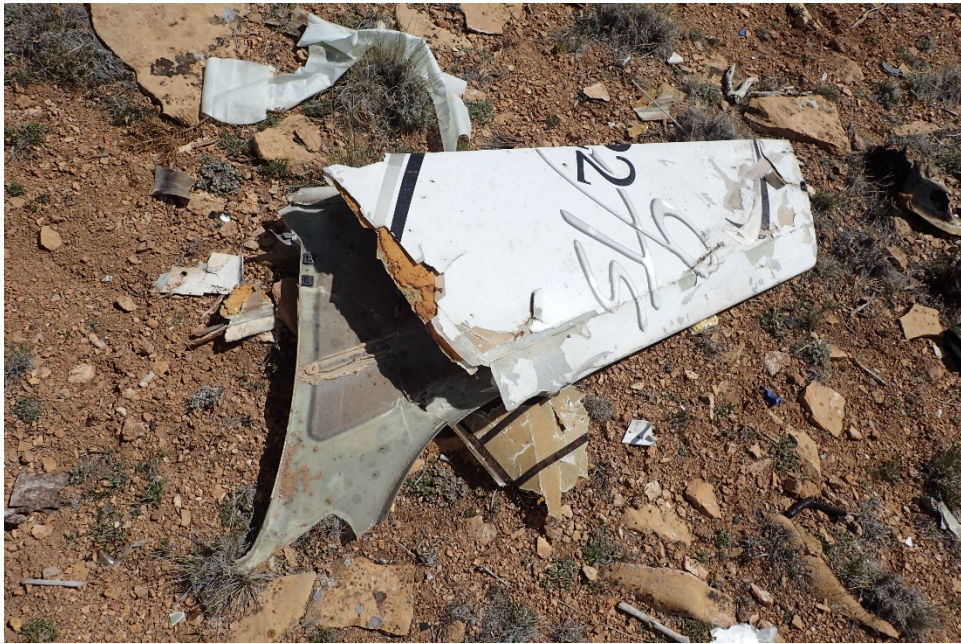
Figure 10: Vertical Stabilizer

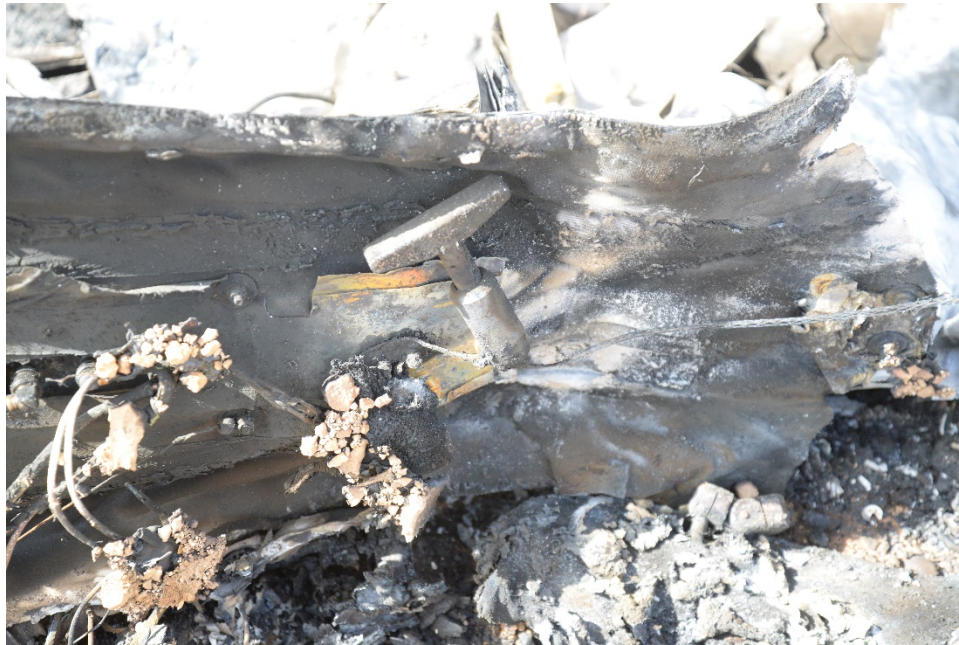
- The parachute handle was still secured to the roof of the airplane
 - It exhibited thermal and impact related damage
 - The handle was found in its handle holder

Figure 11: Parachute Handle

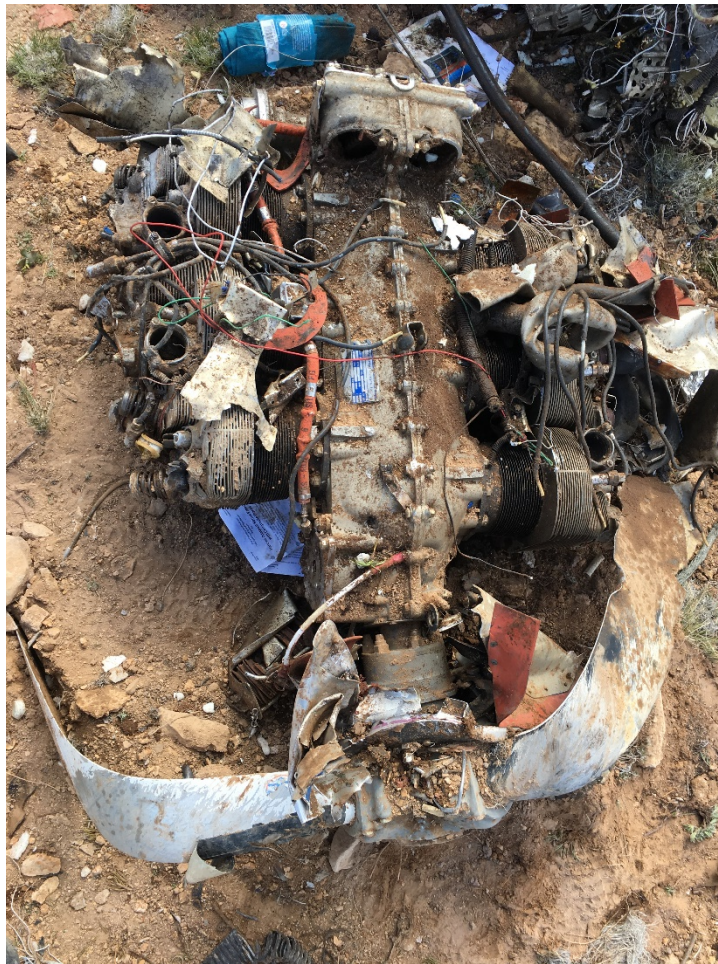
Figure 12: Top of Engine

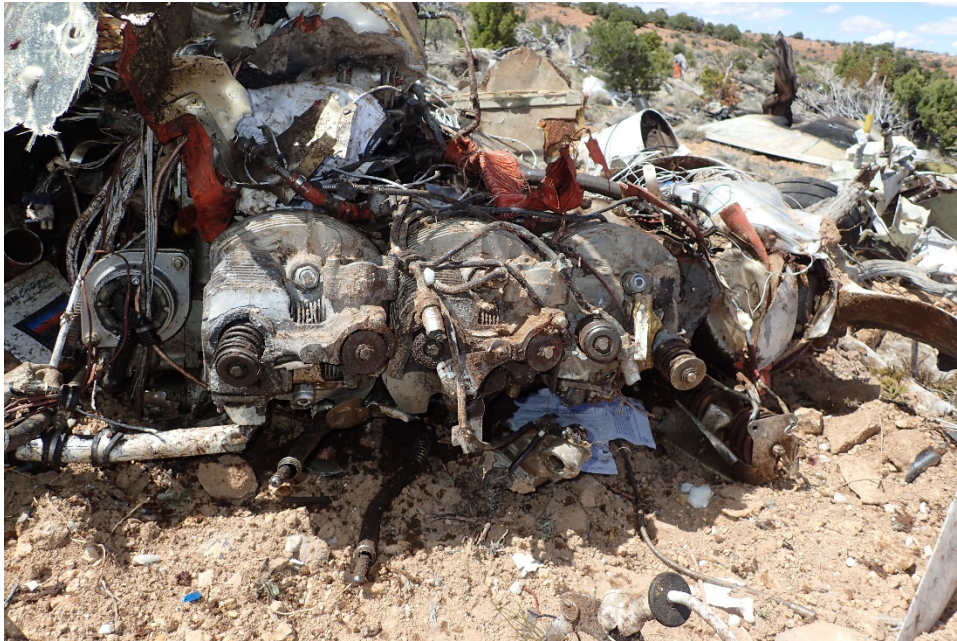
- All six cylinders remained attached to the cylinder bays
 - The right side cylinders exhibited more damage than the left side cylinders.
 - All of the right side cylinders and the #6 cylinder rocker arms had broken free and were scattered throughout the debris field.

Figure 13: Right Side of Engine

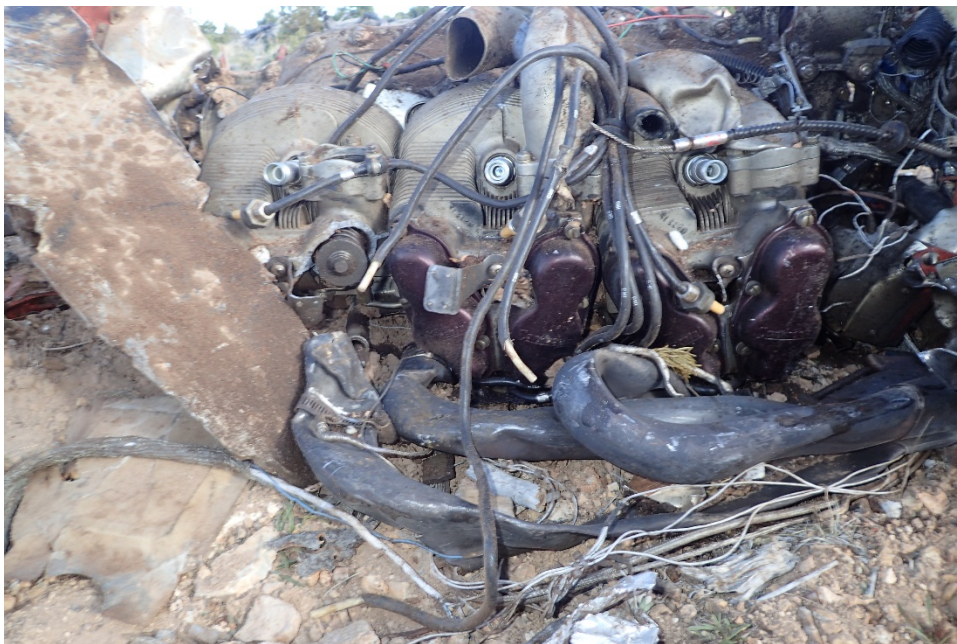
Figure 14: Left Side of Engine

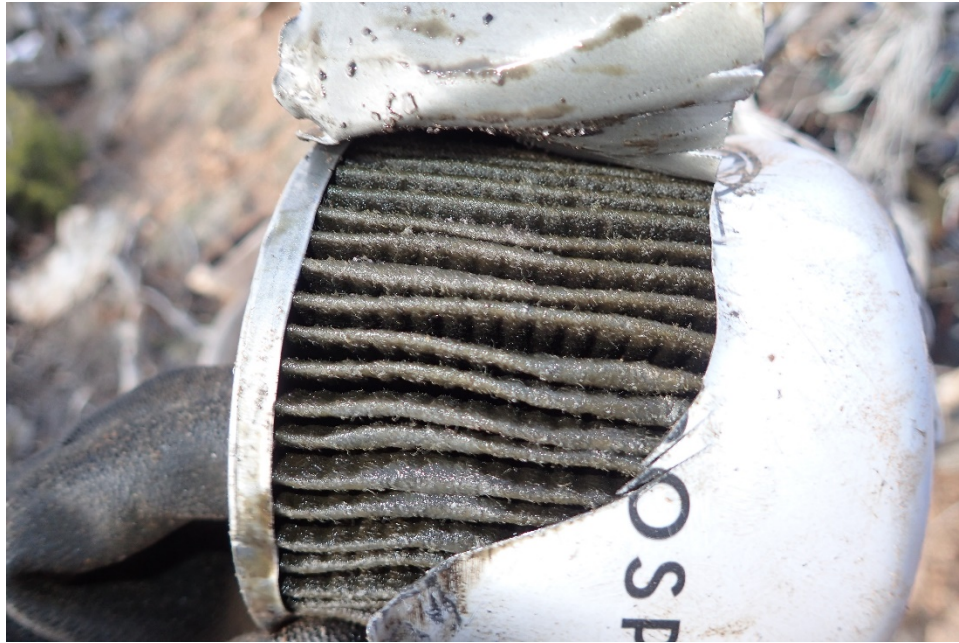
- The oil pump was found attached to the engine and exhibited some impact related damage
- The oil filter was found fracture separated from the engine and exhibited heavy impact related damage

- The filter housing was cut open and the visible pleats did not exhibit metallic material.
 - The filter could not be completely removed from the housing due heavy impact damage.
- The oil cooler was found fracture separated from the engine and displayed impact related damage signatures.
- The starter was found fracture separated from the starter adapter and exhibited impact related damage signatures.
- The starter adapter was found attached to the engine and exhibited impact related damage
- The primary alternator was fracture separated from the engine and was not located
- The backup alternator was found separated from the engine and exhibited impact related damage signatures

Figure 15: Oil Filter

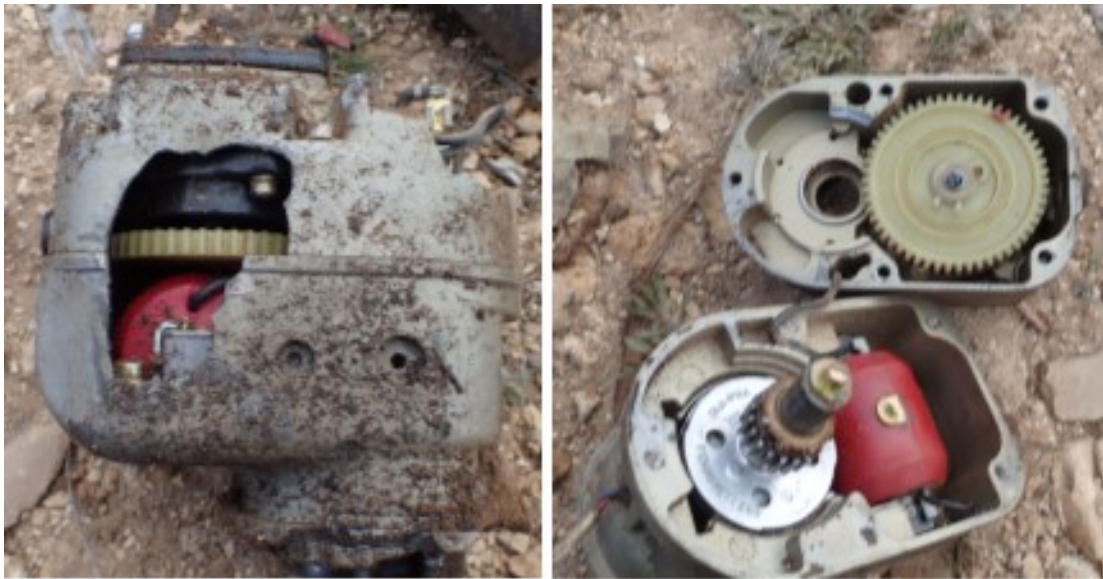
- The manifold valve was disassembled, and the internal components displayed normal operating signatures
- The magnetos were found fracture separated from the engine and exhibited significant impact related damage.

- Both capacitors were fracture separated and were not located
 - One magneto had a large hole in the side that allowed access to view the internal components.

- The internal components exhibited normal operating wear signatures and rotated freely
 - The magneto points exhibited impact related damage
 - The other magneto was disassembled, and the internal components exhibited normal operating wear signatures

- The magneto points exhibited impact related damage
- The ignition harness exhibited heavy impact related damage
- The top spark plugs were removed and exhibited normal operating wear signatures

Figure 16: Magnetos

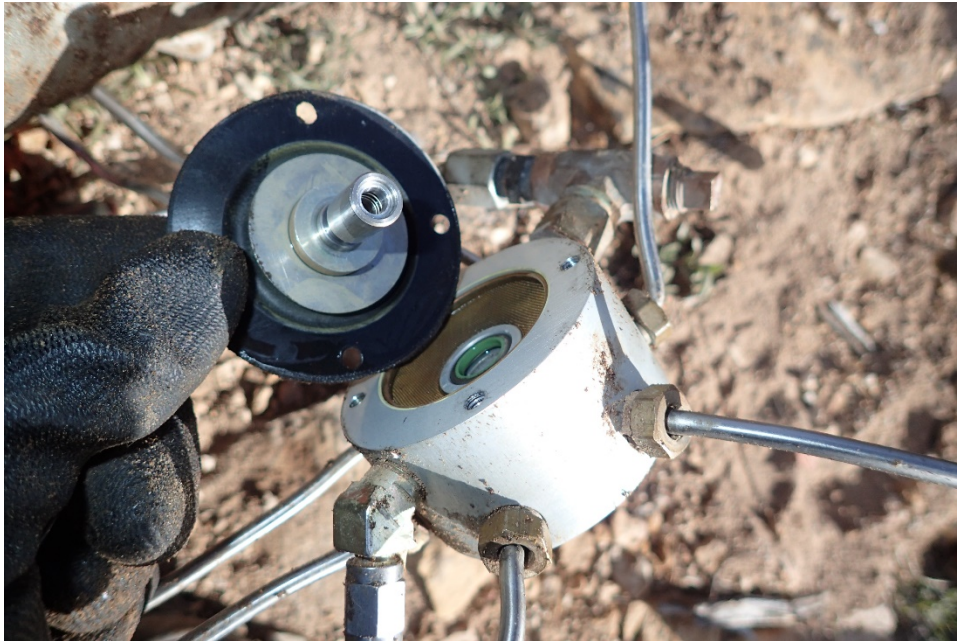
- The metering plug orifice was clear of debris
- The fuel manifold valve remained partially attached to its installation point and exhibited impact related damage.

Figure 17: Fuel Distributor

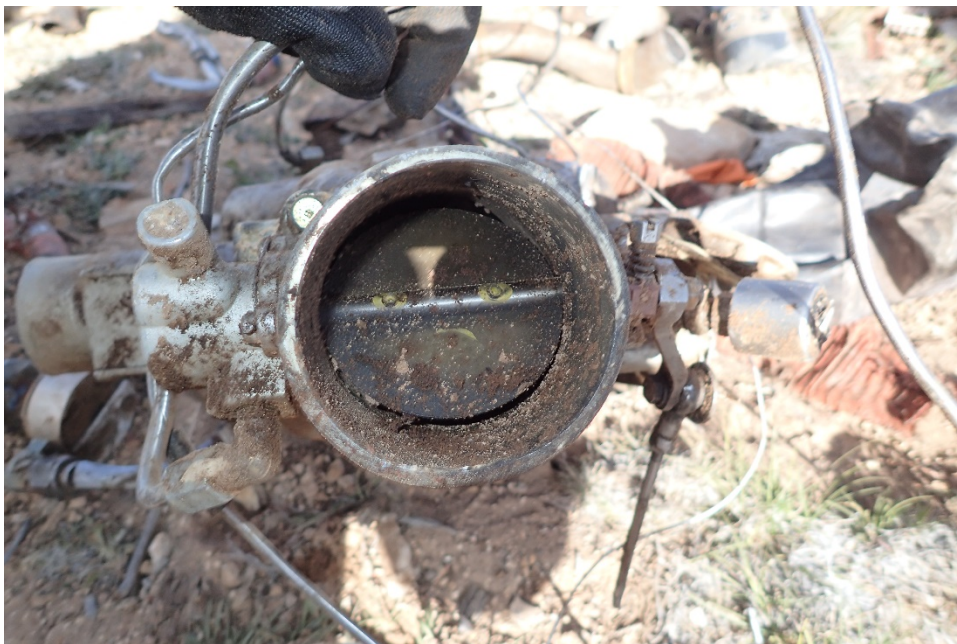
- The fuel pump drive shaft was rotated, and residual fuel pumped through the line
 - The fuel smelled consistent with 100LL
- The throttle and metering assembly were found fracture separated from its installation point and exhibited impact related damage.

- The throttle arm remained secure to the shaft
 - The throttle valve moved, but was restricted due to impact damage
 - The fuel metering portion of the assembly was disassembled; and the internal components exhibited normal operating wear signatures.

Figure 18: Fuel Servo
