On Scene Photos
Courtesy of the Federal Aviation Administration

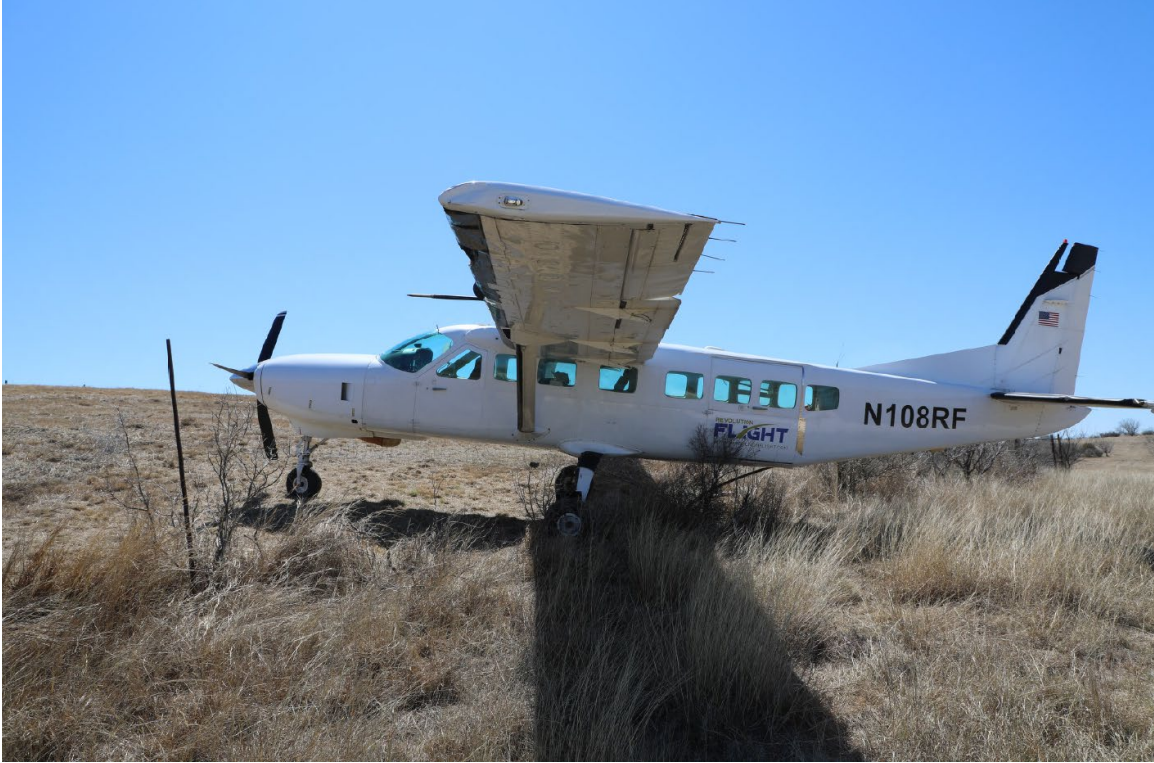
Figure 1: Left side of Airplane

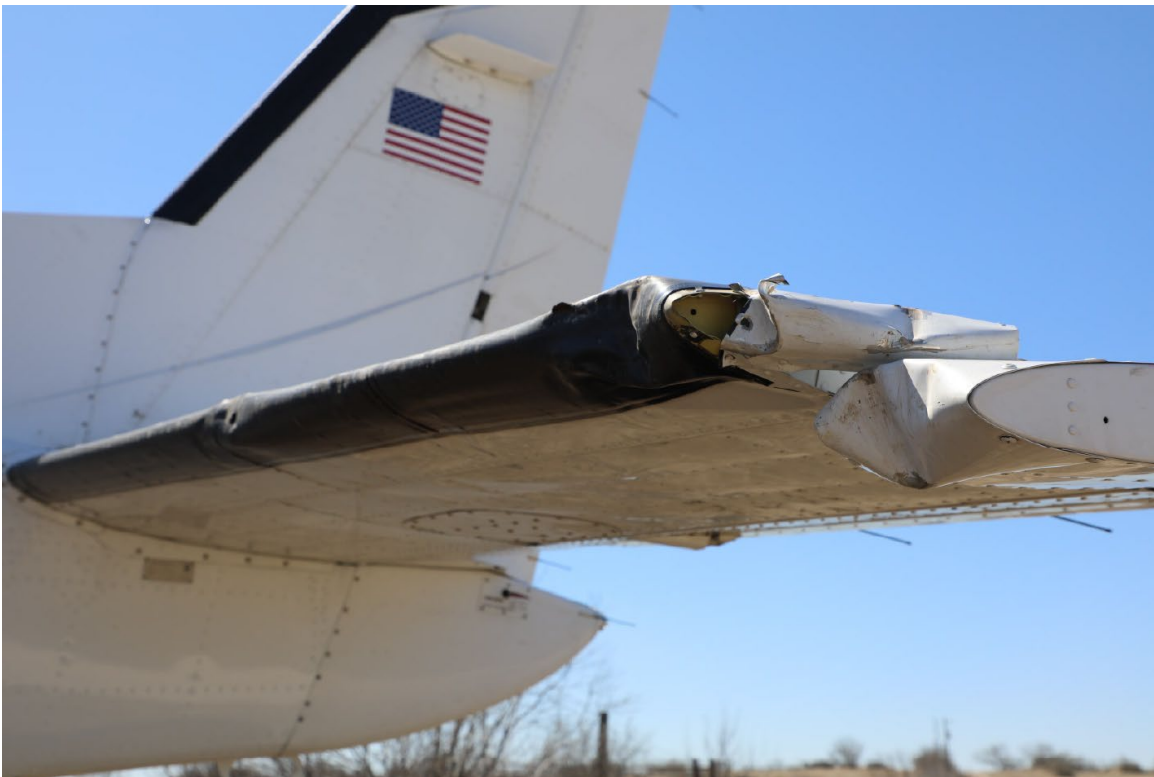
Figure 2: Left Horizontal Stabilizer

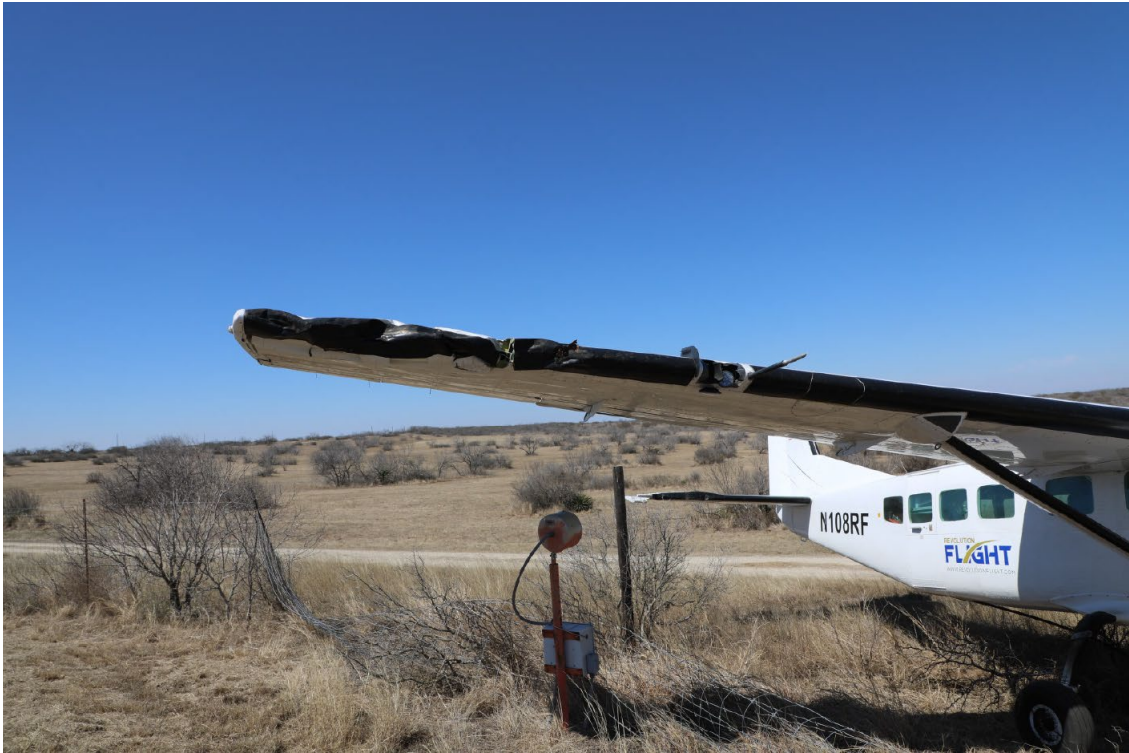
Figure 3: Right side of Airplane

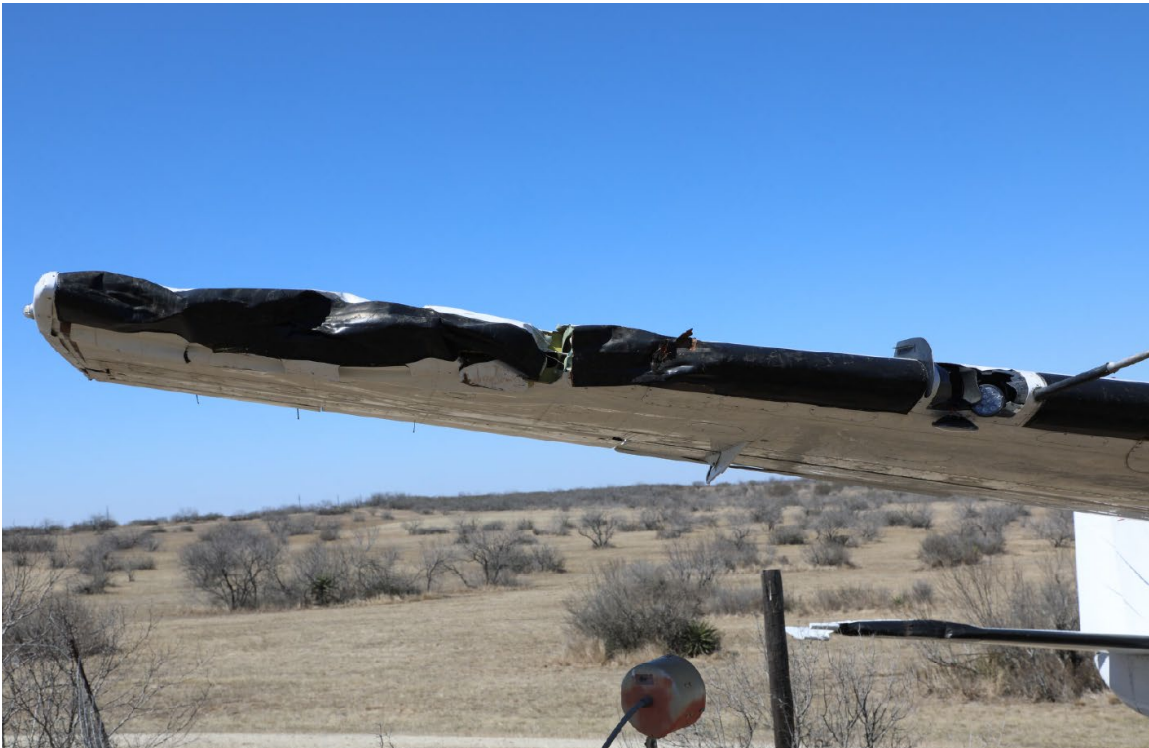
Figure 4: Outboard Right Wing

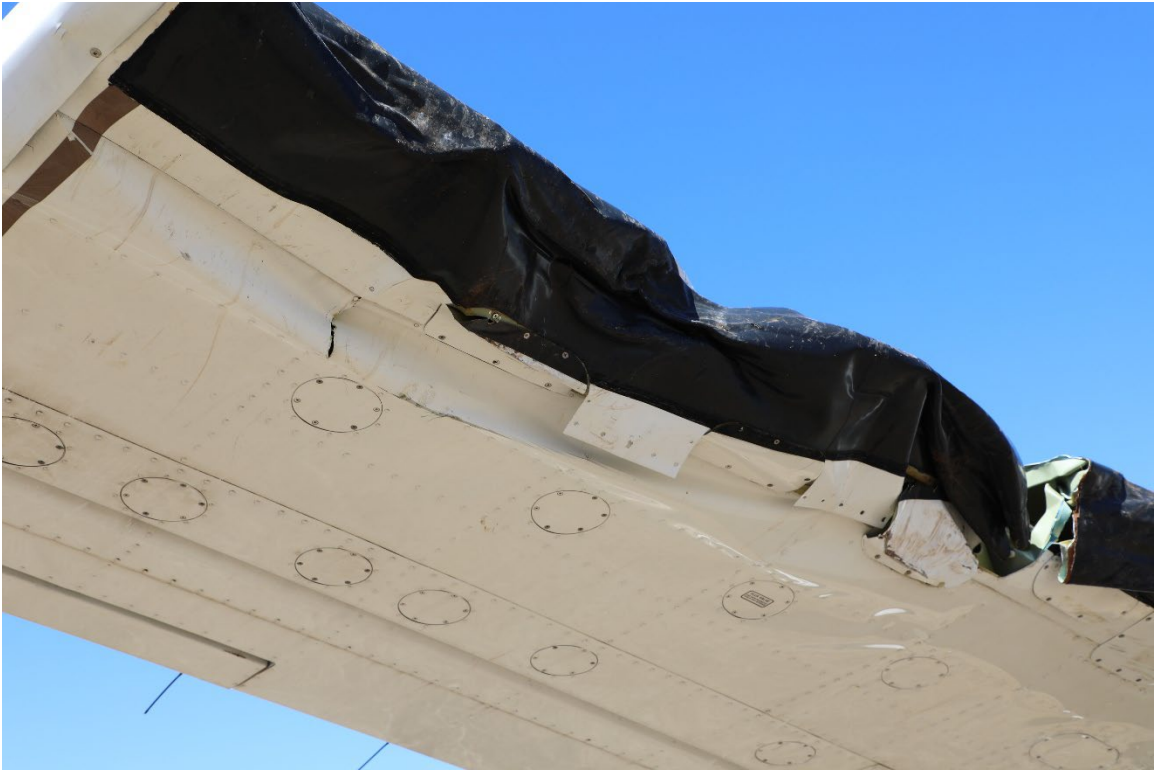
Figure 5: Right-Wing leading edge crush Damage
