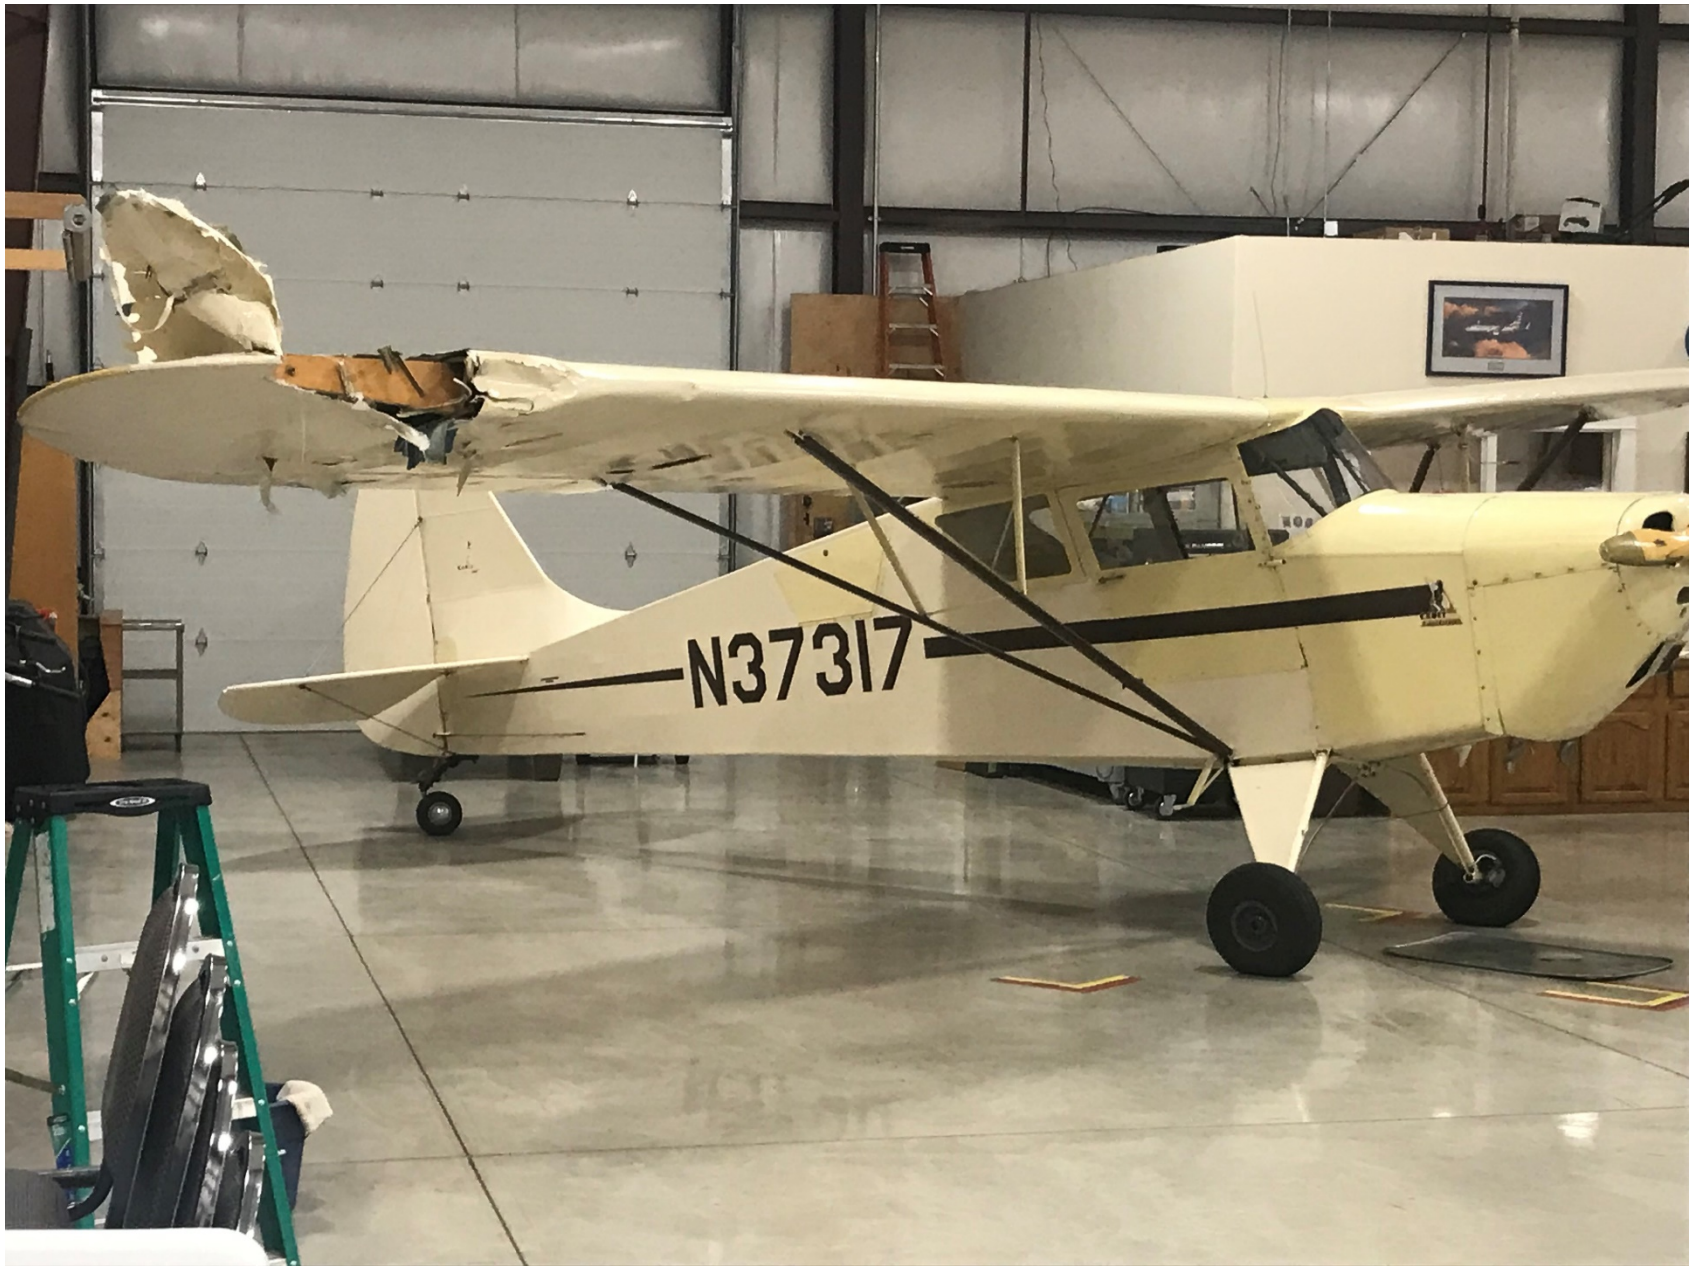
Photo 1 – Photo of the damage to the airplane. Courtesy of the owner.

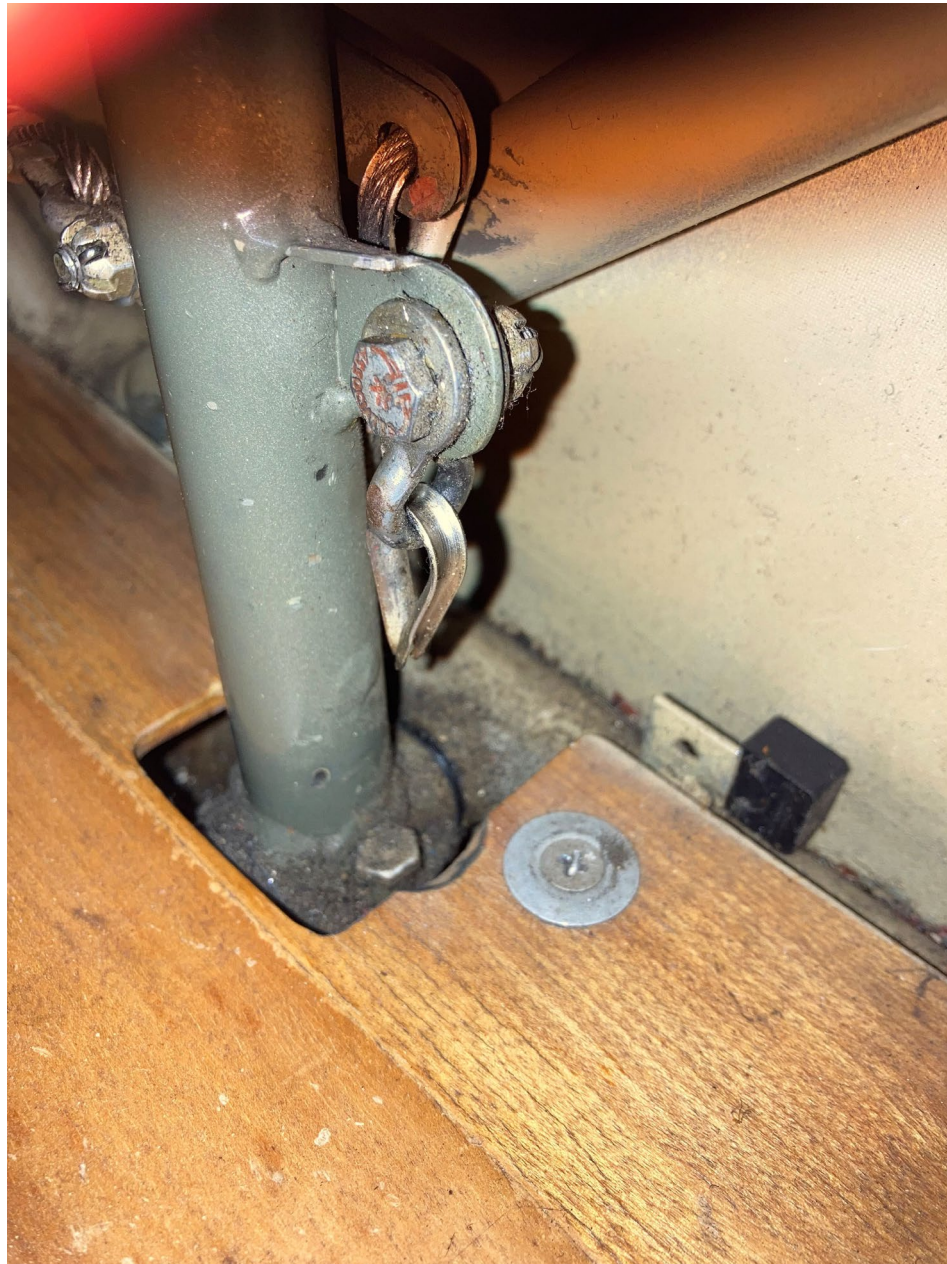
Photo 2 – View of the left rudder cable thimble. Courtesy of the owner.

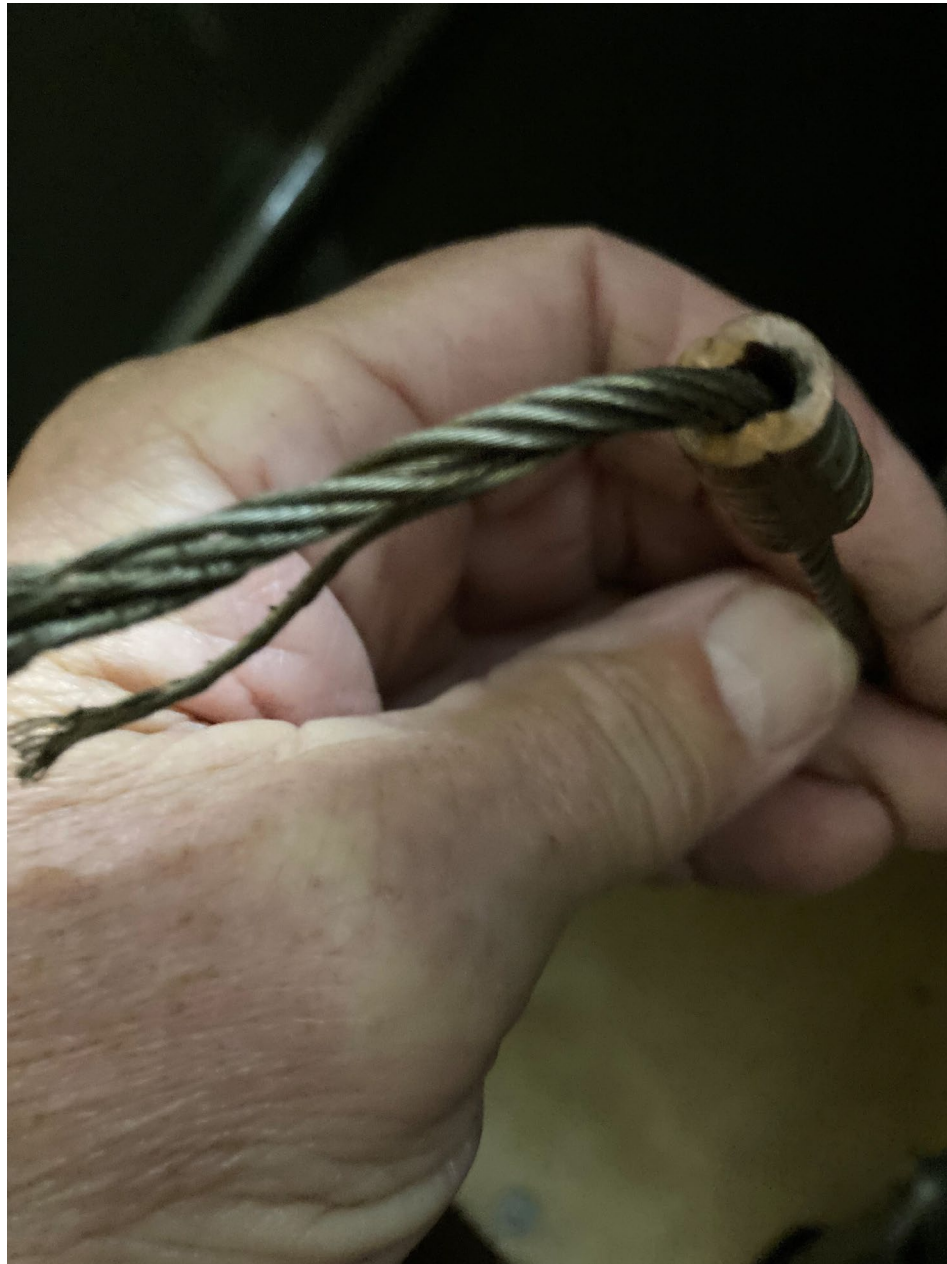
Photo 3 - View of the control cable and nicopress swage. Courtesy of the owner.

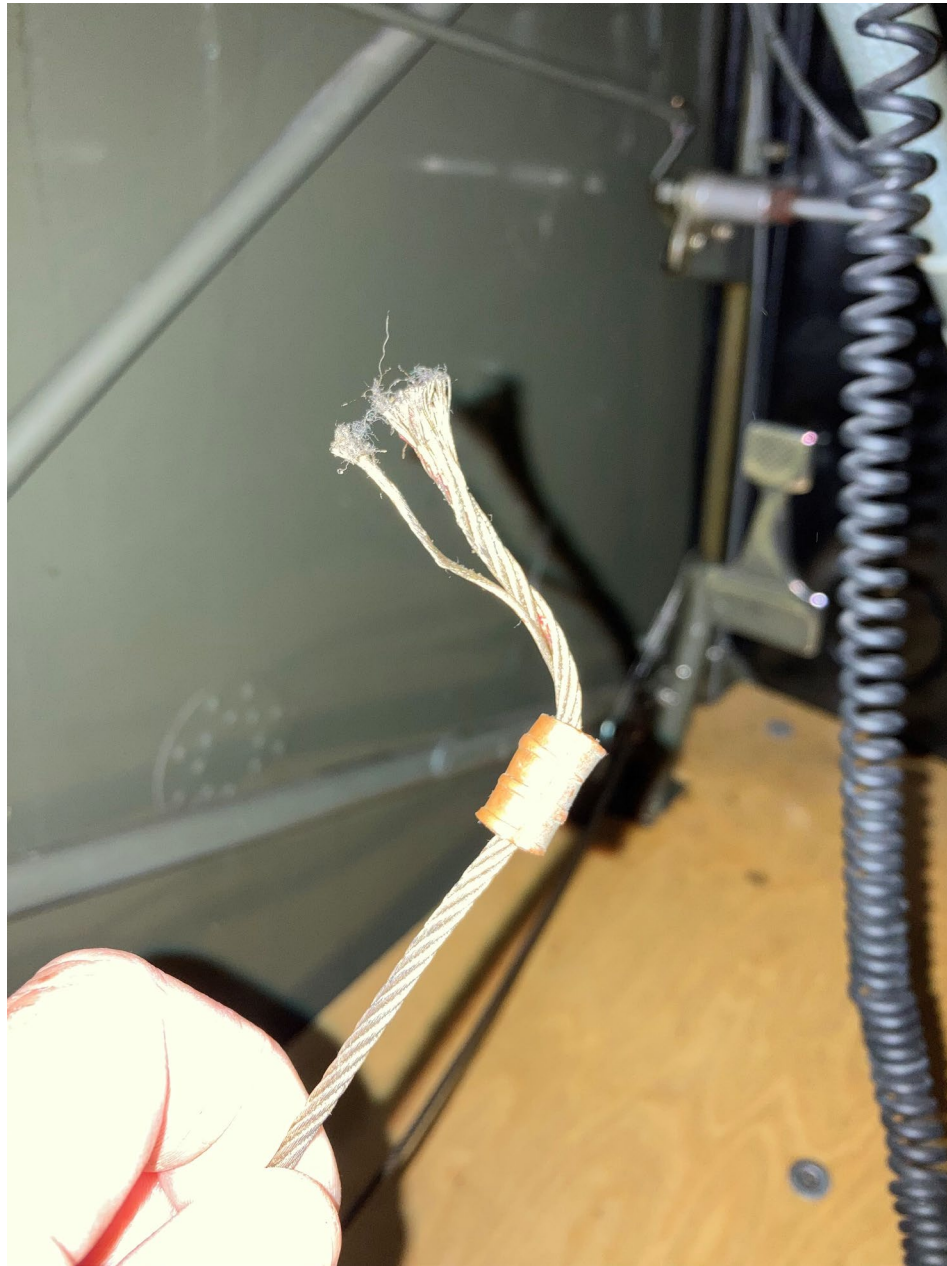
Photo 4 - View of the control cable and nicopress swage. Courtesy of the owner.
