CEN23LA387

INVESTIGATION PHOTOGRAPHS

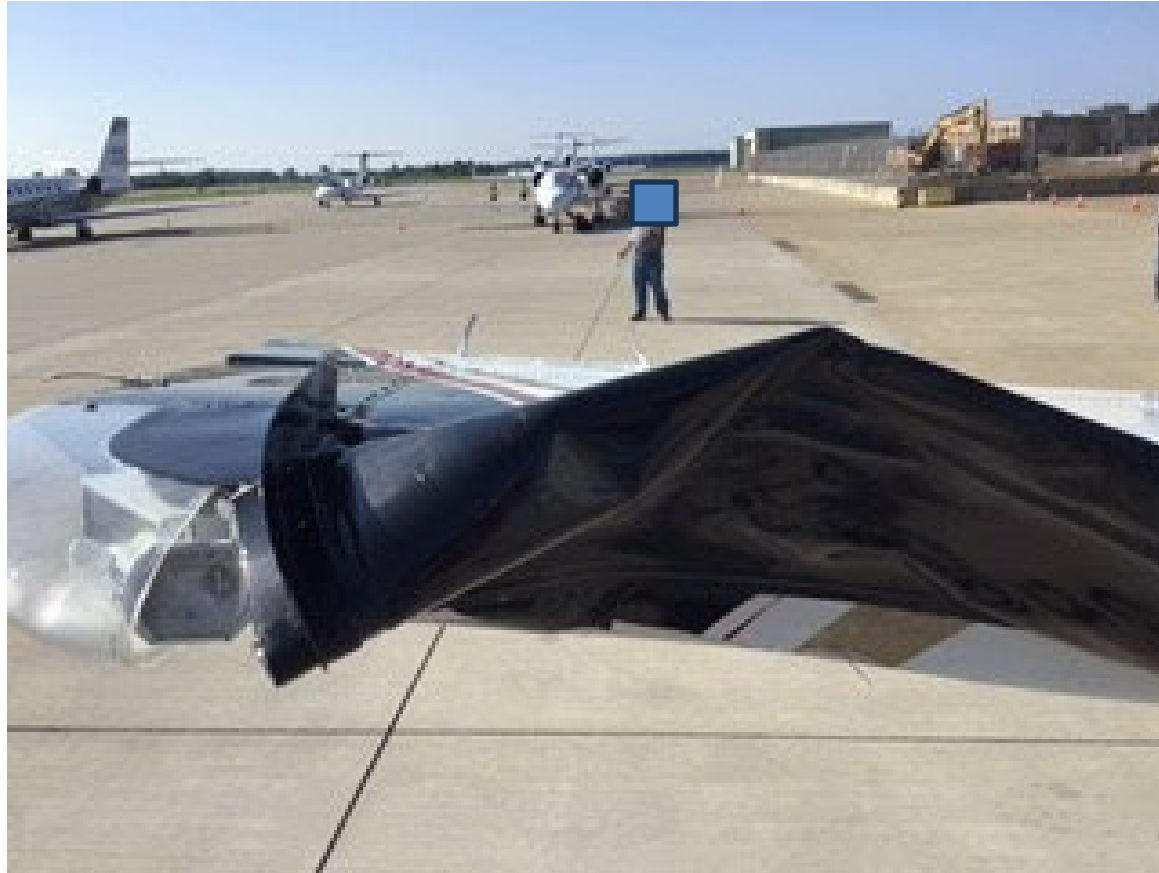
Photograph 1 - Damaged Right Wing Leading Edge (Courtesy of FAA)

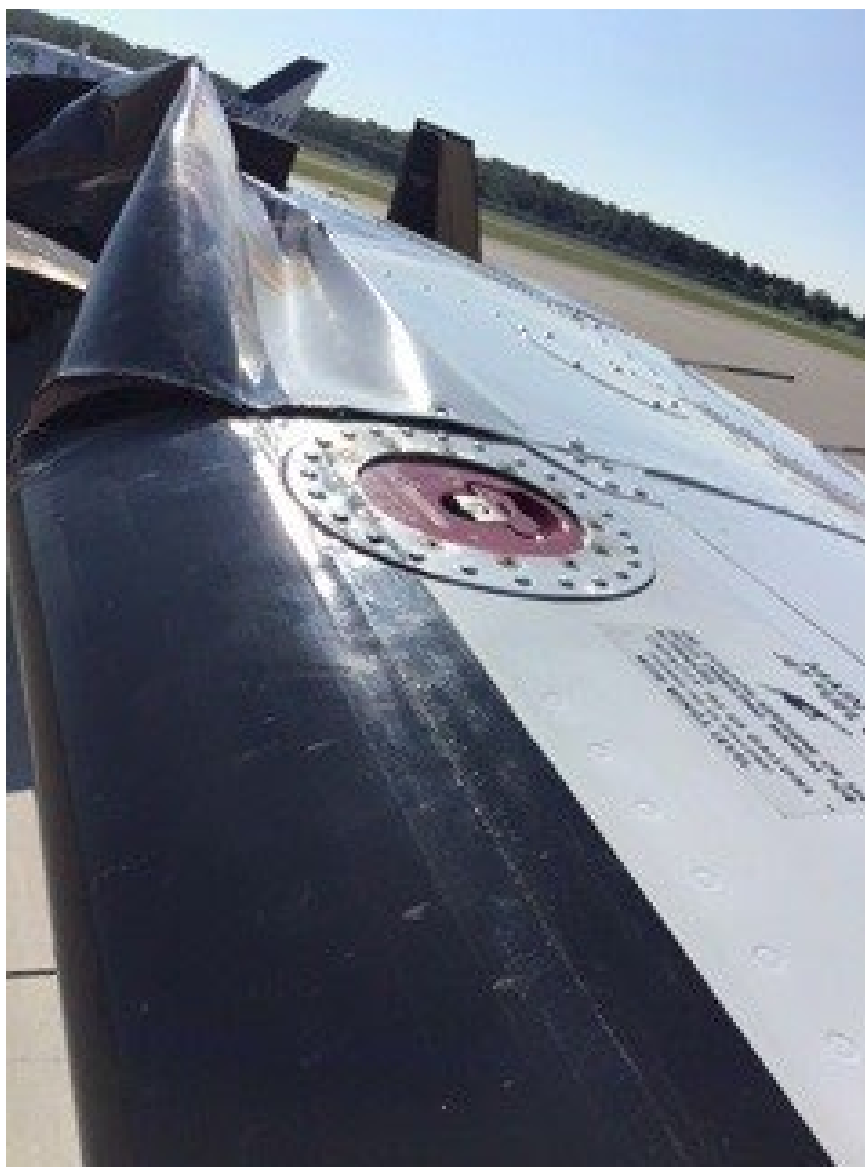
Photograph 2 - Damaged Right Wing Leading Edge (Courtesy of FAA)
