ANC24LA035

**INVESTIGATION PHOTOGRAPHS**

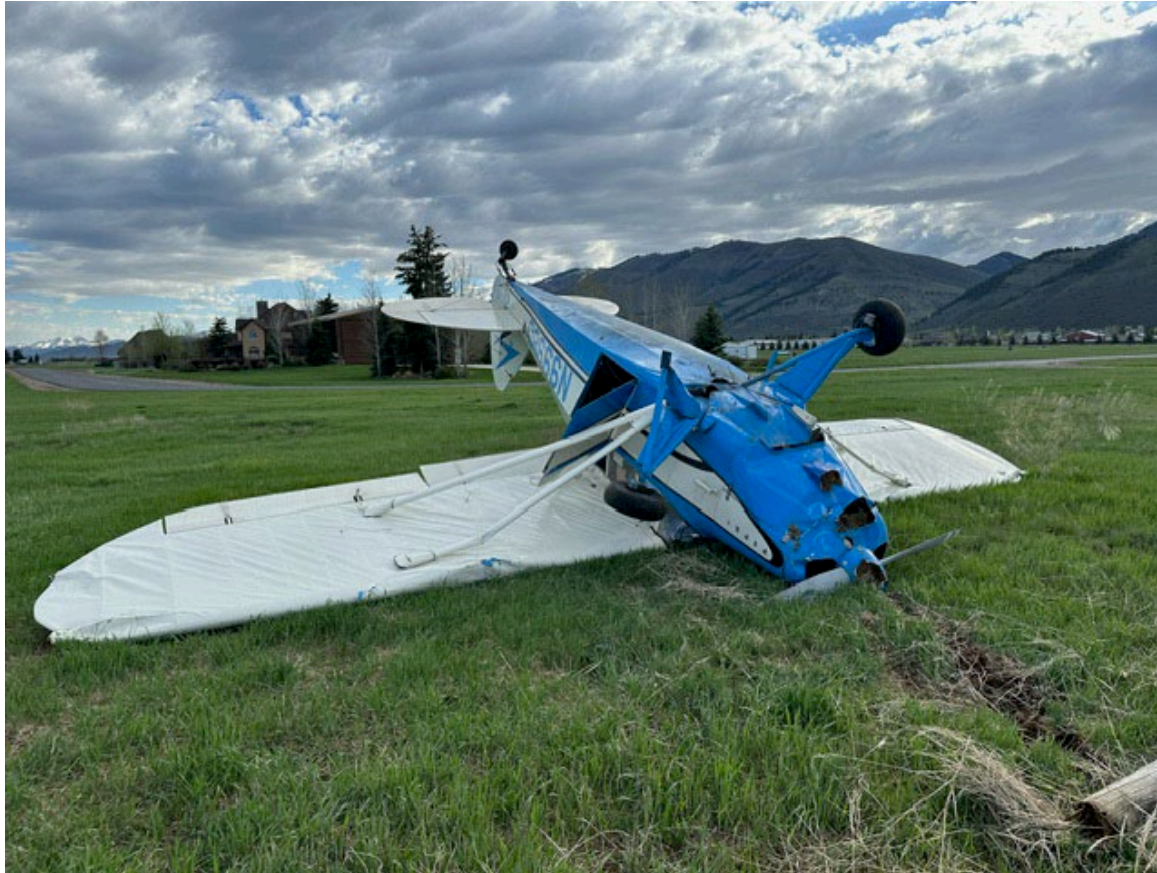
**Photograph 1 - Image of wings, fuselage, and empennage (Courtesy of Airport Manager)**

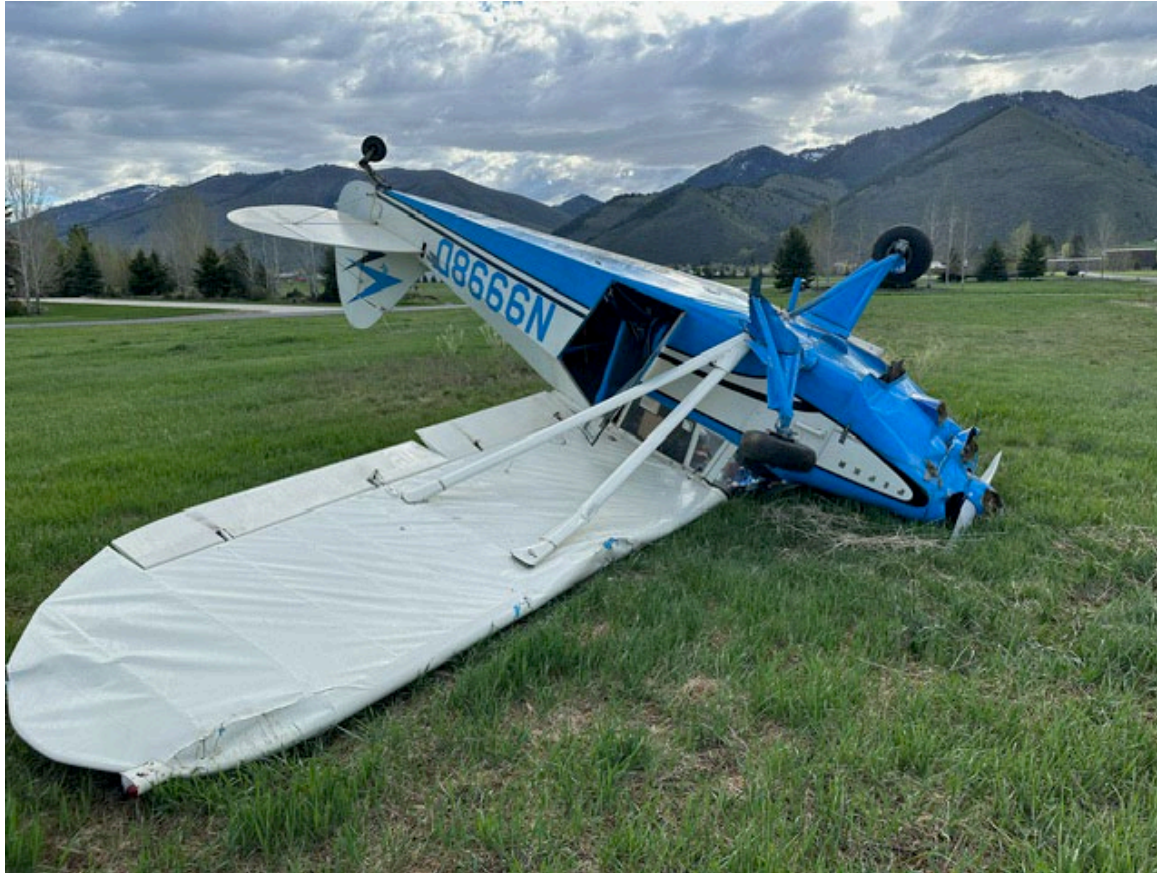
**Photograph 2 - Image of left wing, fuselage, and empennage (Courtesy of Airport Manager)**

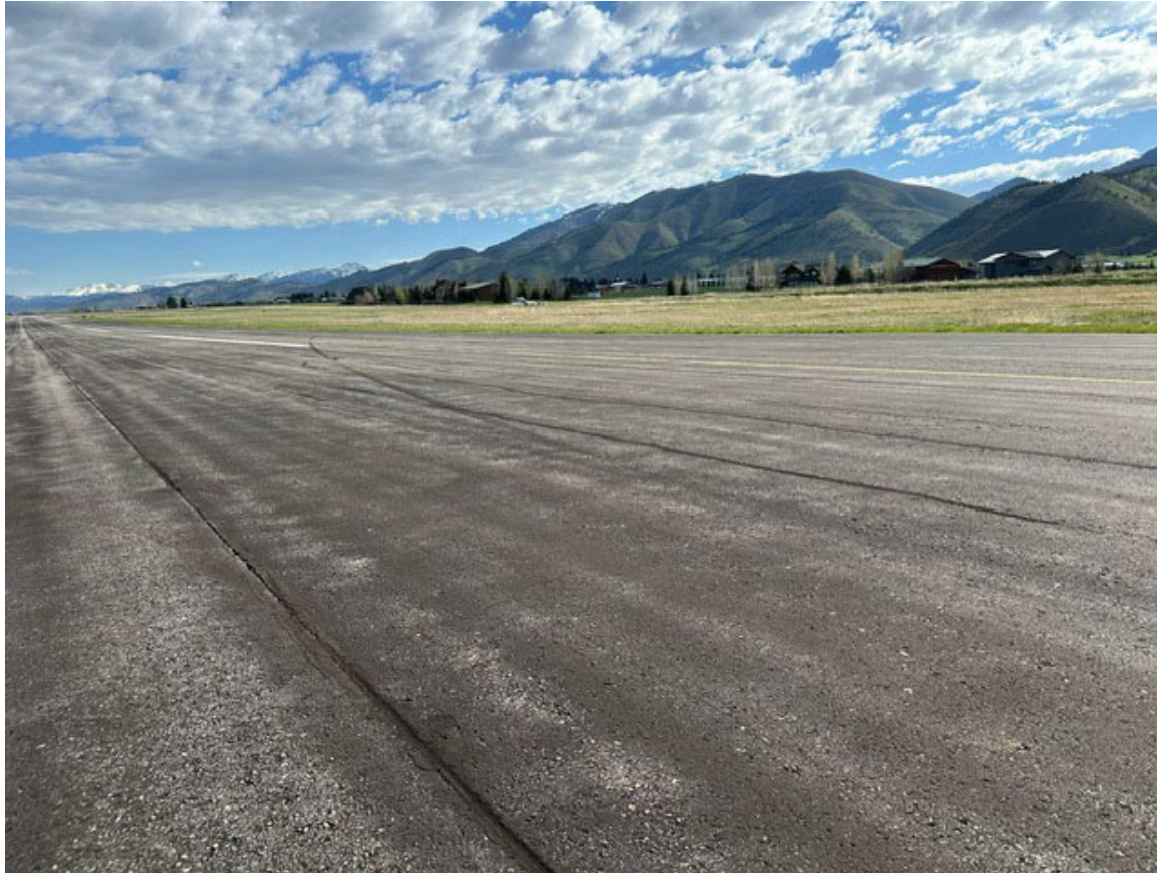
**Photograph 3 - Image of tire signature on runway surface (Courtesy of Airport Manager)**

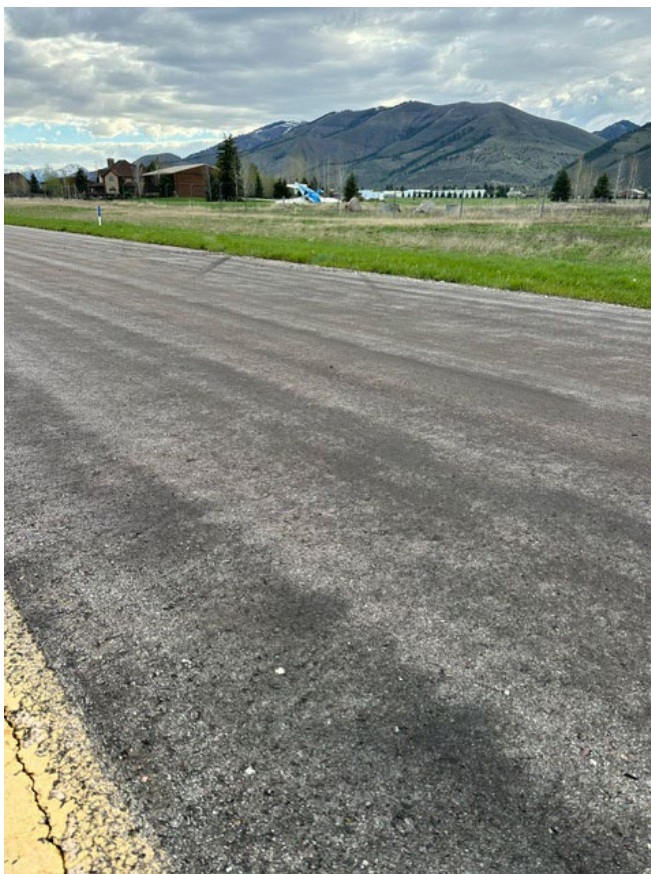
**Photograph 4 - Image of tire signatures on taxiway surface (Courtesy of Airport Manager)**
