WPR22FA331

INVESTIGATION PHOTOGRAPHS

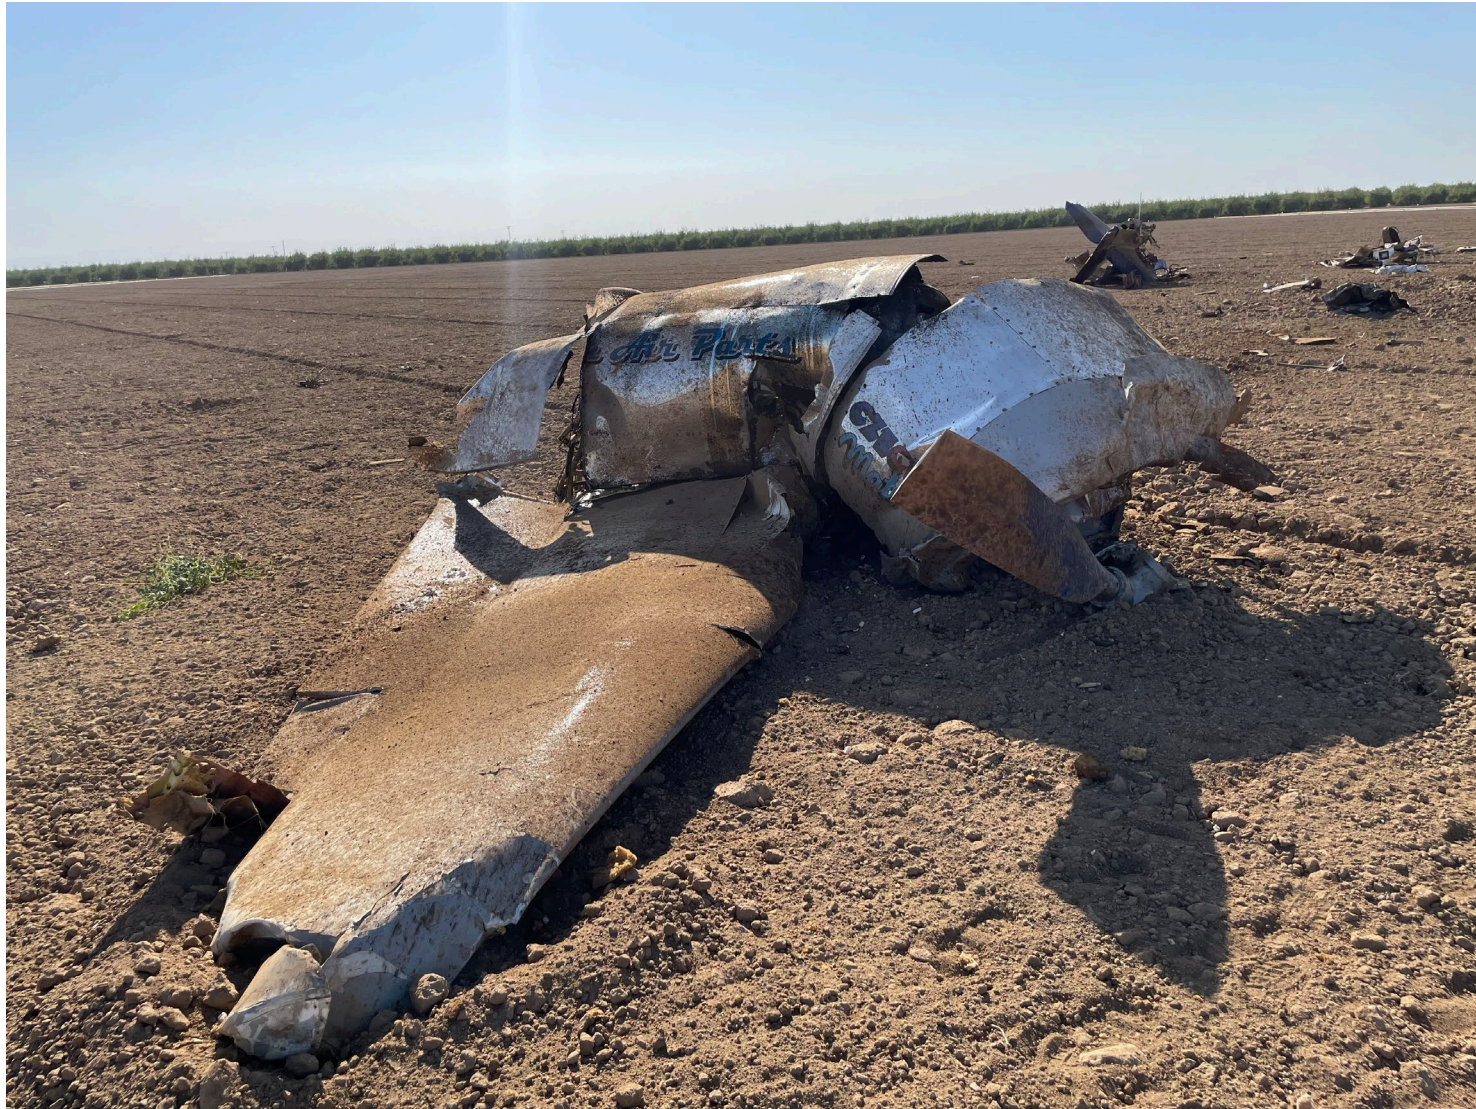
Photograph 1 - View of the forward fuselage, right wing, and engine. (Courtesy of the FAA)

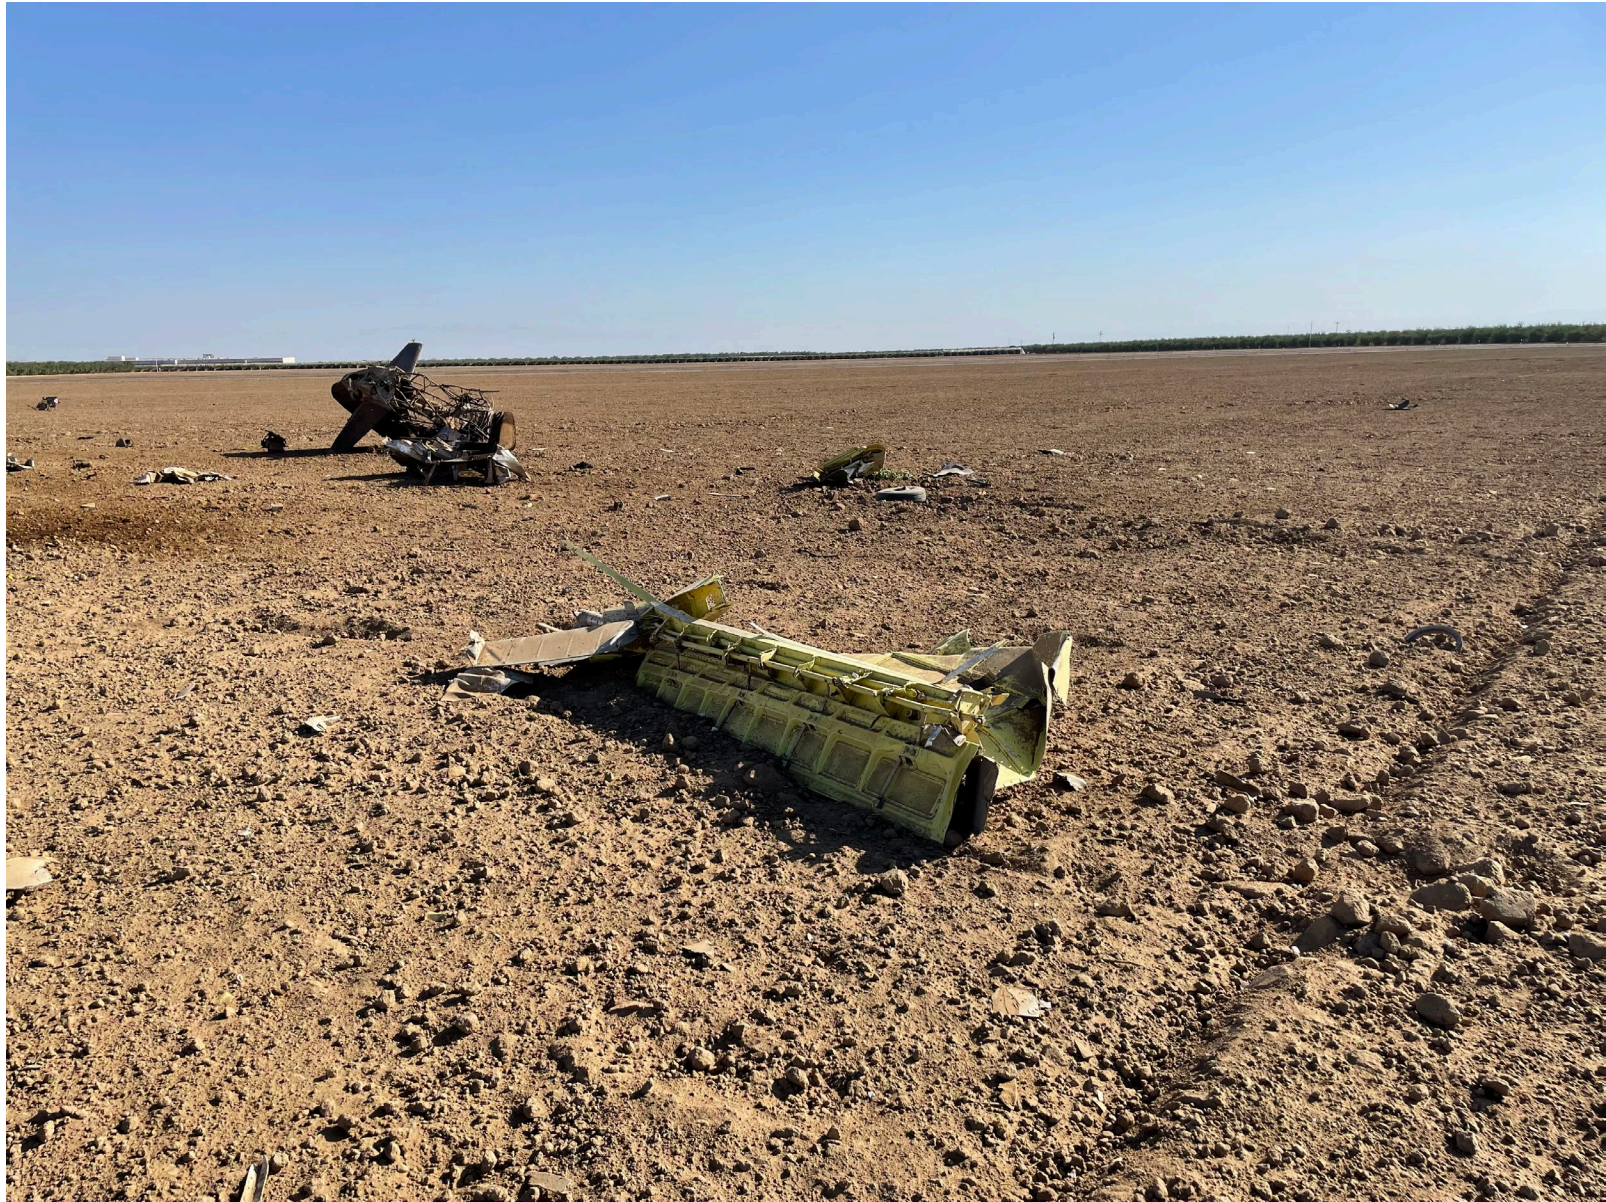
Photograph 2 - View of the accident site. (Courtesy of the FAA)

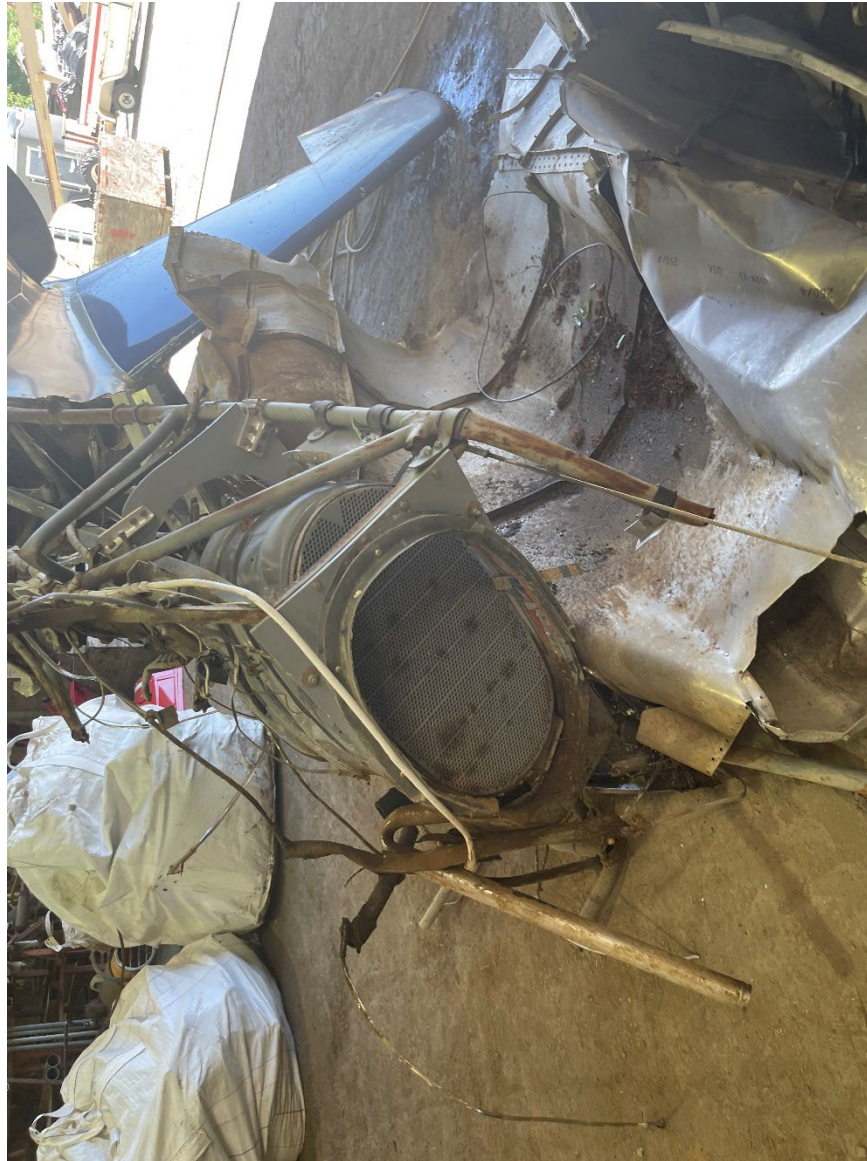
Photograph 3 - View of the aft fuselage structure and oil coolers.

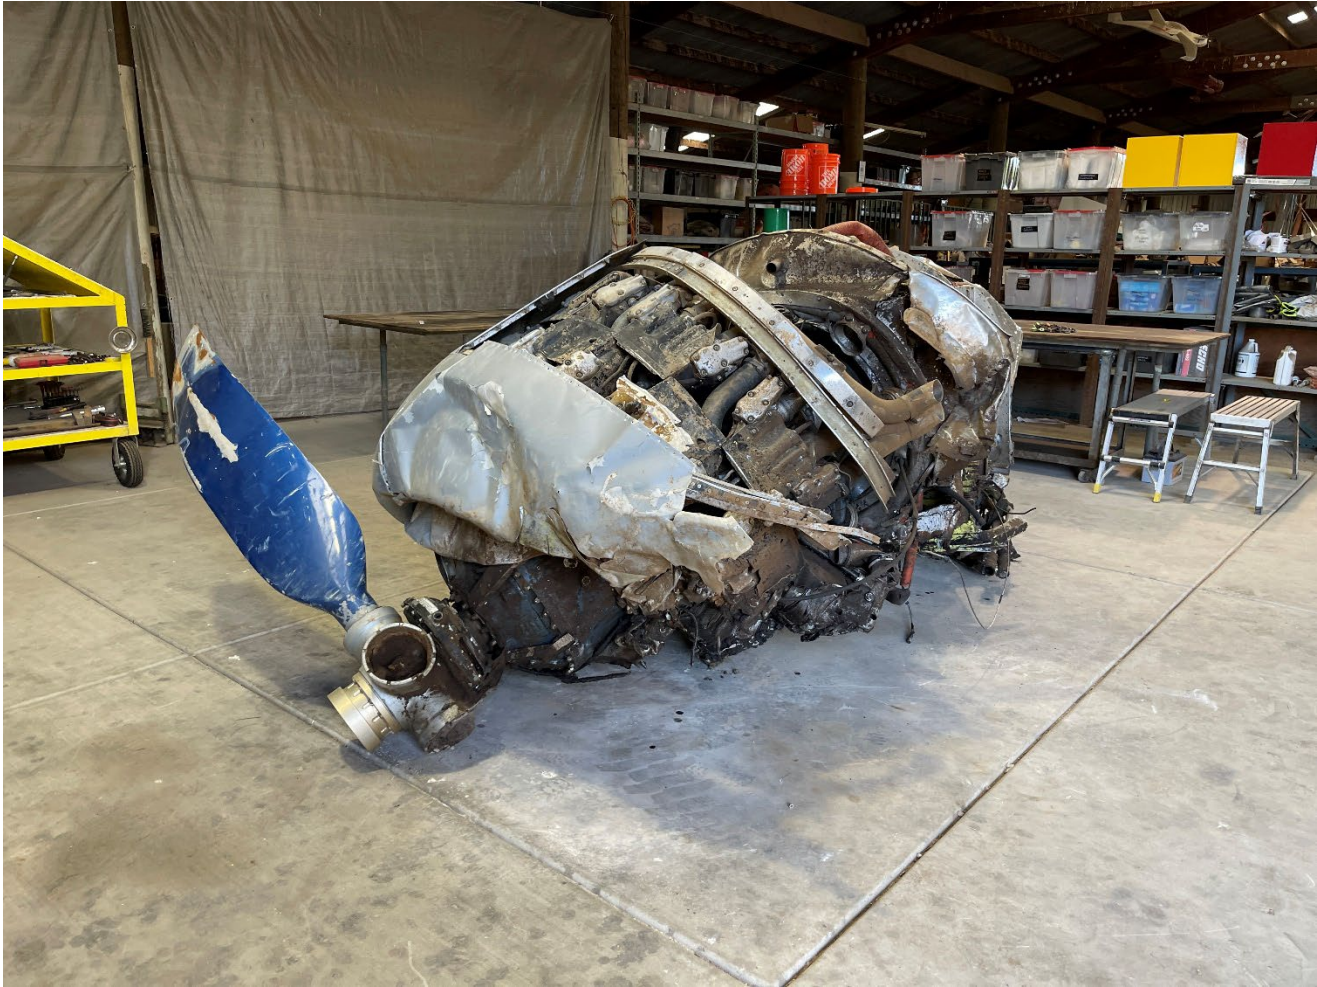
Photograph 4 - View of the recovered engine.
