Photo 1 – Airplane wreckage

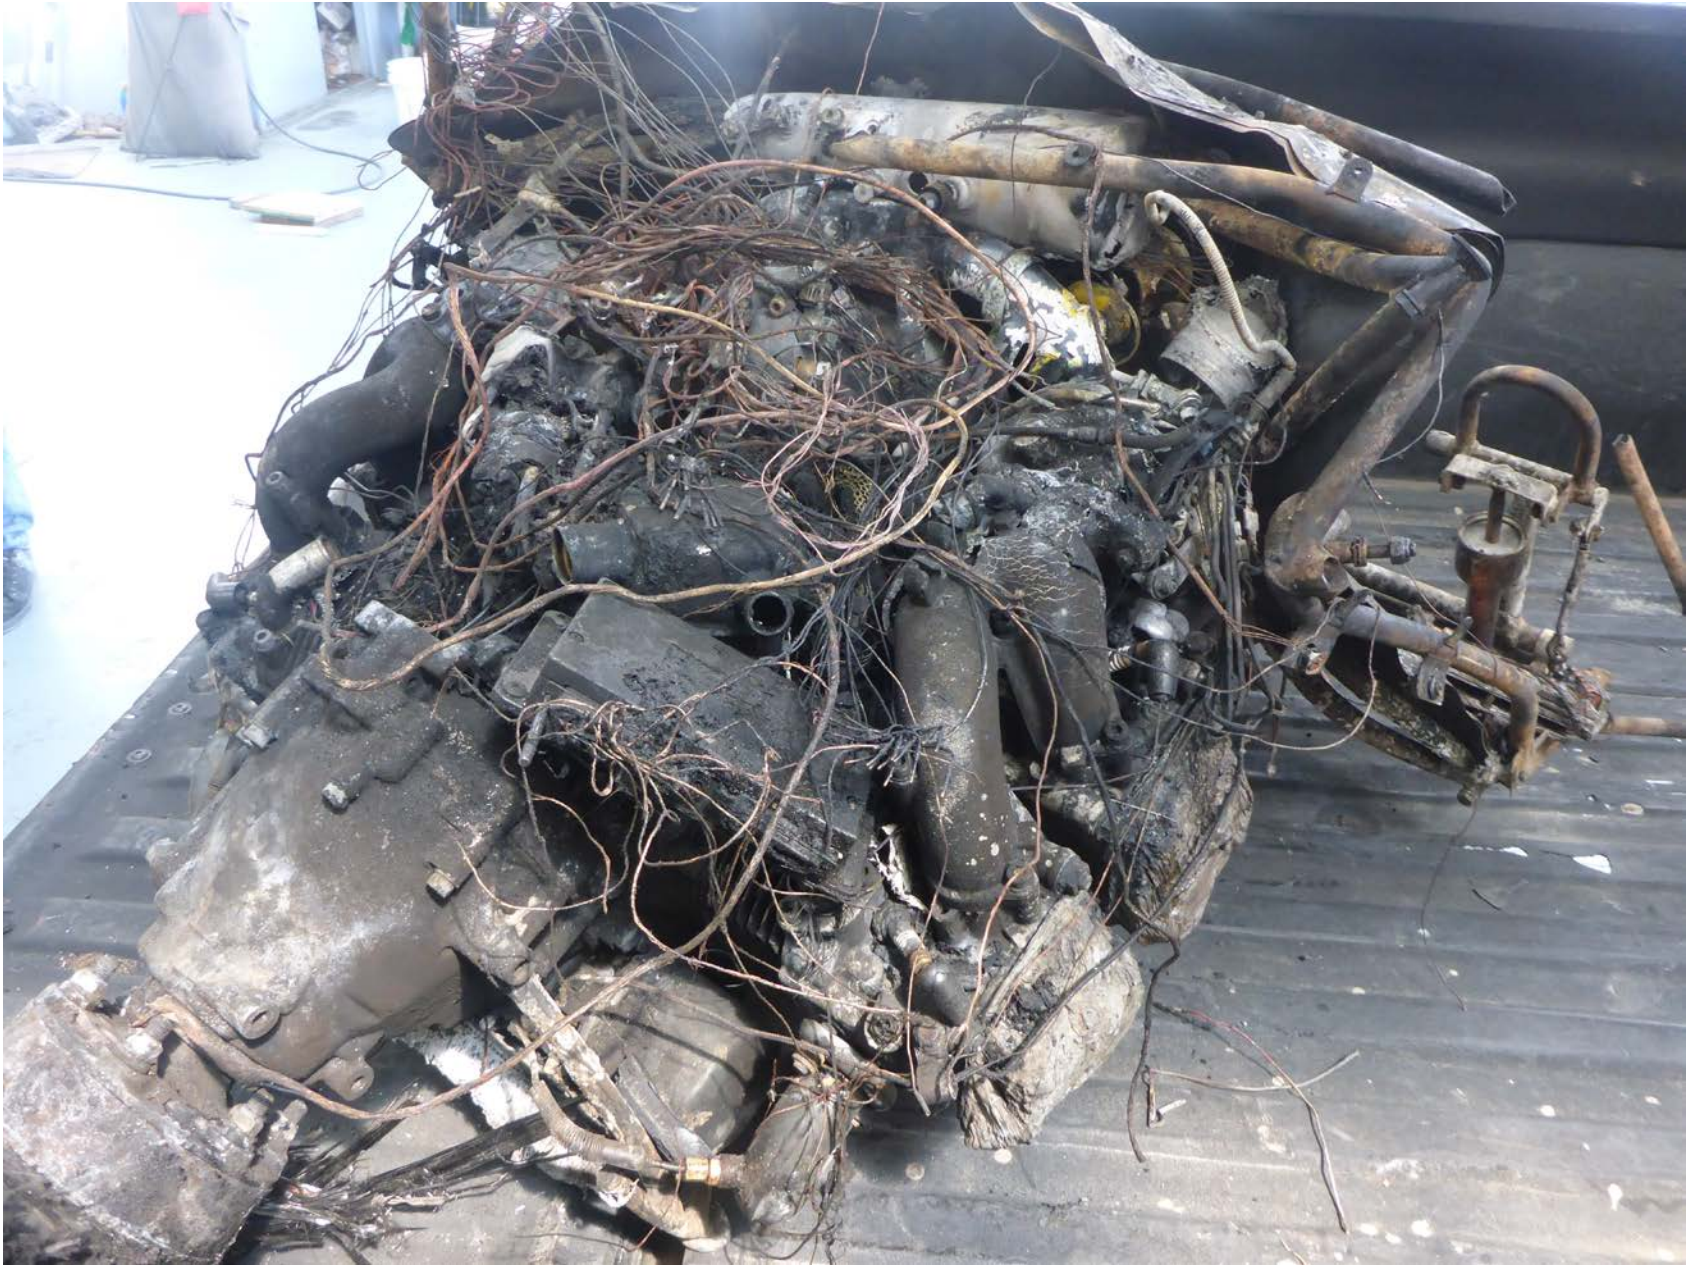
Photo 3 - Engine
