Elliott Simpson  
Senior Aviation Accident Investigator  
AS-WPR

**Subject:** WPR22FA169

**Contact:** Randy A Harris

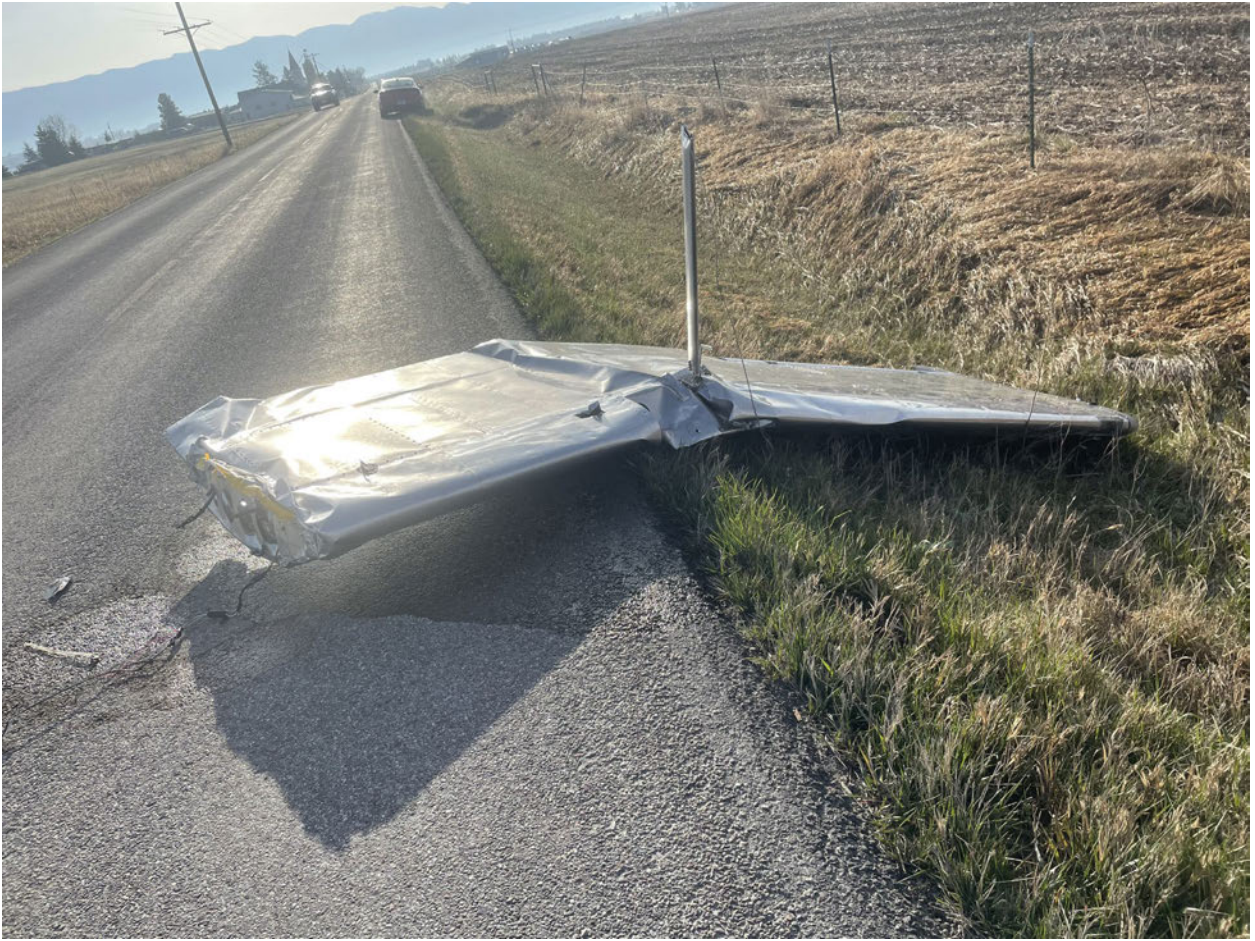
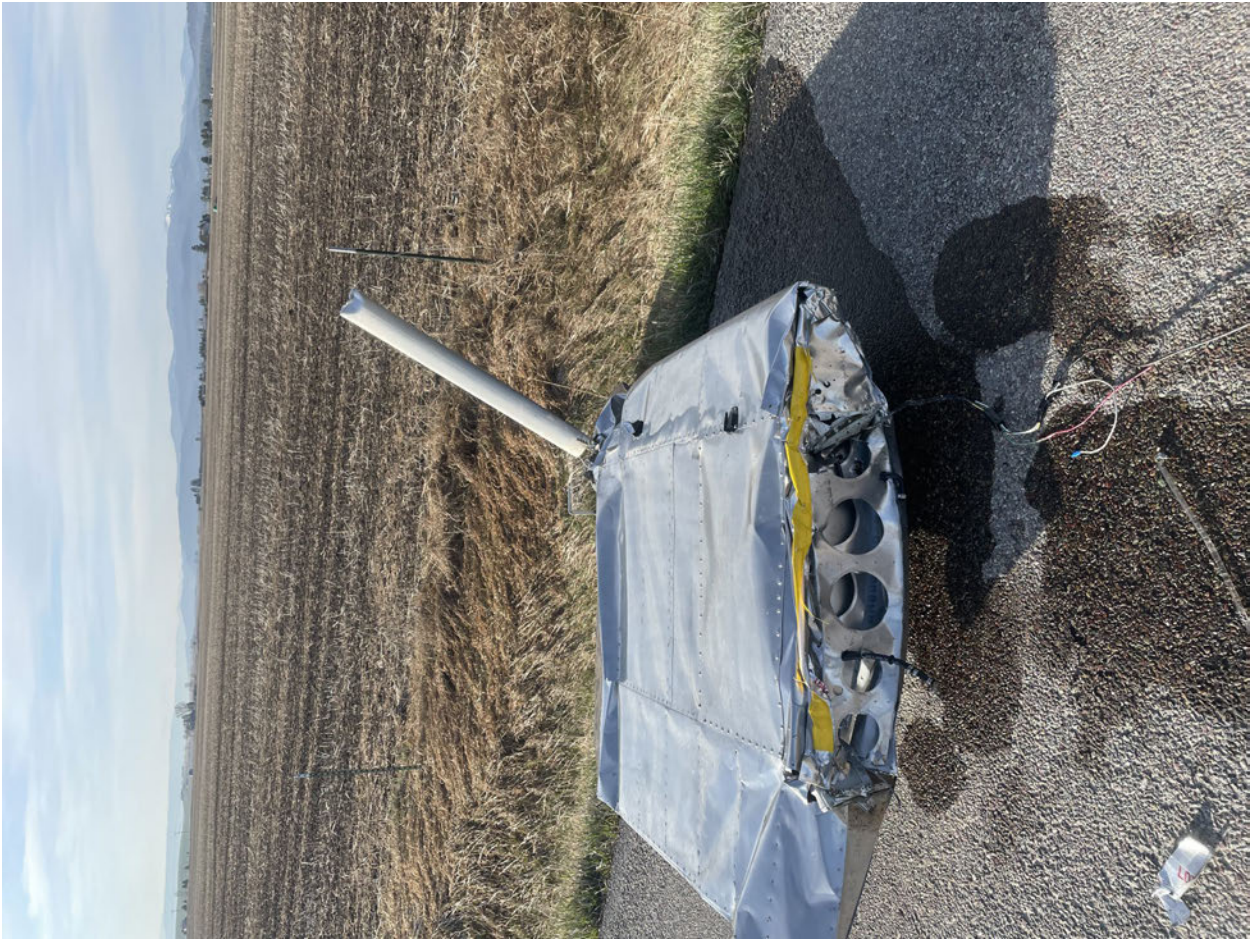
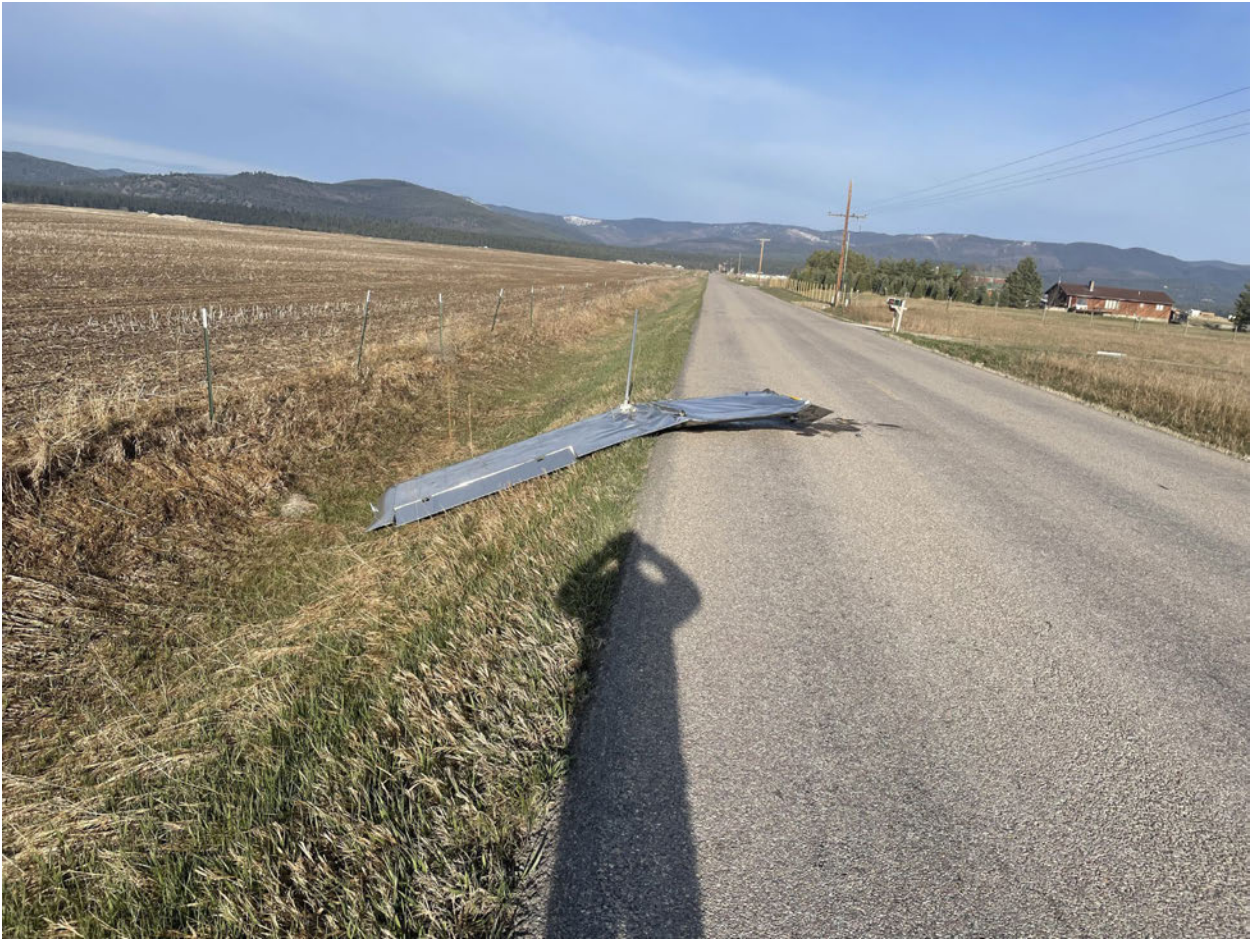
As I got visibility freed from the house, I saw a large rectangular piece of metal fluttering down out of the sky. I would estimate the altitude to be around 300 feet when I saw it. It appeared to land on the road. I jumped into my daughters car and went down the road. I took photos of the wing on the highway. I saw the plane off the road 500 yards or so north west of the wing. Also noted a piece of the plane, likely a spar in the driveway. It is visible in the last picture to the right of the mail box."
