## INTERVIEW SUMMARY

**Interview Date: April 23, 2019**  
**Person Contacted: Angela Ellis – [REDACTED]**  
**NTSB Accident Number: WPR19FA115**

**Interview Date: April 22, 2019**  
**Person Contacted: KENT EWING** [REDACTED]  
**NTSB Accident Number: WPR19FA115**

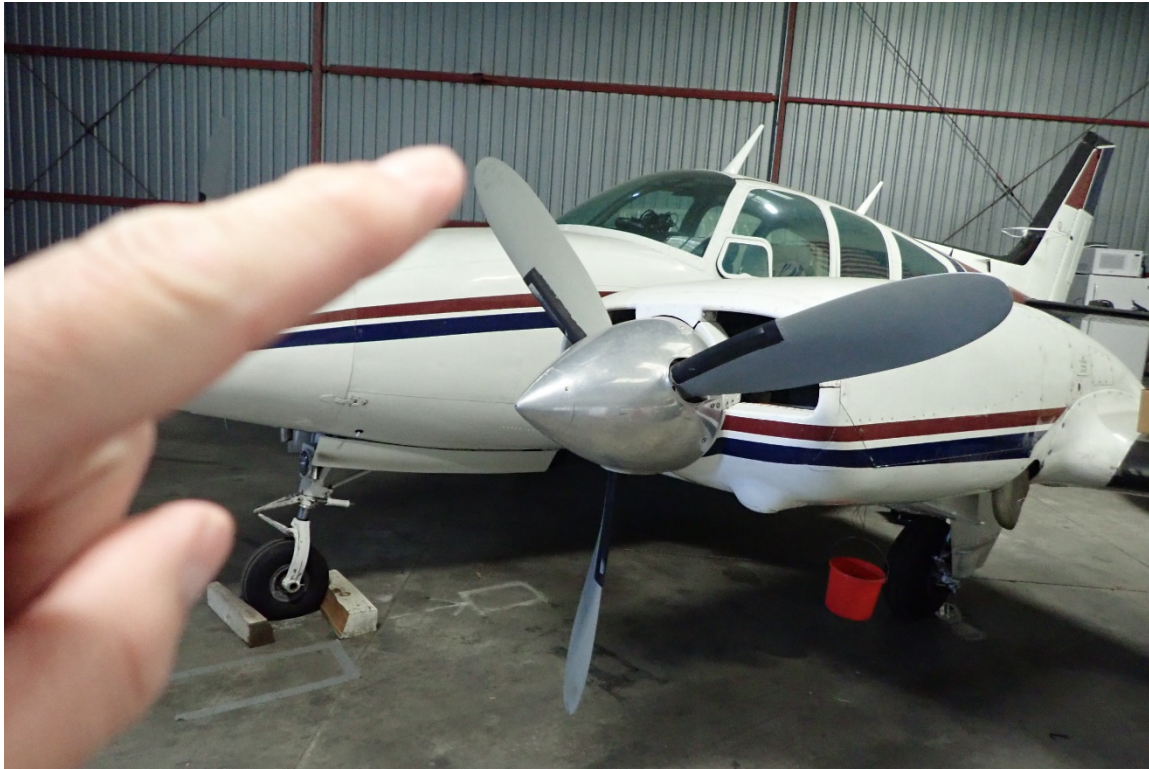
- They then taxied back to the hangar.
- Upon arrival, Mr. Ellis again used Mr. Pont's tug, backing the airplane slowly into the hangar. Just as he came to the end, he informed Mr. Pont that the elevator of N65MY would not clear the left propeller of the other airplane in the hangar (a Baron) (See Photo 1) unless he moved the elevator to the "UP" position.

- Mr. Pont exclaimed skepticism, but Mr. Ellis stated that he had done this before, and it was a regular routine. As he continued to move N65MY back, Mr. Pont could see that Mr. Ellis was correct, and the elevator was going to strike the propeller of the Baron.

Photo 1 – Baron, with Finger indicating Contact Area with M65MY Elevator

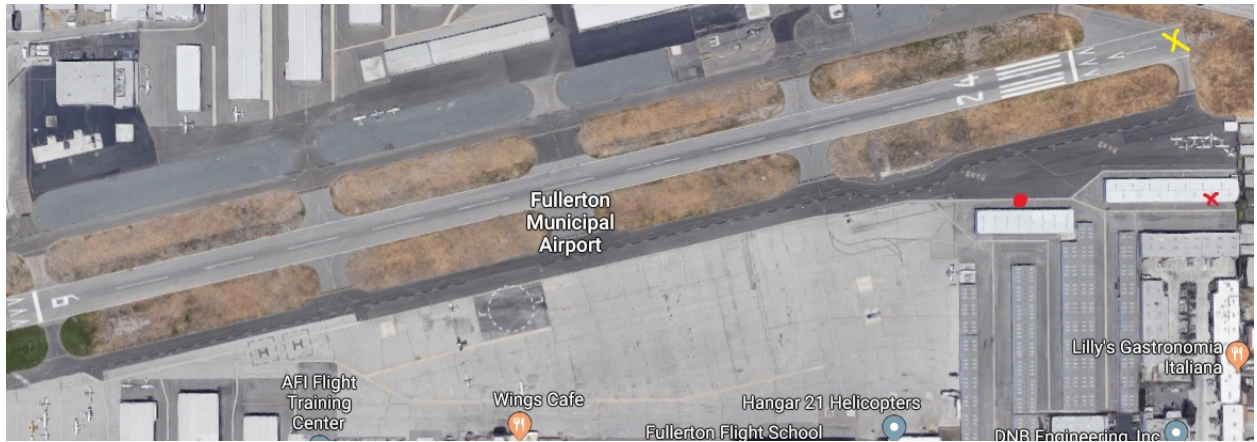
"I don't know if I can add much to the discussion, but I was there when he took off. I have a Mooney in a hangar on the SE side of the airport and had just finished a flight that evening. I put the plane away and was getting ready to leave for home. My hangar is where the red "X" is on the attachment. I heard a plane getting ready to depart as I was driving towards the exit and stopped about where the red circle is on the attachment to watch it. I rolled down my window, he was lined up and on the brakes as he ran his engines up, normal for a twin there. I watched as he released the brakes and started down the runway. Everything looked and sounded normal. As he lifted off, I think at around 1000-1100' down the runway he looked a little squirrely but I have seen enough private pilots take off not to think anything of it. Once he had left the ground I rolled my window up and started to drive off when out of the corner of my eye I saw the fireball.

"He was all the way back at the start of the displaced threshold [yellow X]. He ran the engines all the way up while [ ] on the brakes before releasing. I couldn't say exactly how long he was at full power before releasing, but it was long enough that I had heard him start to run them up as I was driving and had enough time to stop the car (not going fast as it's only a 10 mph speed limit), roll the window down and still wait before he released and started the roll."
