VAN'S AIRCRAFT, INC.

Service Bulletin

SB 06-9-20

Applies to: All RV's with manual trim and all RV-10's.

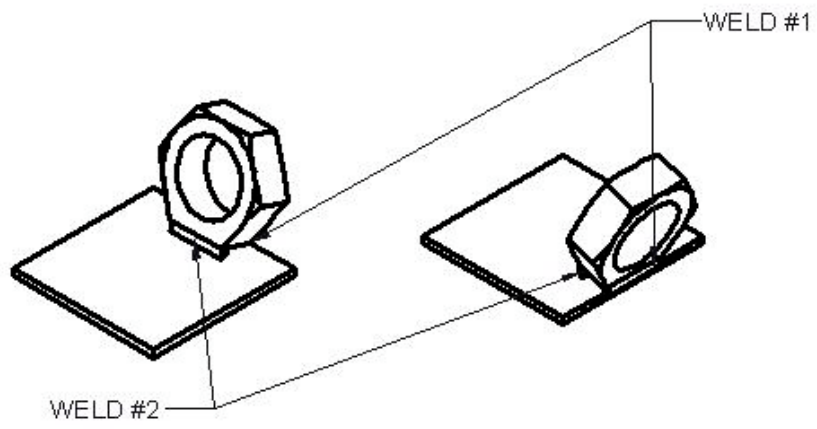
Identification information: Figure #1 below depicts the new anchor, WD-415-1. WD-415-1 anchors can be identified by full width welds on both sides of the nut.

Affected WD-415's are identified by either no aft weld (single weld across the front of the nut) or one long weld across the front of the nut and a small tack weld on the aft side of the nut.

Suggested action: Van's Aircraft recommends that builders and owners of single and two place RV's with manual elevator trim and all RV-10 builders and owners replace older style WD-415 anchors with the WD-415-1 anchor. An entry in the aircraft's airframe log should be made referencing this replacement.
