NATIONAL TRANSPORTATION SAFETY BOARD
Vehicle Recorder Division
Washington, DC 20594

Onboard and Security Video Recordings

Specialist's Factual Report
By Bill Tuccio, Ph.D.

Location:	Fullerton, California
Date:	August 24, 2016
Aircraft:	Siai-Marchetti SF260, N16FD
Operator:	Air Combat USA
NTSB Number:	WPR16LA167

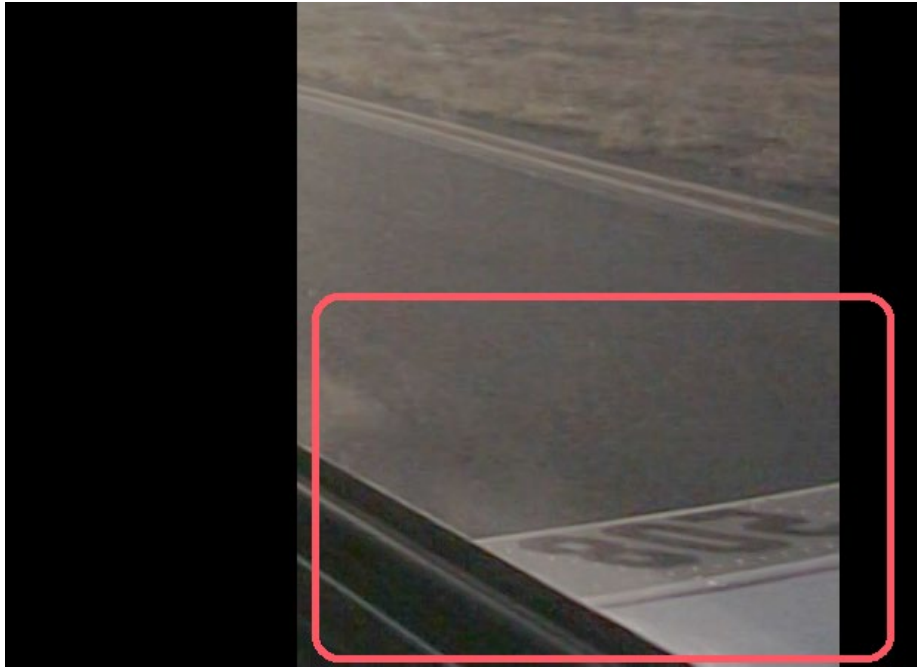
From the start of the video until 00:04, the vantage point was rearward facing (directly towards the crew faces) as N16FD was taxiing. Figures 1 and 2—both from the same video frame—show the flap position at this time.

Figure 2. Flap area from figure 1 expanded (brightness/contrast enhanced).
