NATIONAL TRANSPORTATION SAFETY BOARD

Onboard Imaging Device

Specialist's Factual Report

Location: Four Corners, California
Date: October 21, 2017
Aircraft: Extra 300
Registration: N414MT
Operator: California Extreme Adventures LLC.
NTSB Number: WPR18FA013

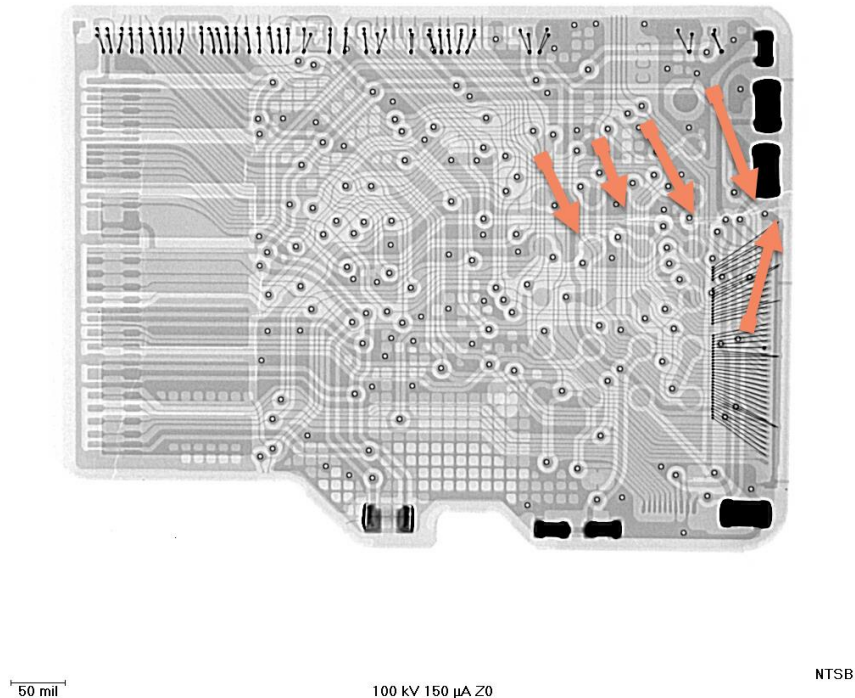
Upon arrival at the Vehicle Recorder Laboratory, an examination revealed the unit had sustained moderate impact damage. The battery compartment was damaged and the battery was removed prior to the device being shipped to the lab. An unbranded 16 GB microSD card was removed from the device. The microSD card was visually inspected and the plastic packaging appeared to be cracked. The microSD card was X-ray examined. An xray examination revealed a crack in the packaging. From the X-ray image, it was unclear if the crack had penetrated the card's silicon die. Figure 1 is a X-ray image of the card taken at the NTSB laboratory. A detected crack is denoted with red arrows.

Figure 1. An x-ray image of the microSD card taken at the NTSB laboratory. Red arrows denoted a detected crack in the memory card.

When inserted into a computer, the card was unreadable.

cracks as well as subsurface cracks that penetrated into the memory card's silicon die. The IEEC determined the damage to the silicon die was unreparable.
