NATIONAL TRANSPORTATION SAFETY BOARD
Vehicle Recorder Division
Washington, DC 20594

Onboard Image Recorder & GPS Data

Specialist's Factual Report
By Sean Payne

Location: Langley, WA
Date: January 12, 2019
Aircraft: Vans Aircraft RV-8A, N800KE
Operator: Private
NTSB Number: WPR19LA062

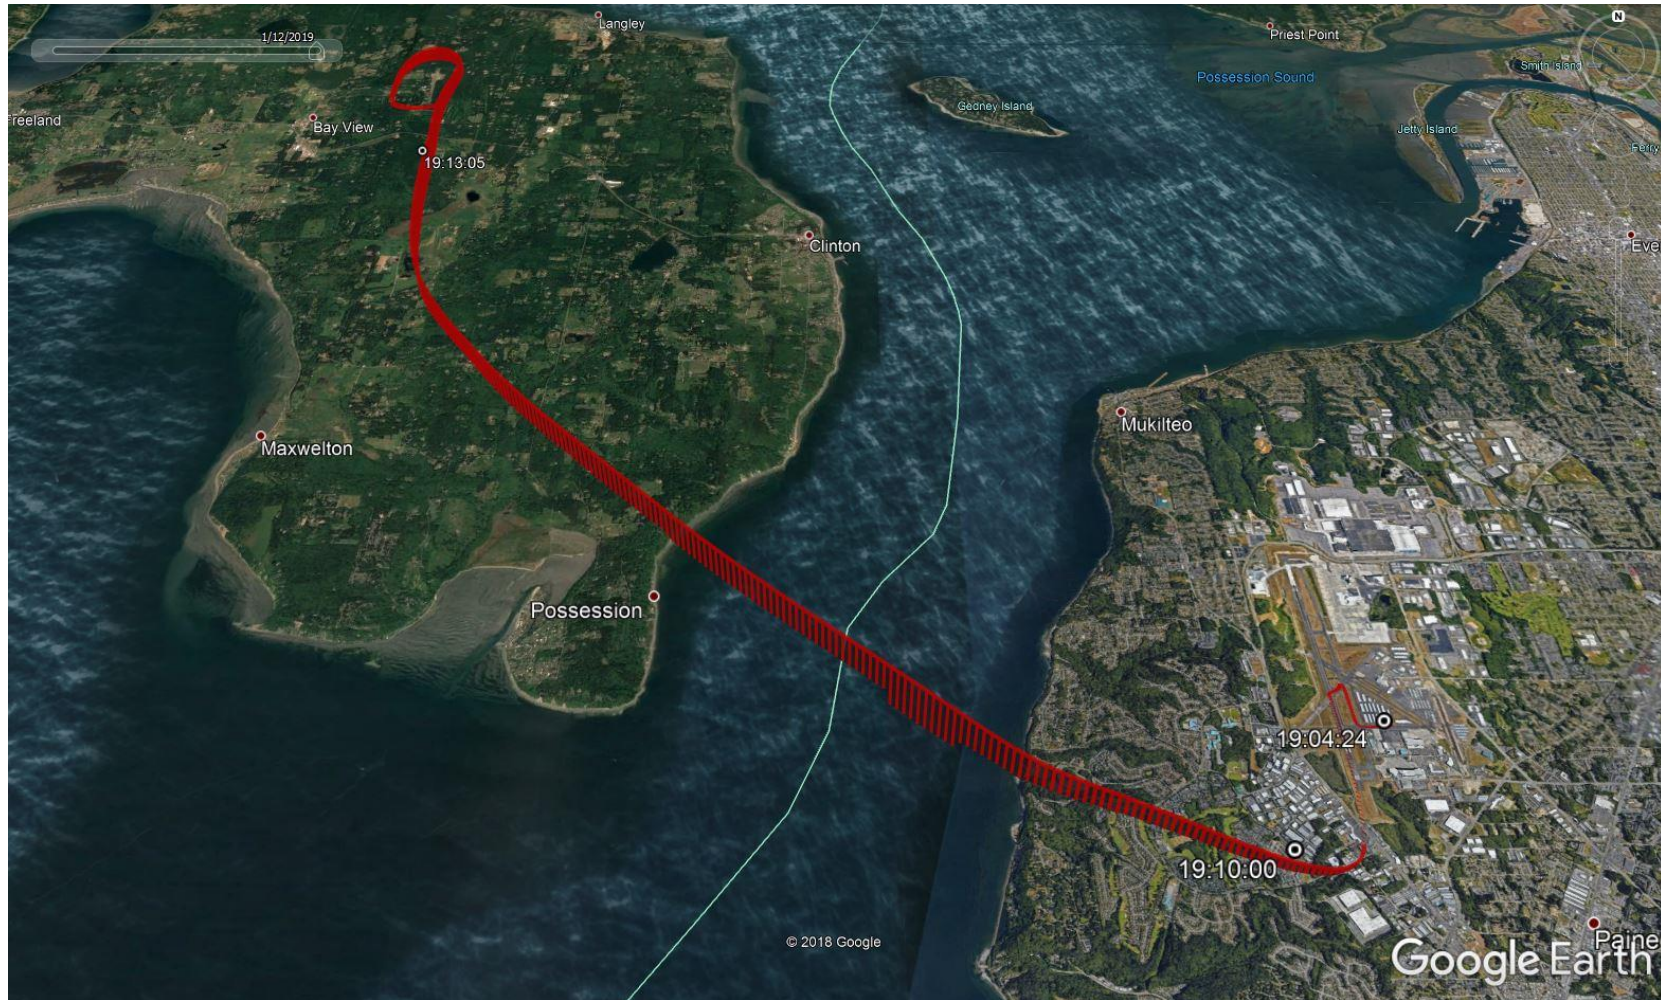
Figure 1 is an overview of the entire accident flight. The overlay is oriented north-up.

Figure 1: A Google Earth overlay oriented north-up showing the entire accident flight.

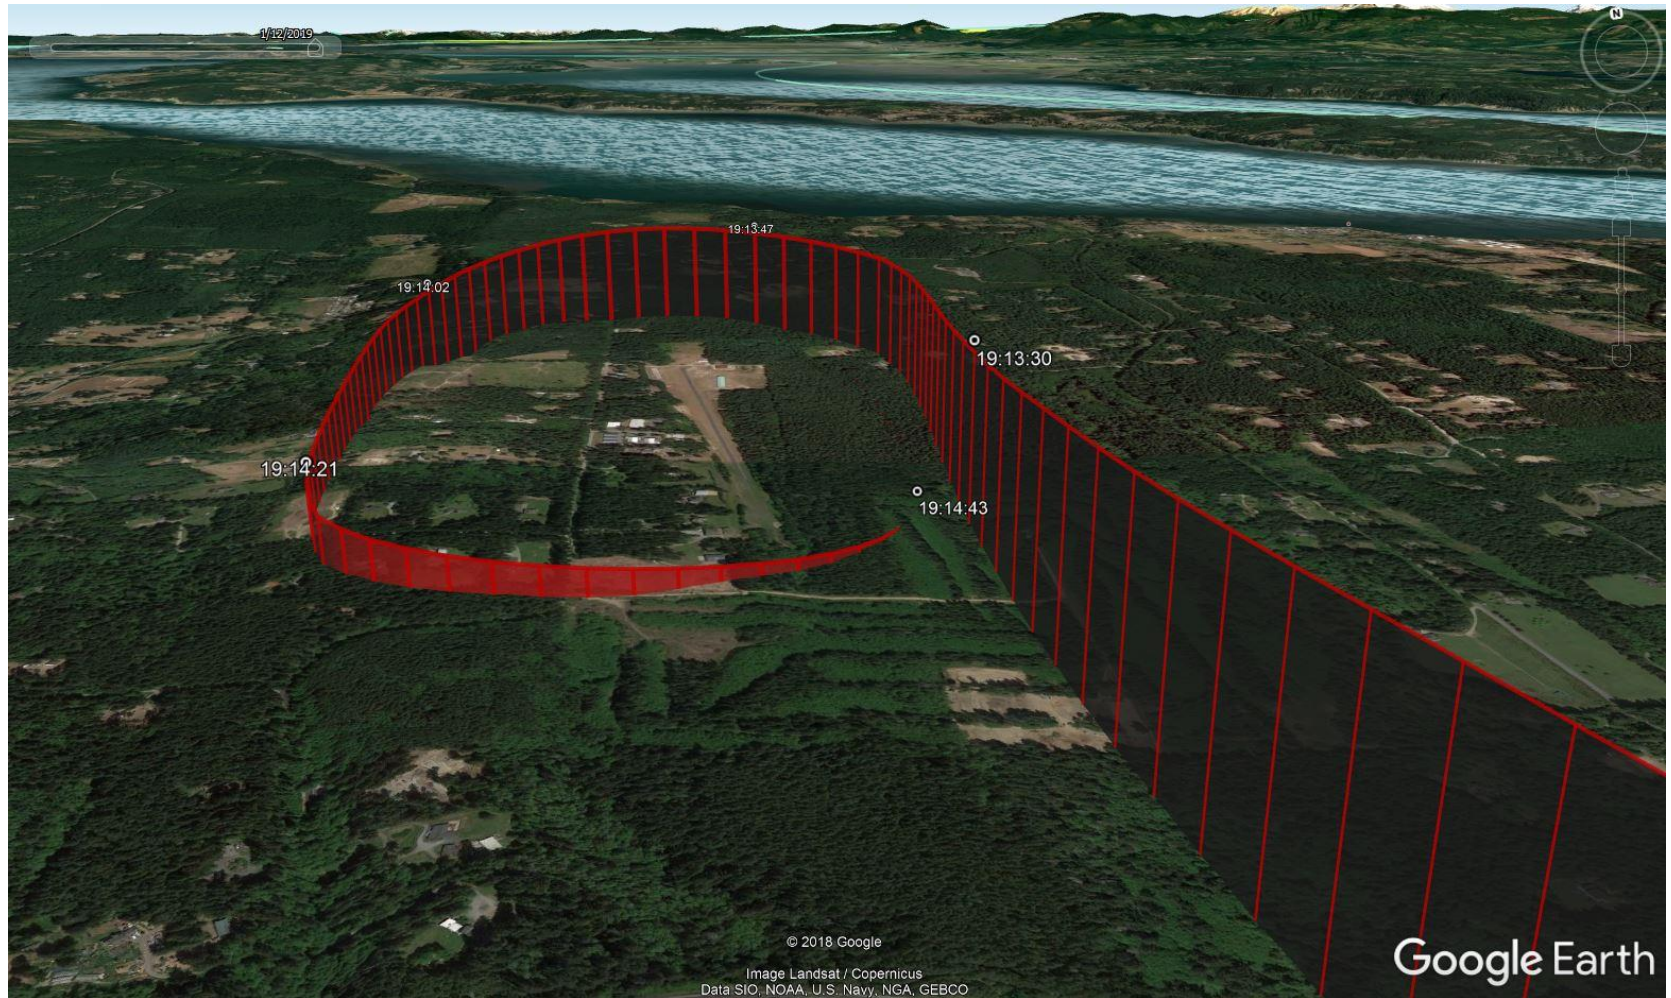
Figure 2 is an overview of the accident region.

Figure 2: A Google Earth overlay oriented north-up showing the accident region. Note that GPS data falls under the WGS84 reference datum at approximately 19:14:43 UTC.

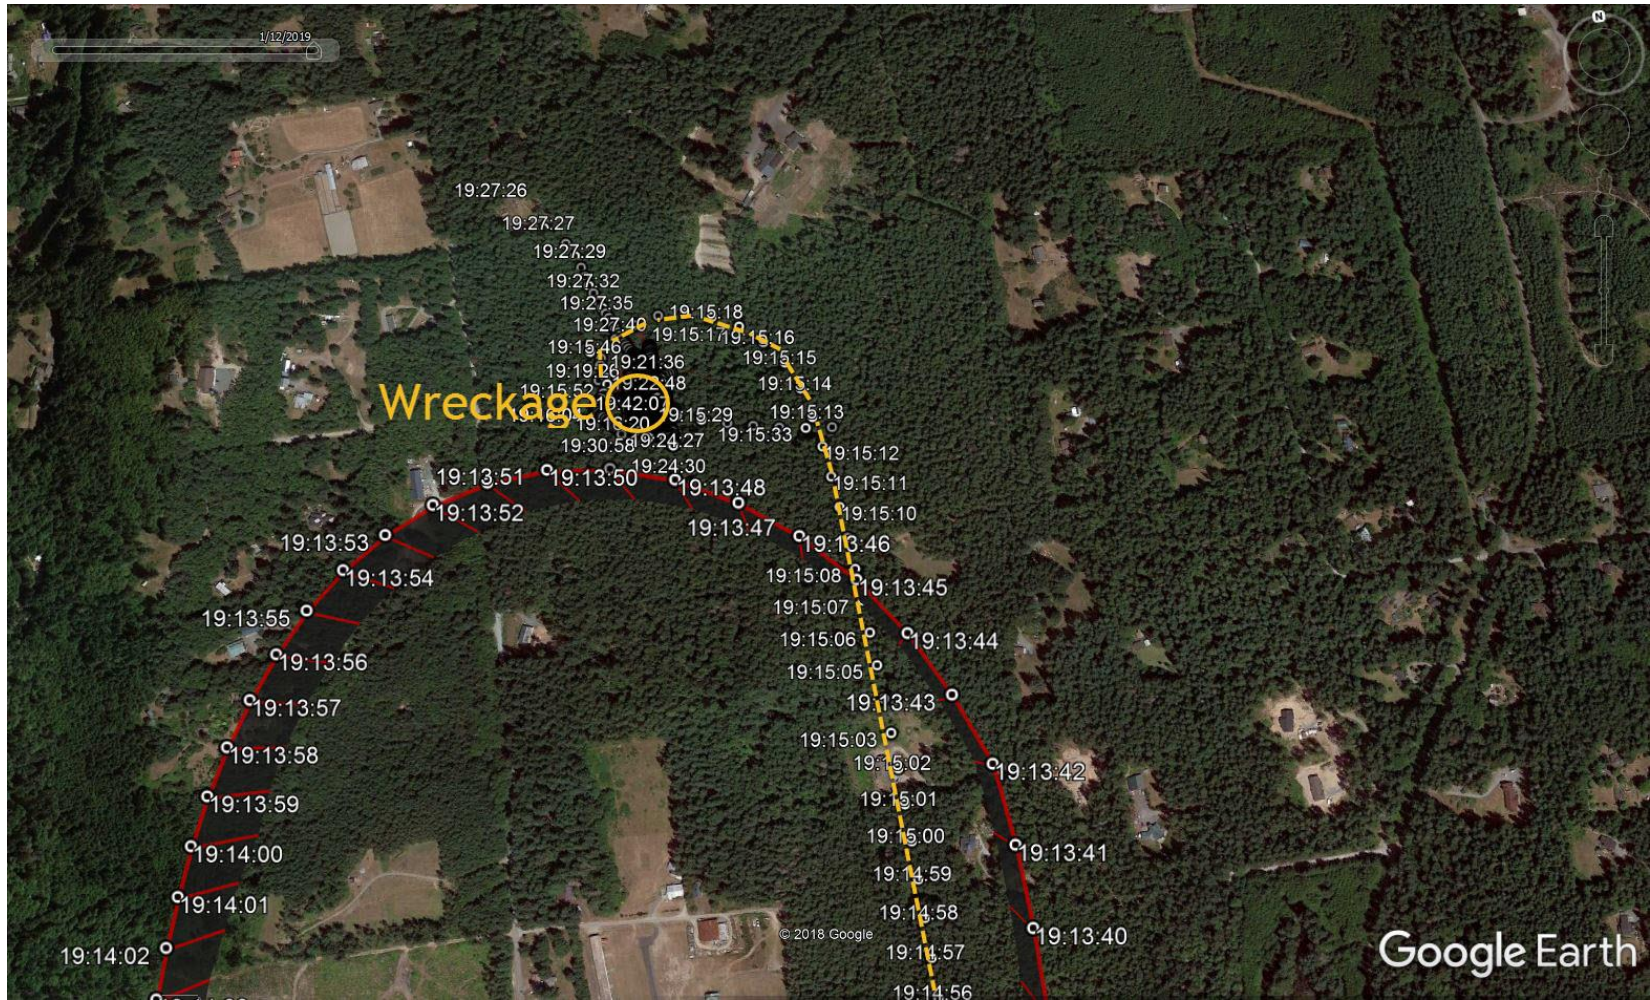
Figure 3 is a top down view of the final portion of the accident flight. Because the GPS data recorded the altitude as under the WGS84 datum for this area, a yellow line was added to clarify the final tracklog points. A yellow circle denotes the area in which the physical wreckage came to rest.

Figure 3: A Google Earth overlay oriented top down showing the accident location. A yellow dotted line was added to indicate the final tracklog points as they were represented below the WGS-84 datum.
