# NATIONAL TRANSPORTATION SAFETY BOARD

## Video Study

Specialist's Factual Report  
By Sean Payne

Location: Las Vegas, NV  
Date: October 29, 2020  
Aircraft: Cessna 310, N101G  
Operator: Private  
NTSB Number: WPR21LA030

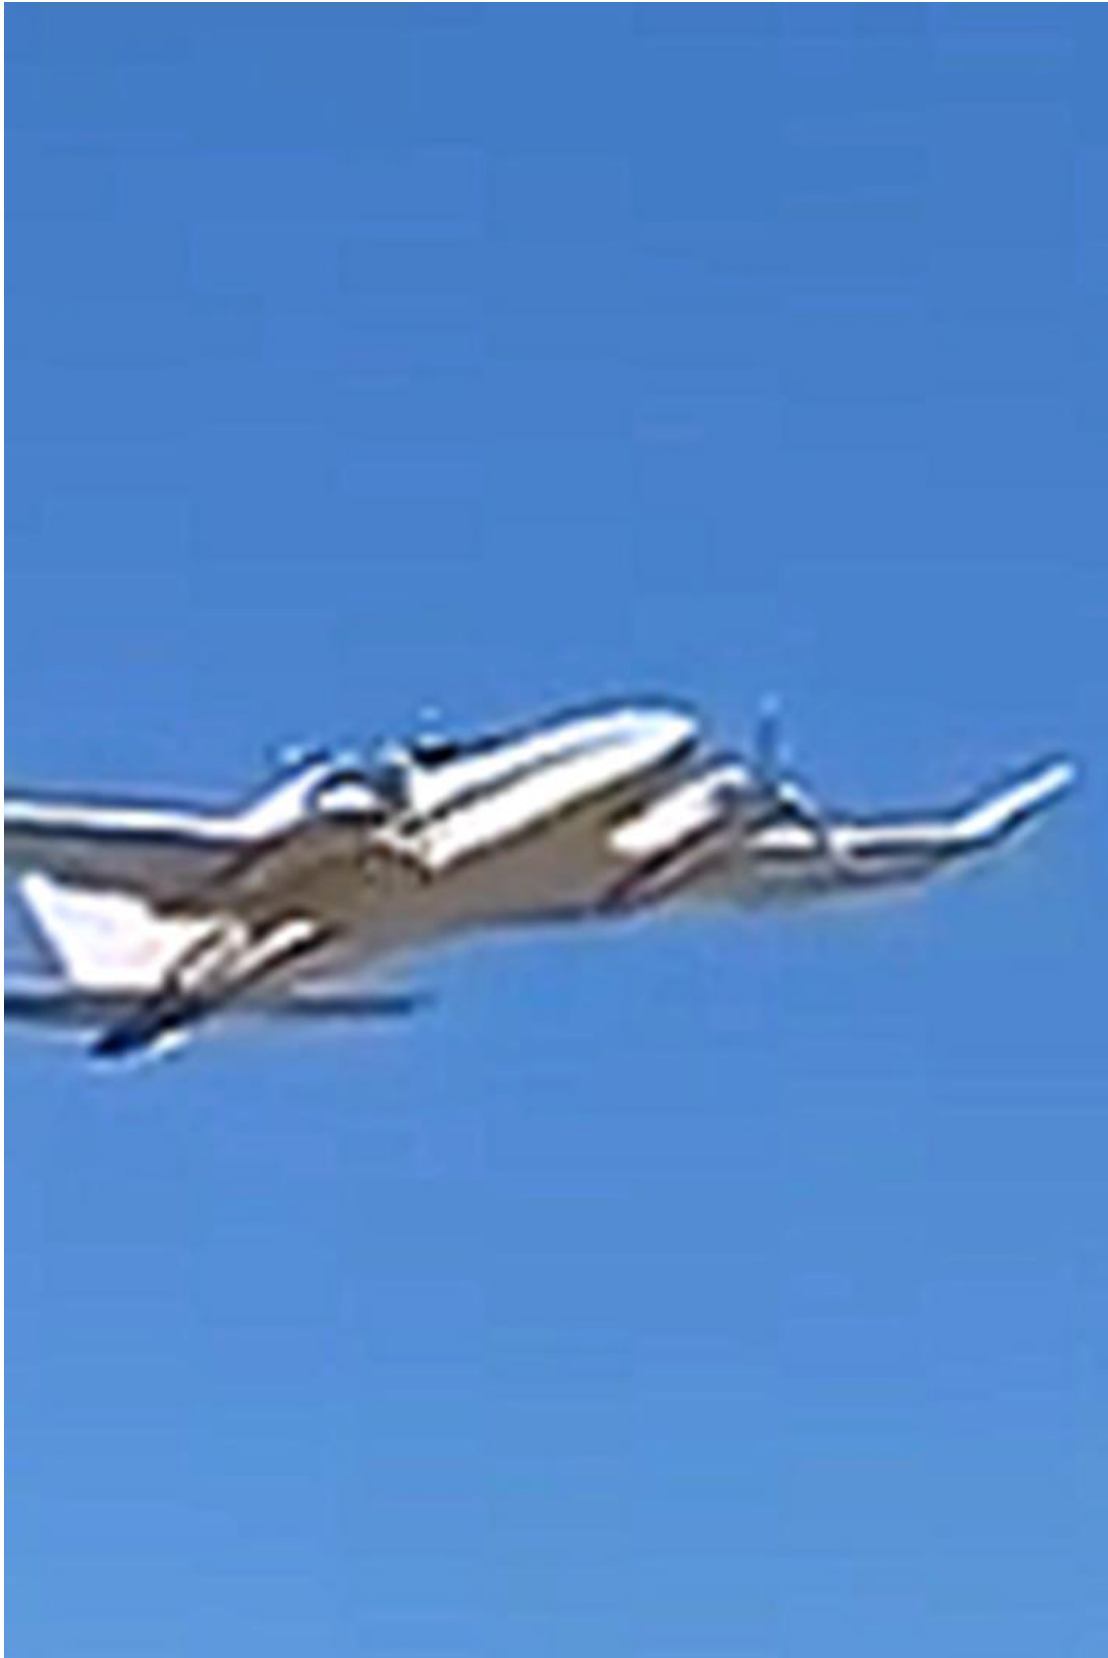
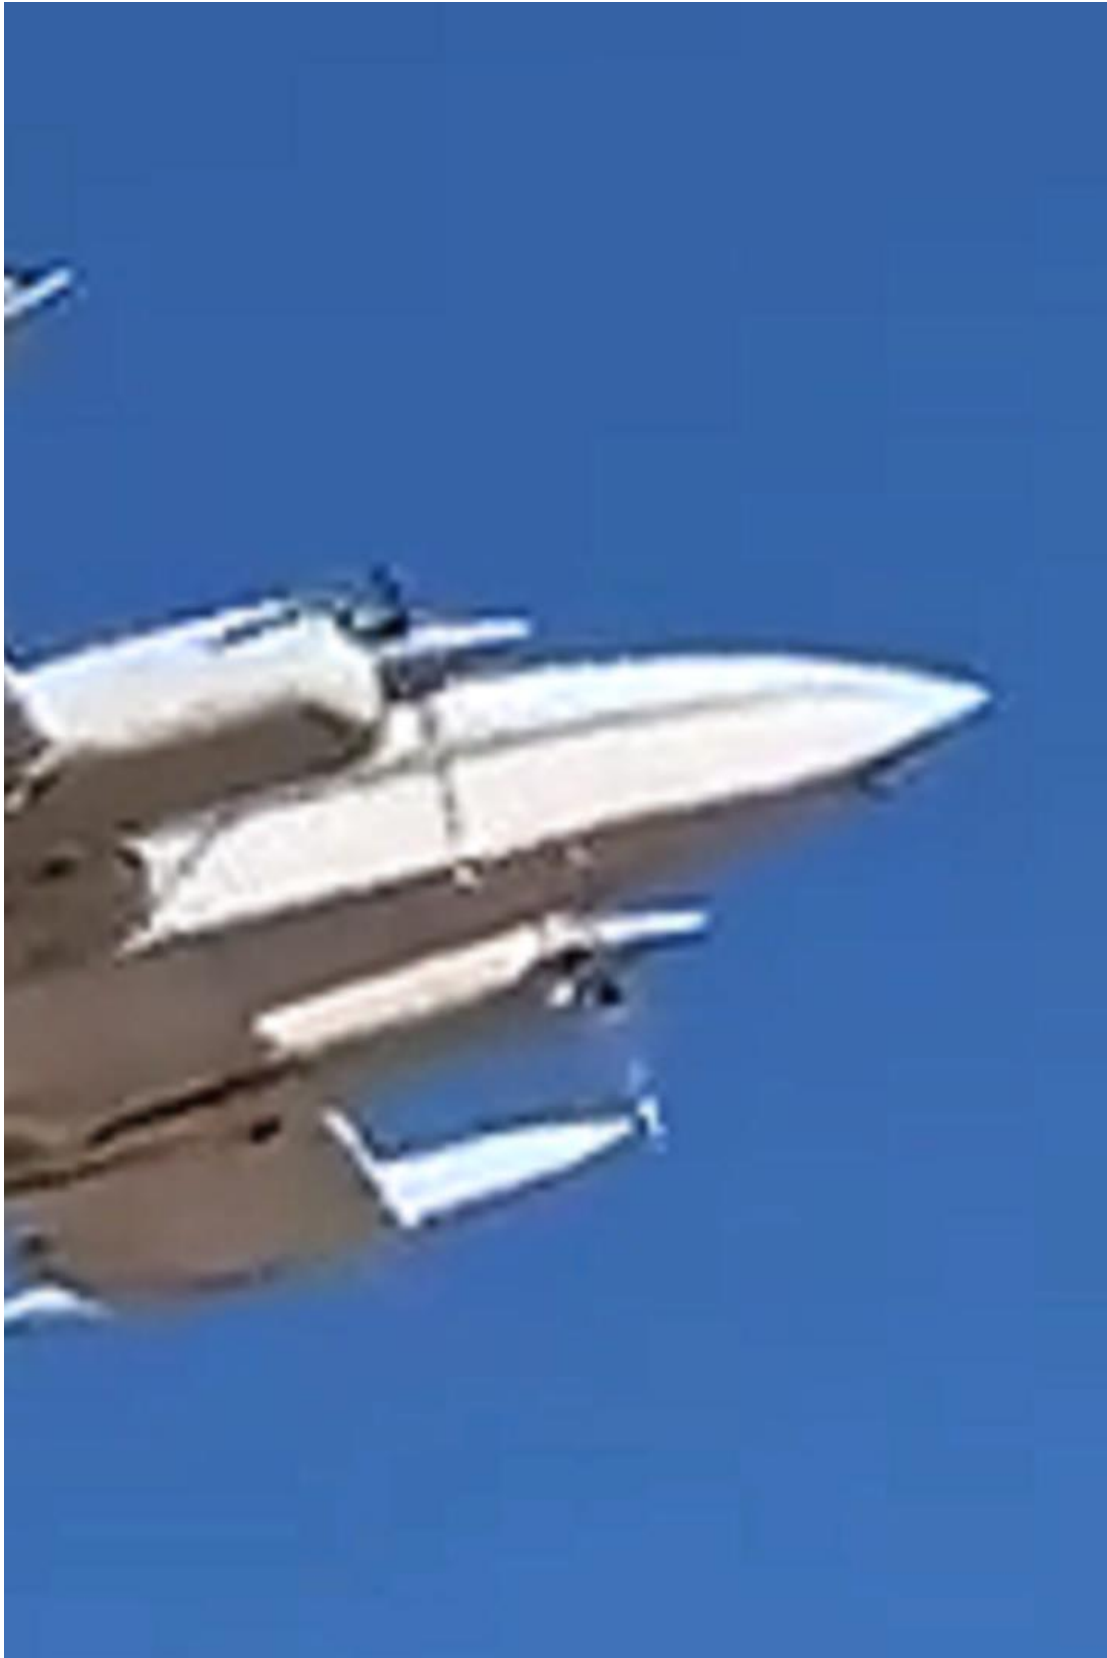
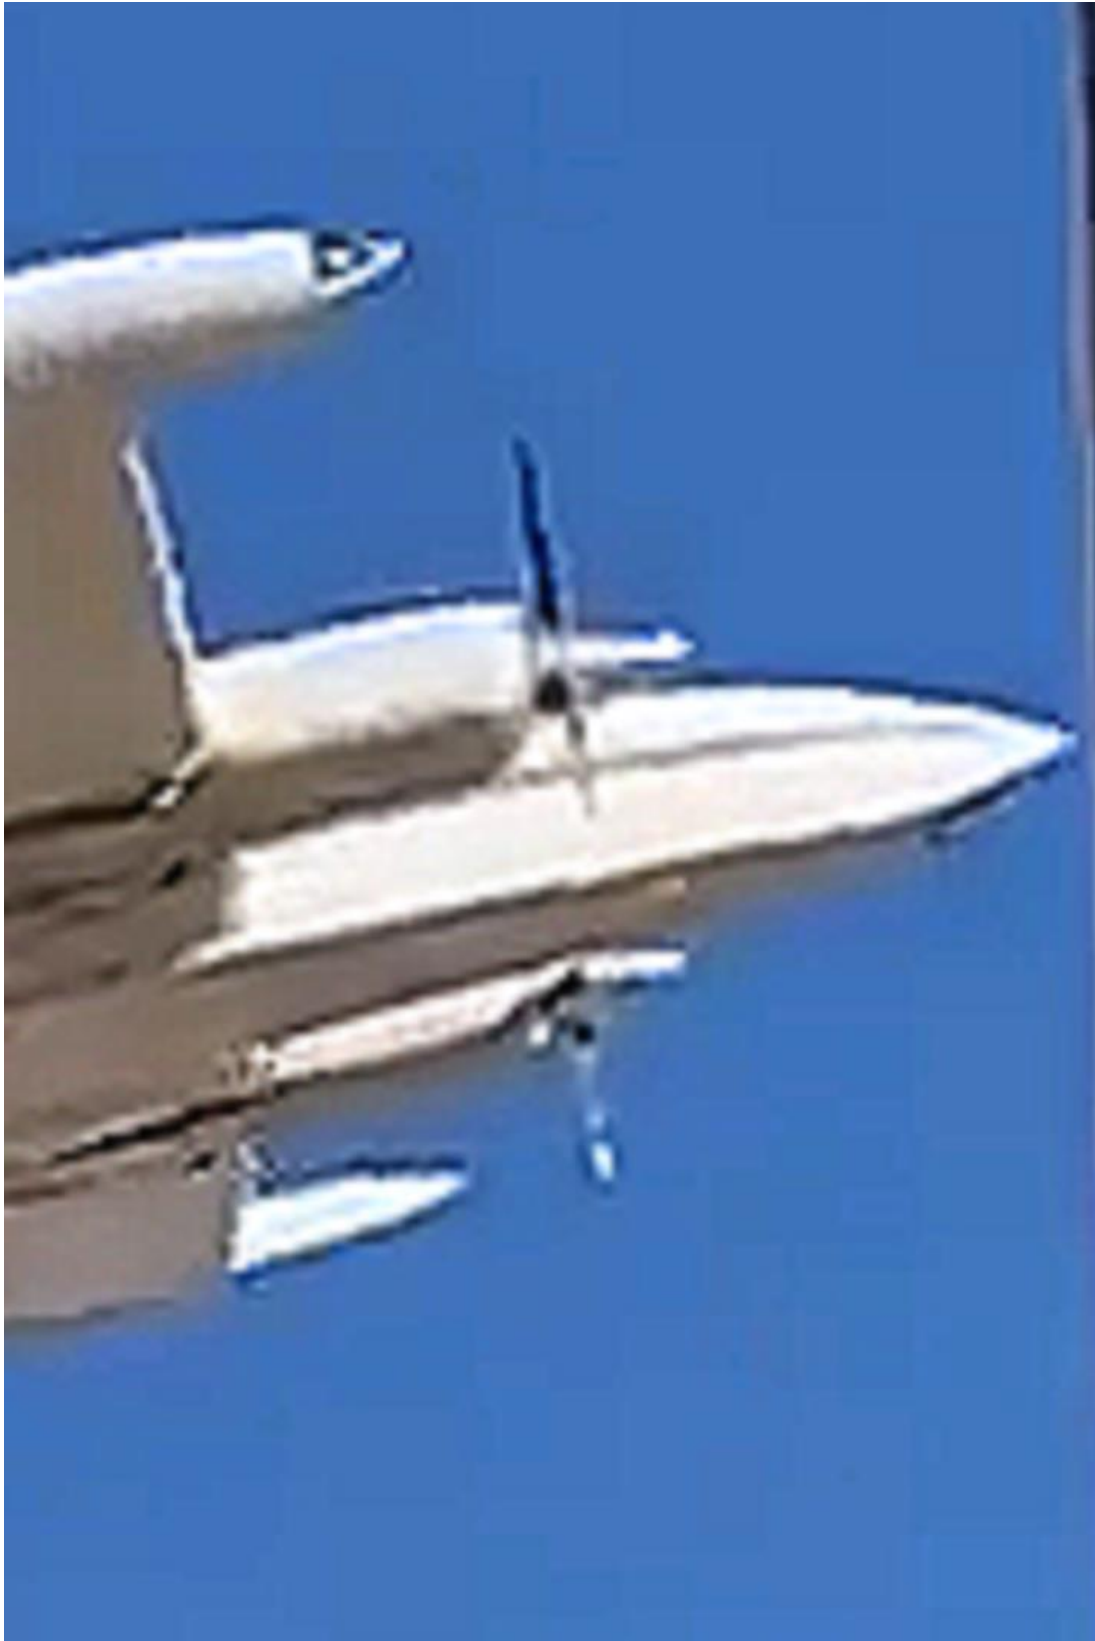
Attachment 2 is a version of the video that has been zoomed to show the accident aircraft. A slight blur and sharpen combination effect have been applied in an attempt to clarify the video. It is apparent that the right propellor is spinning and the left propellor is stopped.

Figures 1, 2 and 3 are still image exports from the video file. These still images have had a zoom, contrast, and sharpen filter applied. The files were then saved as lossless bitmaps (.bmp). The condition of the left engine propellor is examined.
