## **NATIONAL TRANSPORTATION SAFETY BOARD**

### **Factual Report**

# **OPERATIONAL FACTORS**

**WPR19MA177**

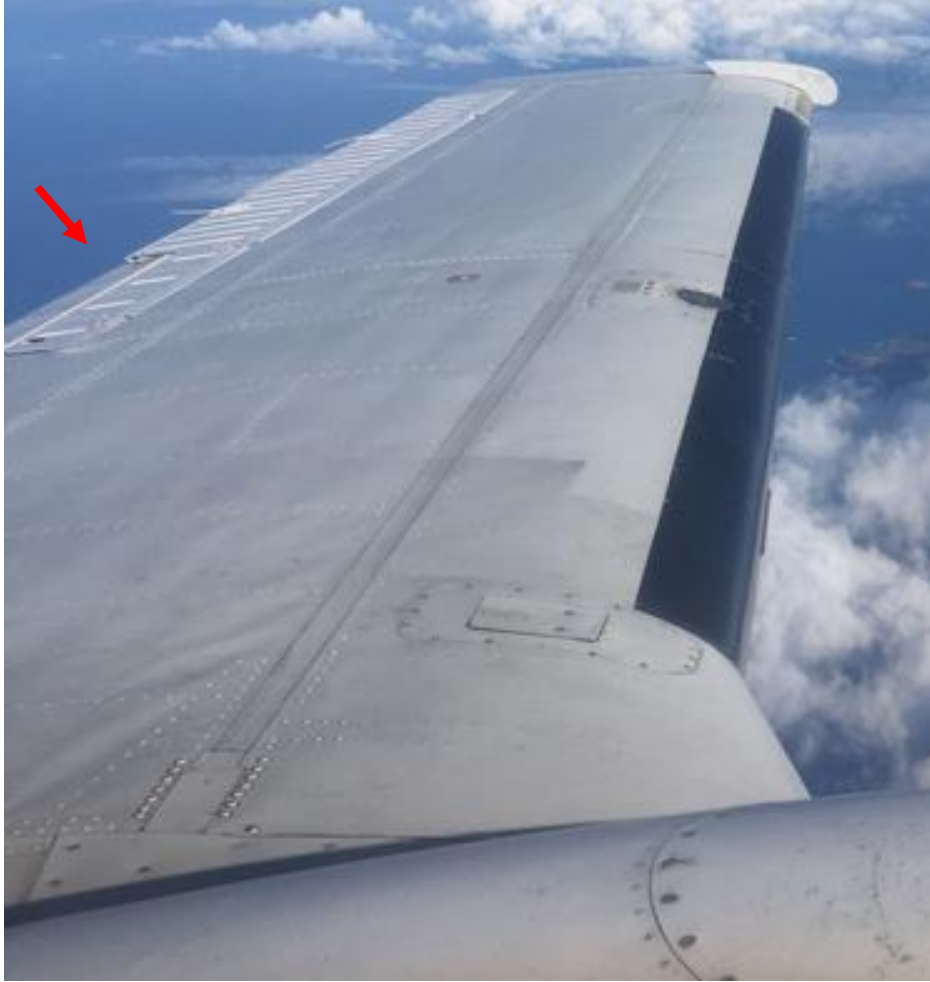
The pilot who test flew the airplane after the 2017 repairs on the horizontal stabilizer, and the pilot who ferried the accident airplane over from the U.S. to Hawaii in 2017, both could not recall the airplane needing additional aileron trim.

**Photo 4: Inflight photo of N256TA during 2017 delivery to Hawaii. The red arrow shows the aileron trim tab deflection.<sup>118</sup>**

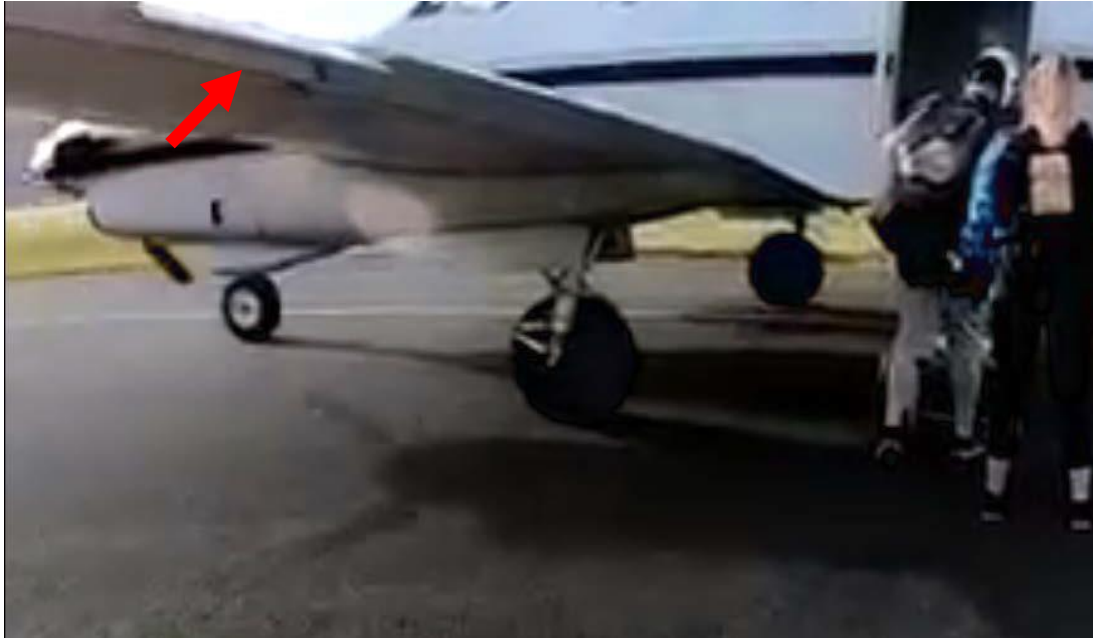
**Photo 5: Witness-provided photo of N256TA at HDH showing aileron trim tab in a trailing edge down position, indicated by the red arrow. Date of photo is unknown.**

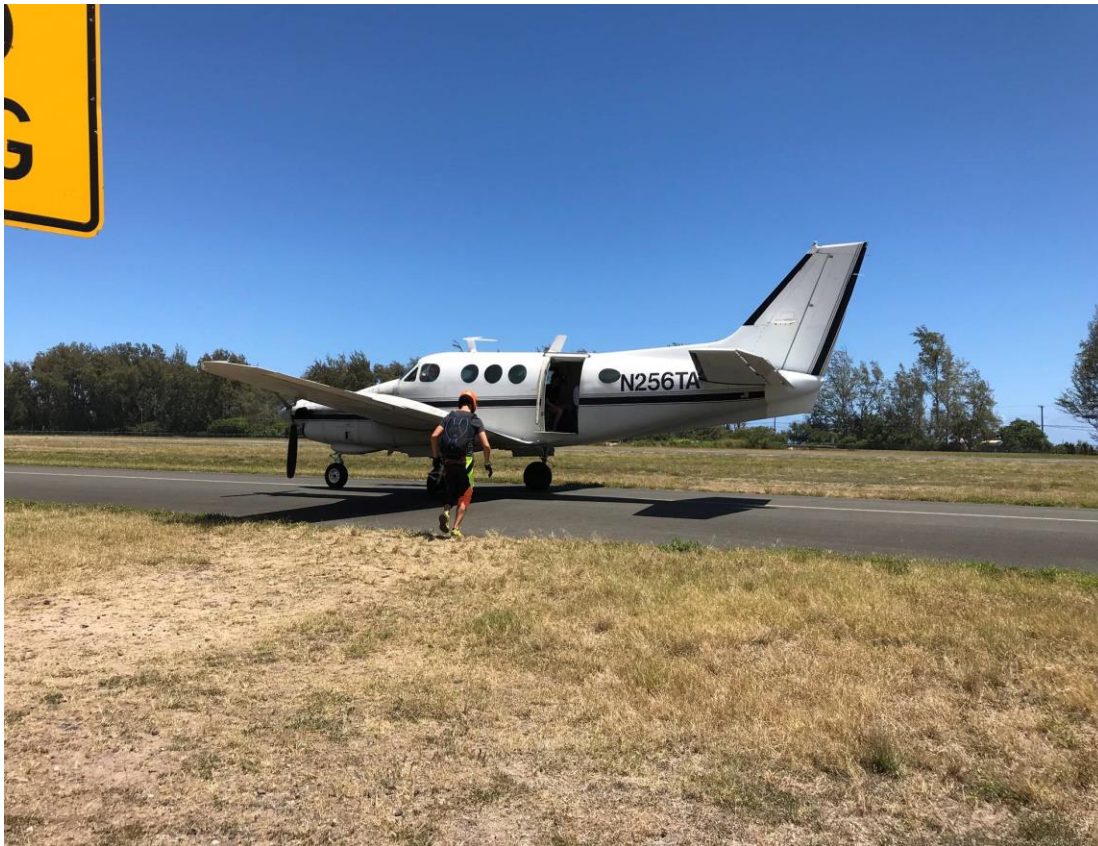
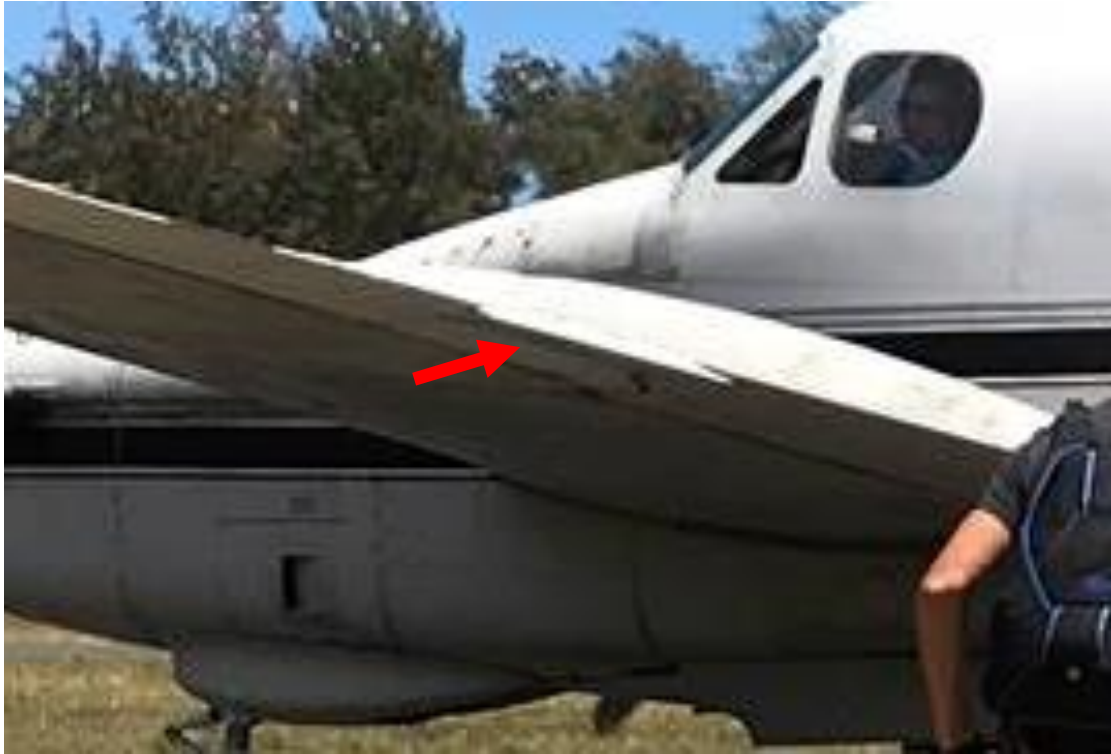
**Photo 6: Witness-provided photo of N256TA at HDH dated June 16, 2019.**

**Photo 7: Enlargement of previous photo showing aileron trim tab in a trailing edge down position, indicated by the red arrow.**

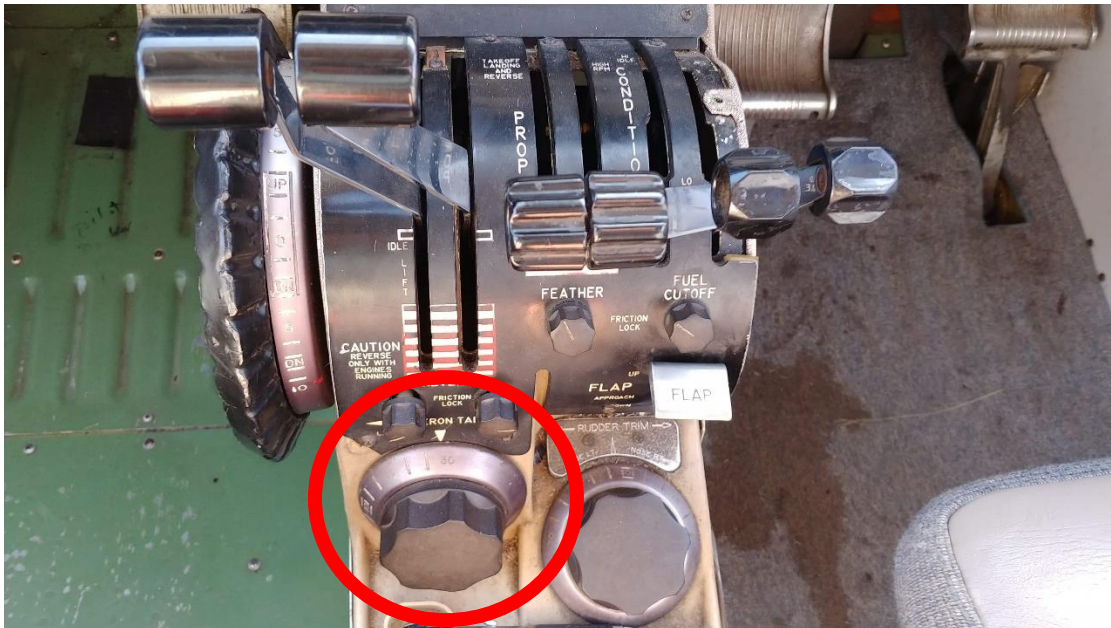
According to the Systems and Structures Group Chairman’s Factual Report, the aileron trim tab knob was found adjusted in the full left wing down position. Further, the left wing trim tab in the left wing was found fully left wing down.<sup>116</sup> This position was consistent with multiple other post-2016 photos of the accident airplane that showed the same left wing down aileron position.

**Photo 8: Photo of N256TA Aileron trim, indicated by red circle. Photo shows aileron trim knob indicating full left wing down orientation.<sup>119</sup>**

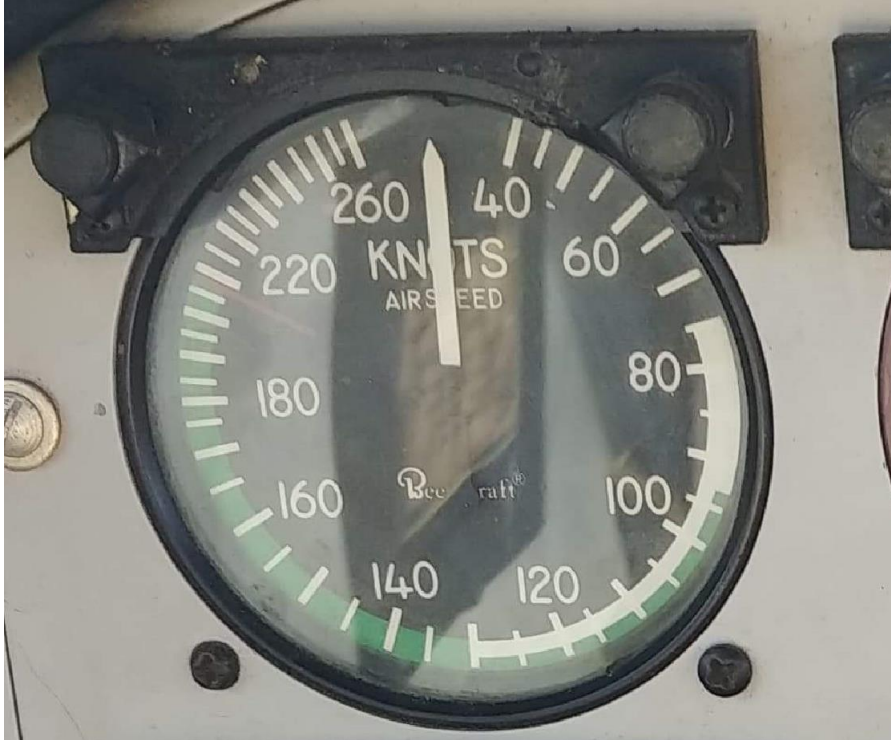
According to the FAA Airplane Flying Handbook (FAA-H-8083-3A, dated 2004),  $V_{MC}$  was typically marked with a red radial line on most airspeed indicators. There was no red radial on the accident airplane's airspeed indicator

**Photo 9:** Close-up photo taken by a former Oahu Parachute Center pilot, showing the airspeed indicator on the accident airplane.
