# National Transportation Safety Board

## Performance Study

Location: Salt Lake City, Utah  
Date: November 12, 2019  
Time: 20:08 mountain standard time (MST)  
Airplane: Agusta A109, N271HC  
NTSB Number: WPR20LA029

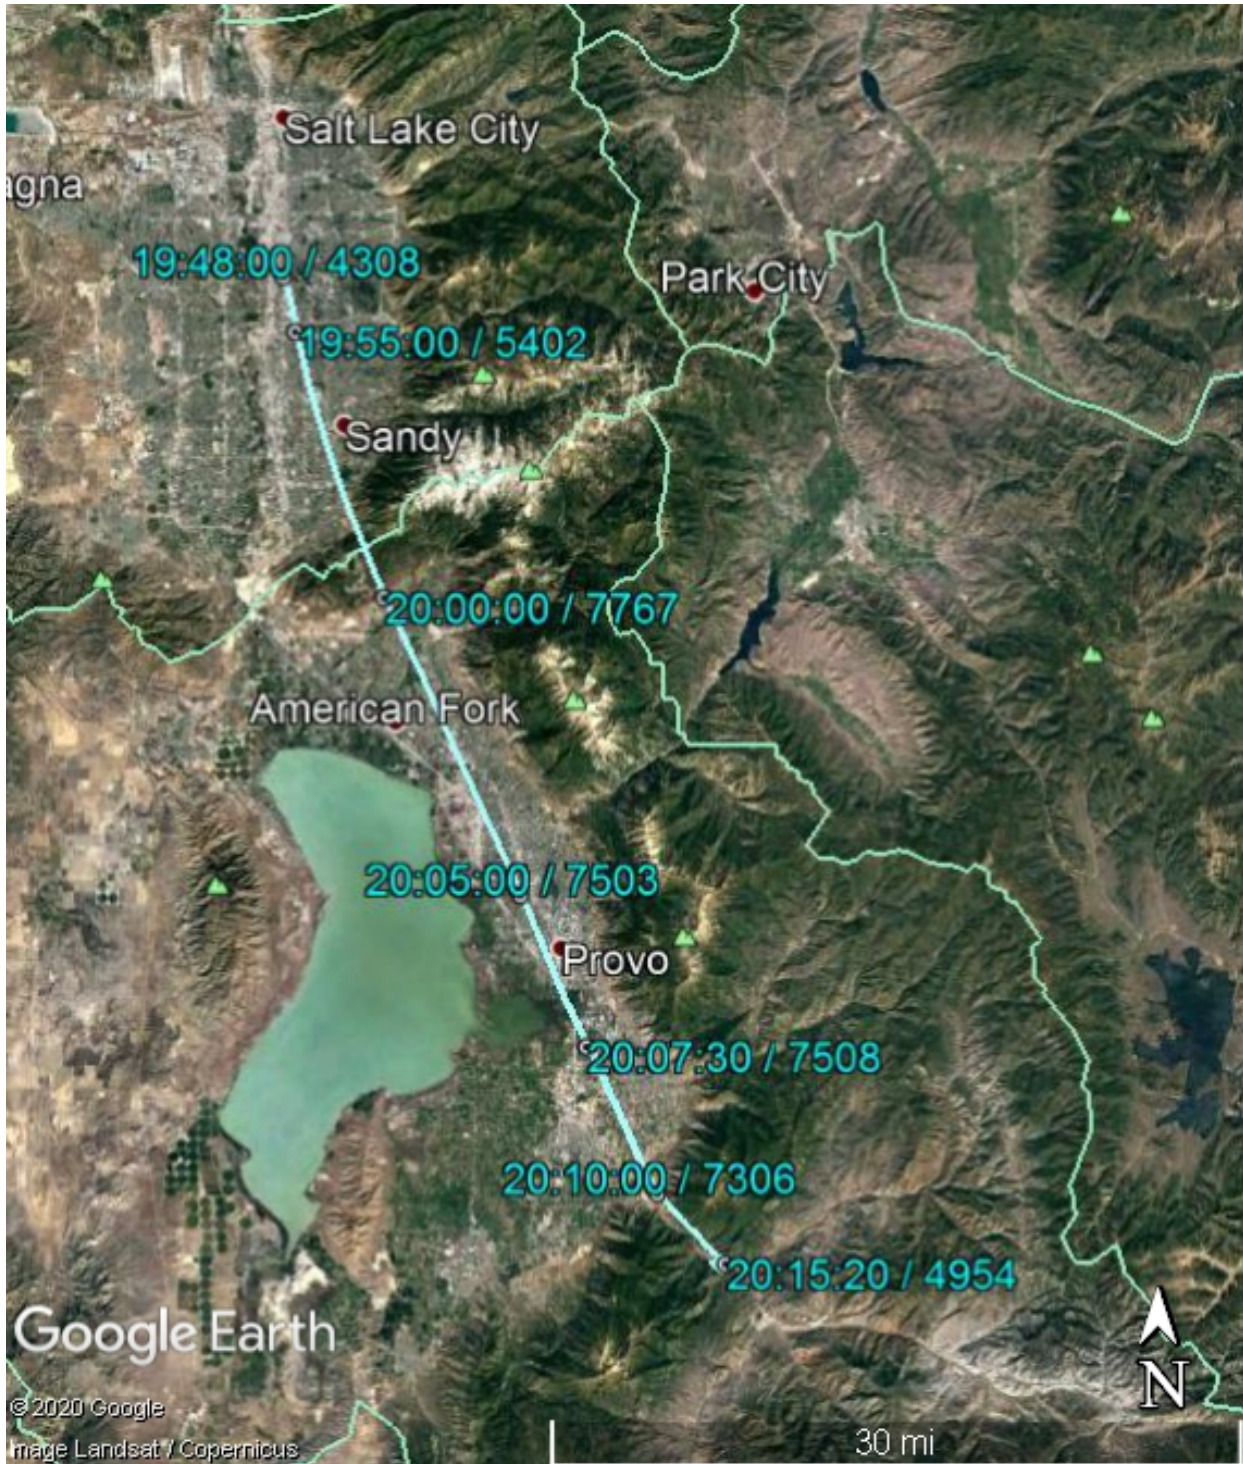
Figure 1 shows the helicopter flight path and Figure 2 the altitude and groundspeed. The helicopter departed Murray, Utah and traveled southeast to a motor vehicle accident. The pilot reported that about five minutes from the destination, the flight nurse, seated in the left front seat, inadvertently stepped on the left tail rotor pedal when attempting to activate a floor-mounted press-to-talk radio microphone. The pilot reported immediately countering the resulting yaw to left with right tail rotor pedal input. The helicopter was at an altitude of about 7,500 ft msl (mean sea level) and a groundspeed just under 150 kts when the event occurred. Ground elevation in the area was about 4,500 ft. A post-flight inspection revealed damage to the tail boom and tail rotor blades, indicating that the tail rotor blades had impacted the tail boom.

Figure 1. Accident flight in blue with select times and altitudes in msl annotated in blue.

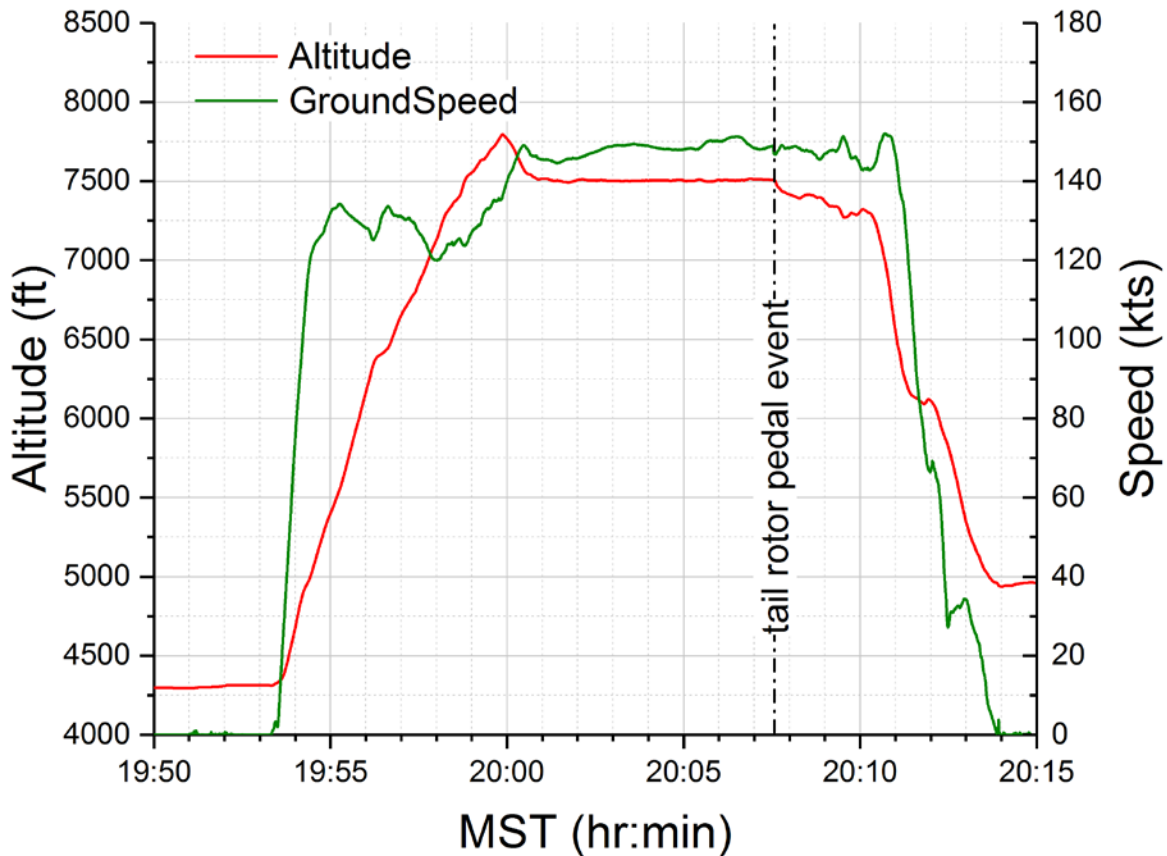
**Figure 2.** Altitude (msl) and groundspeed during the accident flight.

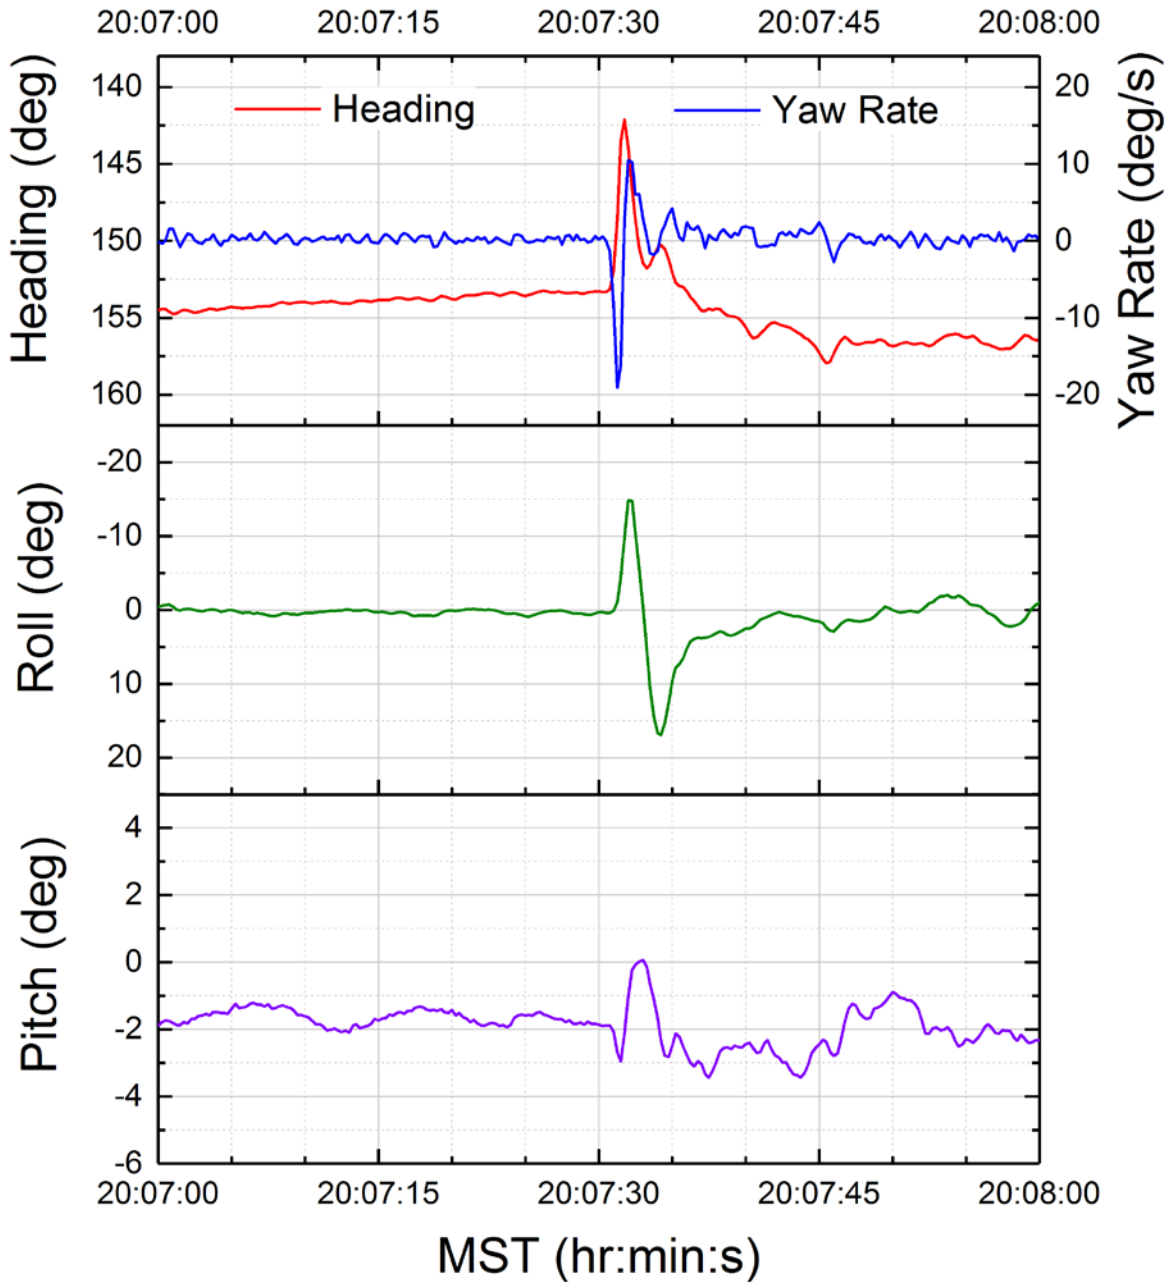
Figure 3 shows the recorded change in heading and yaw rate of the event and the motion in roll and pitch. The helicopter was on a heading of  $153^{\circ}$  at 20:07:30.5 when it rapidly went to  $142^{\circ}$  by 20:07:31.75, a yaw rate of nearly 20 deg/s. The right tail rotor pedal input by the pilot is reflected in the data as the helicopter returned to  $151^{\circ}$  by 20:07:33.25. In addition to the lateral motion, the helicopter also responded by rolling from level to  $-15^{\circ}$  left side down and then to  $15^{\circ}$  right side down in under four seconds before returning to level after the event. Pitch briefly went from  $-2^{\circ}$  nose down during level flight to briefly nose level. The helicopter slowed and descended after the event, reaching its destination by 20:12 and landing at 20:15.

Figure 3. Recorded heading, yaw rate, roll, and pitch.

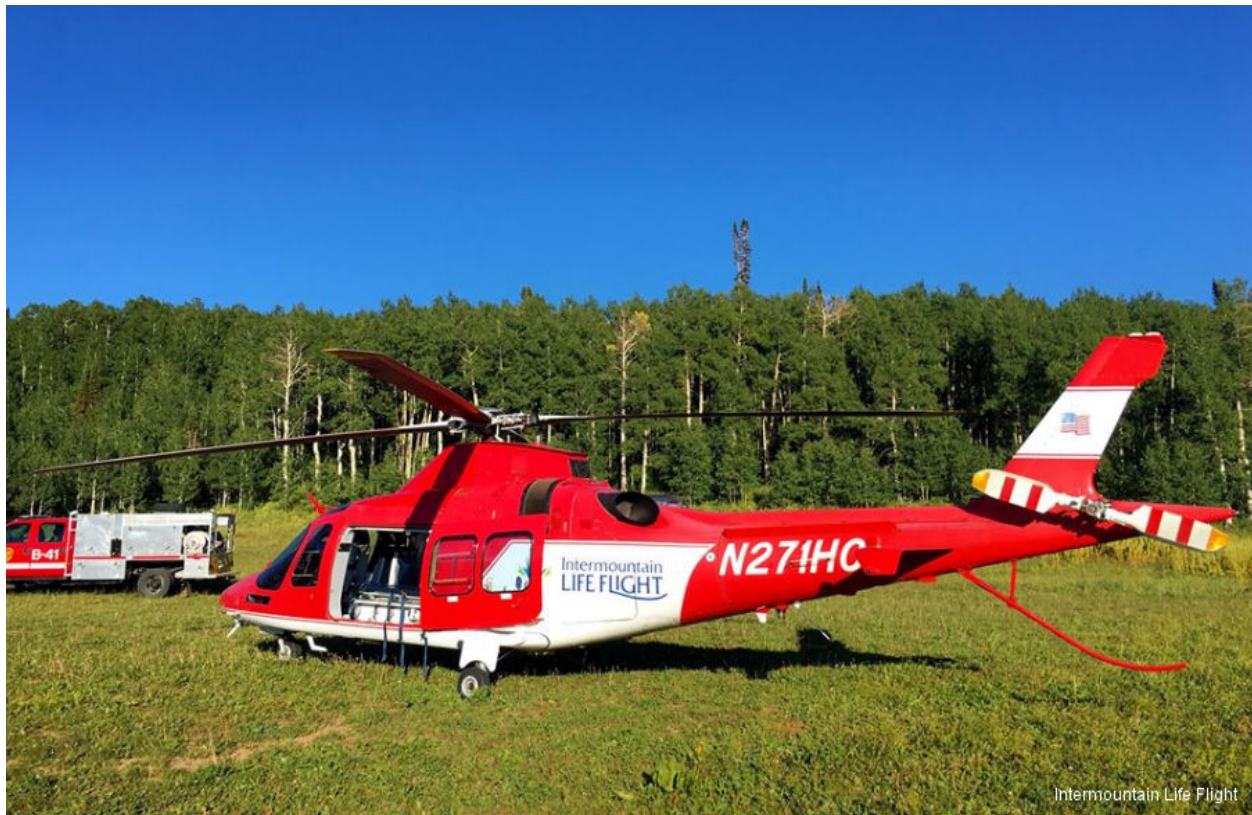
An Agusta A109 has a main rotor that rotates counterclockwise (viewed from above) and a clockwise natural yawing motion. The tail rotor, mounted on the left side of the vertical stabilizer, imparts an opposing anti-torque to maintain heading. The accident helicopter is shown in Figure 4.

**Figure 4.** Image of accident helicopter.
