**NATIONAL TRANSPORTATION SAFETY BOARD
VEHICLE PERFORMANCE DIVISION
WASHINGTON, D.C.**

**VEHICLE PERFORMANCE STUDY/ EVALUATION OF
MOTORCOACH ENGINE CONTROL MODULE DATA**

NTSB #: **HWY20MH002**

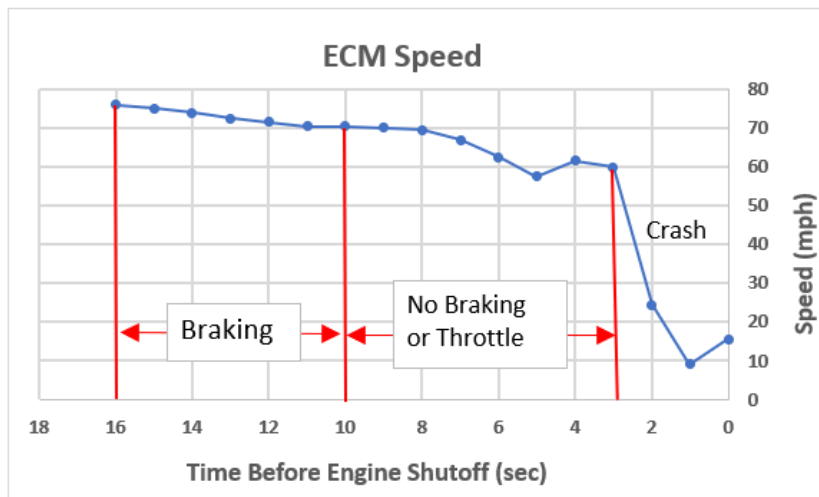
A plot of the speed data obtained from the motorcoach's Engine Control Module (ECM) is shown in Figure 1. This study is primarily concerned with the reductions and variations in speed that occurred between 10 and 3 seconds prior to engine shutoff when the ECM data indicates the motorcoach was slowing but no braking or throttle was being applied by the driver. (During this time period the ECM data indicated: (1) no brake lamp switch activation, which requires minimal depression of the brake pedal by the driver; and (2) 0% throttle, which, implies no throttle pedal/linkage actuation by the driver.) To identify possible causes of the slowing and variations in speed a series of simulations were conducted. These simulations examined several potential causes for the speed readings including the driver steering, the use of the engine compression (Jacobs Vehicle Systems) brake by the driver and the grade of the road. In addition to the ECM data, the study also examines the effects of vehicle speed and wet pavement on the available traction in the curve using measured tire data.

Figure 1 –Electronic speed data from the Motorcoach's ECM for 16 seconds prior to engine shutoff. The impact with the embankment occurred between 3 and 2 seconds prior to engine shutoff.

As indicated in the introduction, this study was primarily concerned with identifying the type of motorcoach dynamics that would result in the slowing and variations in speed that occurred between 10 and 3 seconds prior to the engine shutoff in the motorcoach's ECM speed data (Figure 1).

In the simulations, speed readings similar to the ECM readings between 10 and 3 seconds could be modeled by applying aggressive back and forth steering in the curve when the Jake brake was on. This steering resulted in "fishtailing" which caused variations in the speed readings just prior to the location where the crash occurred. (Fishtailing occurs when the rear tires begin to lose traction and the driver counter-steers in an attempt to stabilize the vehicle.) Other attempts to match the data were unsuccessful.

Attempts to model the ECM data without the Jake brake engaged were unsuccessful and did not reproduce the overall slowing or variations in speed indicated in the ECM data just before the crash. While it cannot be verified if the Jake brake was turned on at the time of the accident, the results of the simulations indicate that if the Jake brake was engaged it would have increased the risk of the drive axle tires beginning to slide and the motorcoach "fishtailing".

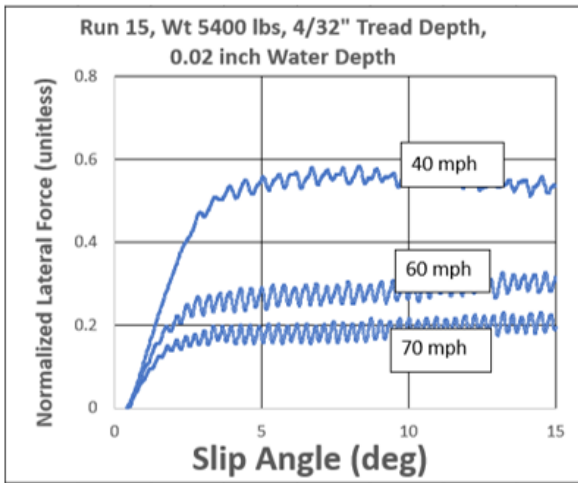
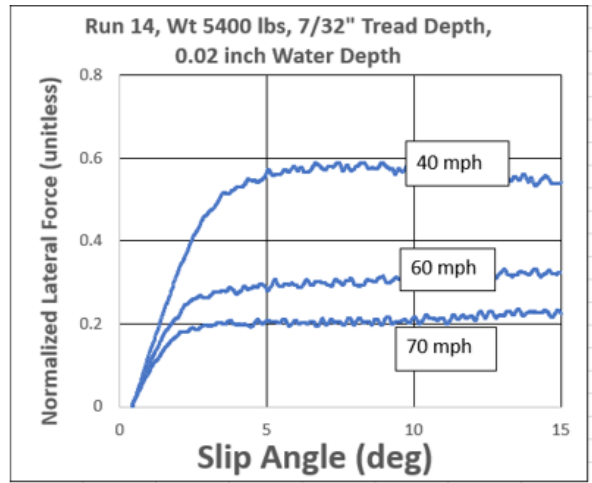
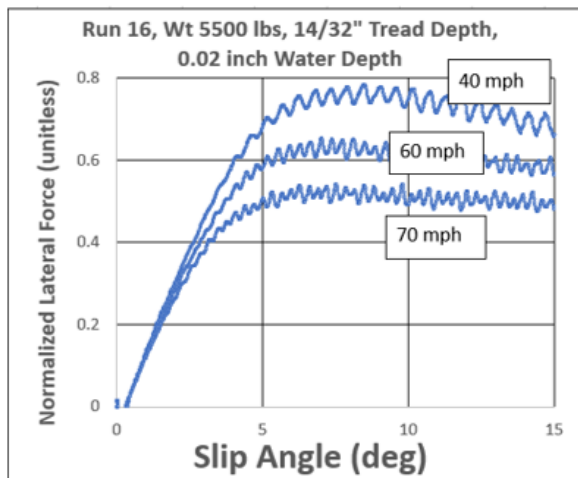
Raw data from the Hewitt tire tests that were used in the study are summarized in Figure 2 and in Table 2. This testing was performed using a tire test machine and evaluated tire forces over a wide range of speeds, water depths and tire tread depths. Additional data can be found in the docket for the Hewitt accident. The data in Figure 2 and Table 2 supports that on wet pavement the tire/road friction (normalized forces) drops off significantly between 40 mph and 70 mph. The data in Table 2 further indicates that the peak frictions at higher speeds for tires with tread depths below 10/32” are approximately twice the slide frictions on wet pavement. (This differs from dry pavement where the differences are typically much smaller.)

Figure 2- Normalized lateral tire force measurements from the TIRF testing conducted in support of the Hewitt, TX accident [4] using tires similar to the accident tires.

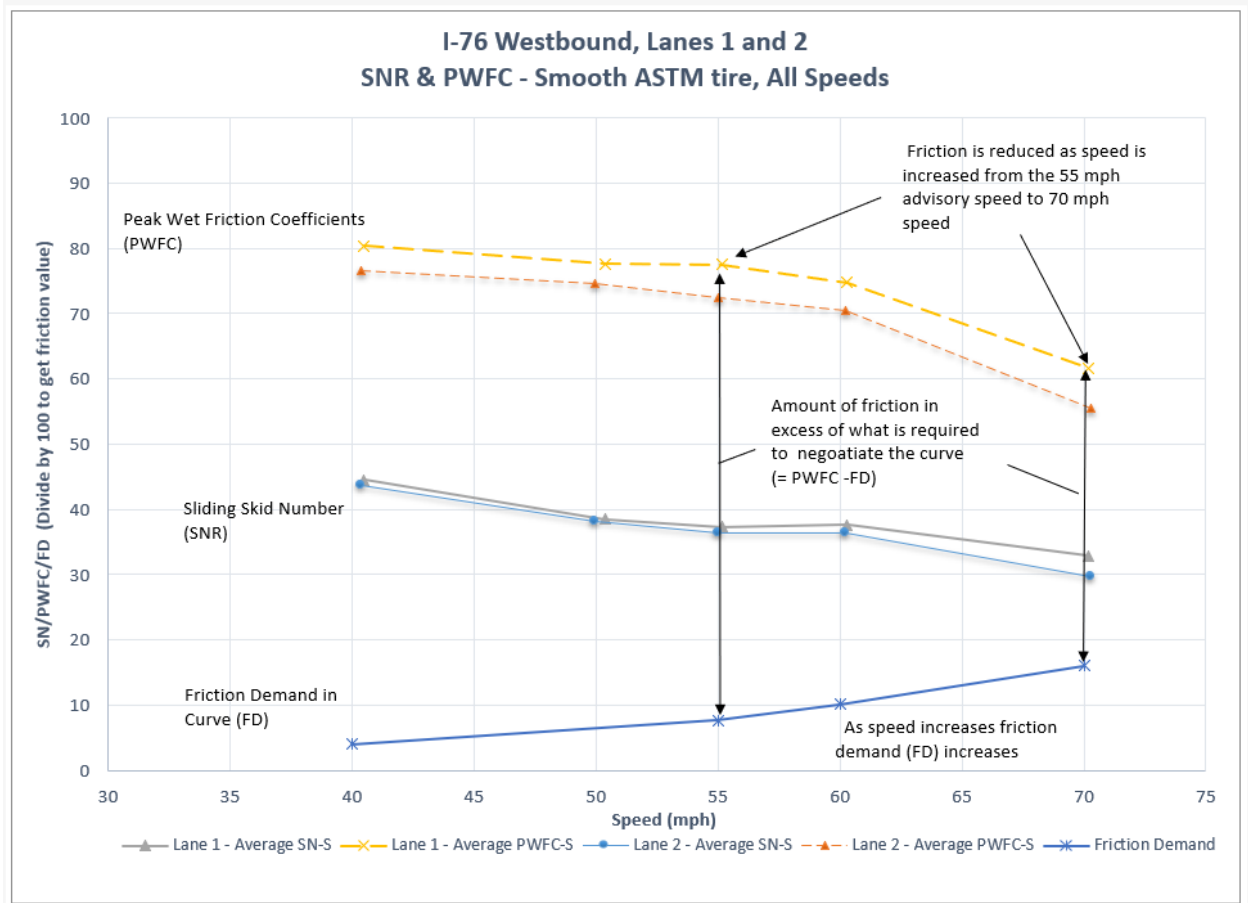
The tire test data from the Hewitt motorcoach tire tests were calibrated to the accident road surface traction using ASTM E-274 [5] test measurements from the accident curve and comparing them to similar ASTM measurements made on the TIRF test surface. (ASTM E-274 is a standard used to measure skid resistance on paved surfaces. Tires used in the testing are the ASTM E-524 smooth tire [5] and the ASTM E-501 ribbed tire [5]. Testing is typically performed at a constant speed of 40 mph as the tires are dragged over a wet pavement surface at a specified water depth.) To aid in the calibration, additional measurements of the peak and slide frictions were made using ASTM smooth (ASTM E-524) and ribbed tires (ASTM E-501) in the accident curves at speeds of 40, 50, 55, 60 and 70 mph [3]. The water depth used in these measurements was 0.02 inches (the depth typically used in ASTM E-274 testing and close to the estimated water depth at the time of the accident). Based on the evaluation of the Hewitt tire tests data and the ASTM tire data, it was determined that it was sufficient for the purposes of this study to use the peak and slide frictions from the ASTM smooth tires to estimate the tire frictions for the accident tires with tread depths between 4/32” and 10/32” (7 of the 8 tires) and to use the ribbed ASTM tire to model tires with tread depth greater than 10/32” (1 of 8 tires). It is likely that these frictions underestimate the actual tire/surface frictions since the testing conducted in the Hewitt accident indicates that partially treaded motorcoach tires will develop slightly greater friction values than the smooth ASTM tire at similar speeds. As indicated by the data in Figure 3, the peak tire frictions generated by the smooth ASTM tires in the testing conducted at various speeds in the curve exceed the friction demand. These results support that there was likely adequate traction for the motorcoach to safely negotiate the curve. (Friction demand is the minimum tire friction needed for a point mass to negotiate the curve radius). The data further indicates that there were significant reductions in

peak frictions in tests conducted at the 70-mph speed versus tests conducted at the 55- mph advisory speed with the smooth tire.

Figure 3 – Comparison of ASTM smooth tire measurements at various speeds in the curve with the friction demand in the curve. Lane 1 is the left lane and Lane 2 is the right lane for motorists traveling in the westbound direction. The friction measurements shown are the average frictions.

The tire data described in this report supports that reducing the speed of the motorcoach to the 55-mph advisory speed prior to entering the transition and the curve would have increased the available tire friction. Reducing the speed to 55 mph would have also reduced the overall friction demand. The increase in traction along with the reductions in the friction demand would have better enabled the driver to maintain control.
