NATIONAL TRANSPORTATION SAFETY BOARD

Onboard Image Recorder

Specialist's Factual Report

Location: Mount Pleasant Township, Pennsylvania
Date: January 5, 2020
Vehicle: 2018 Freightliner Cascadia Semi-truck with 2019 Hyundai Semitrailer
Operator: FedEx Ground
NTSB Number: HWY20MH002

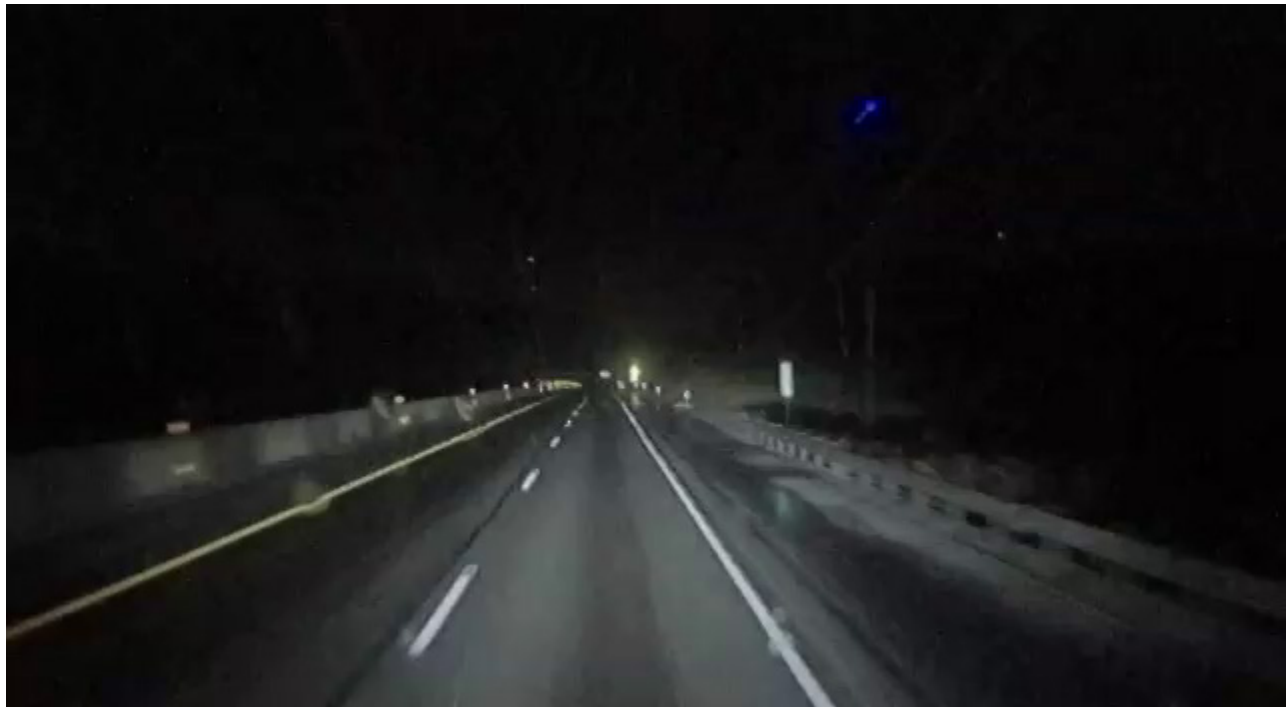
Video Elapsed Time (mm:ss)	Observations
00:01	At the start of the video, the view included the center median, both travel lanes, and the right shoulder. All lane markings were visible ¹ . The semi-truck was traveling in the right, westbound lane. No accumulated snow was visible on the road surface. See Figure 1.
00:19 to 00:21	The motorcoach could be seen passing the semi-truck in the left, westbound lane. Rear lights on the motorcoach were illuminated. See Figure 2 and 3.

Figure 1. FFC View.

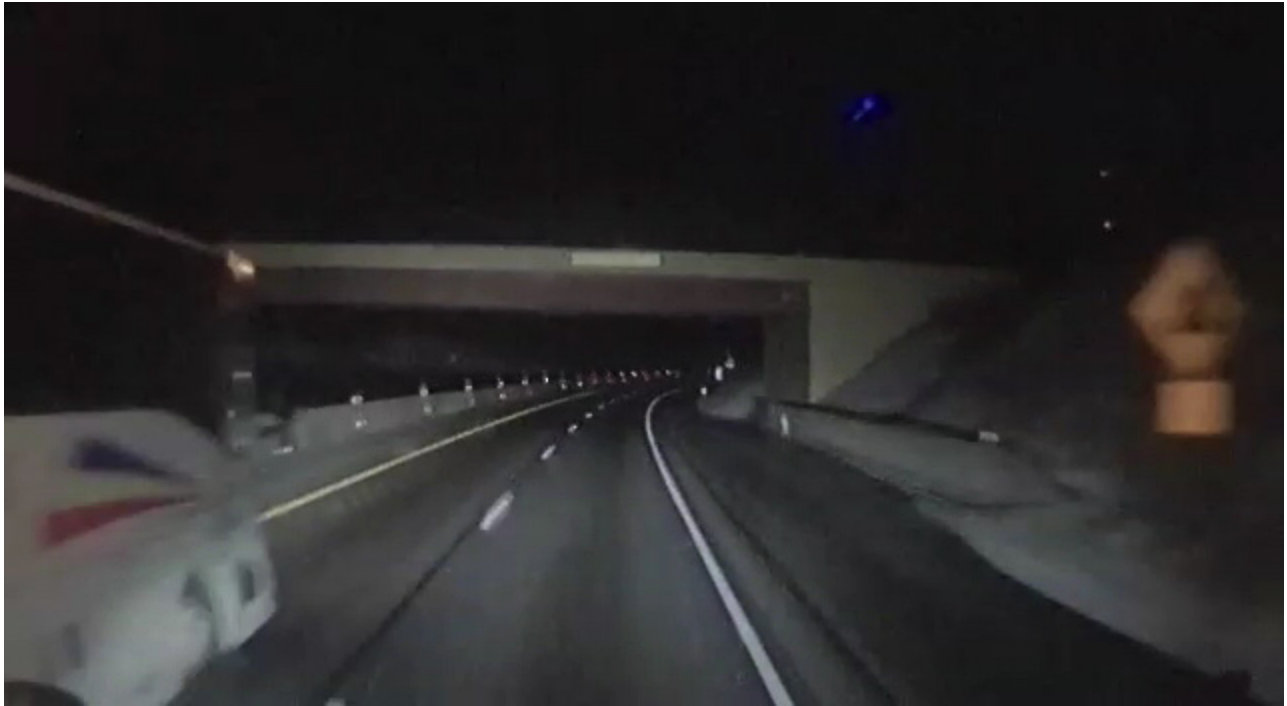
Figure 2. Motorcoach Passing Semi-truck – FFC.

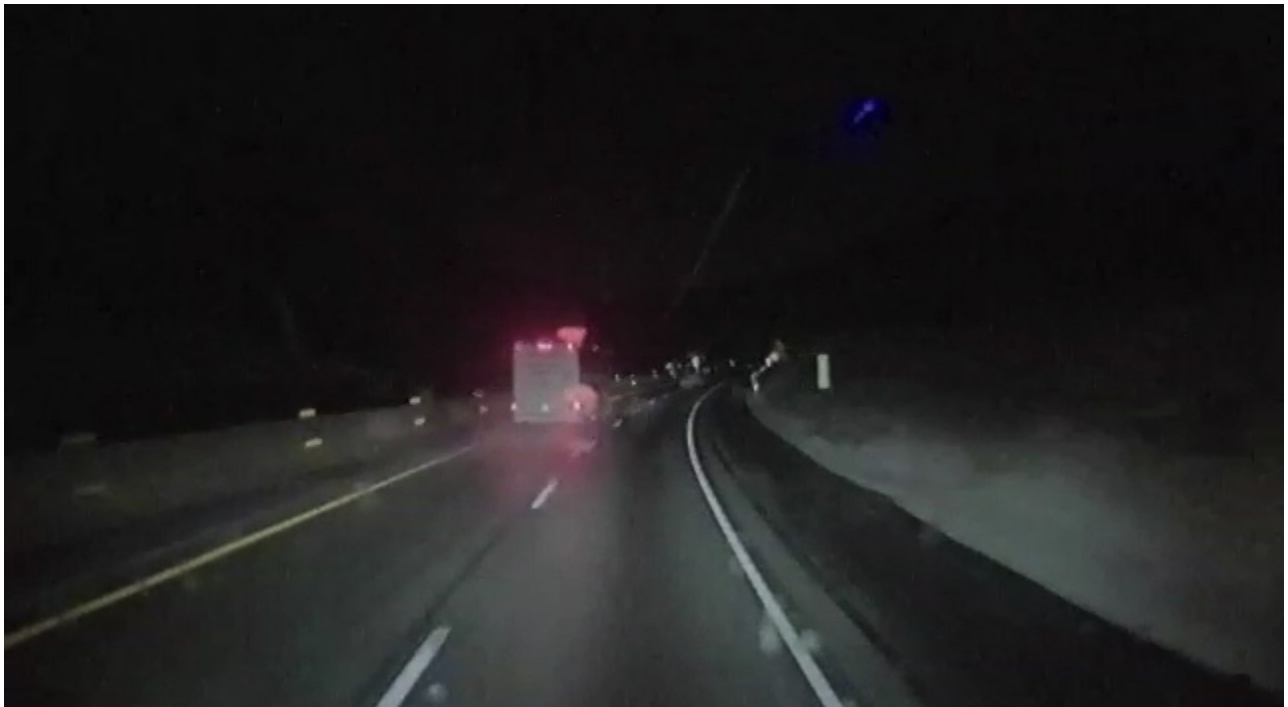
Figure 3. Motorcoach After Passing the Semi-truck - FFC.

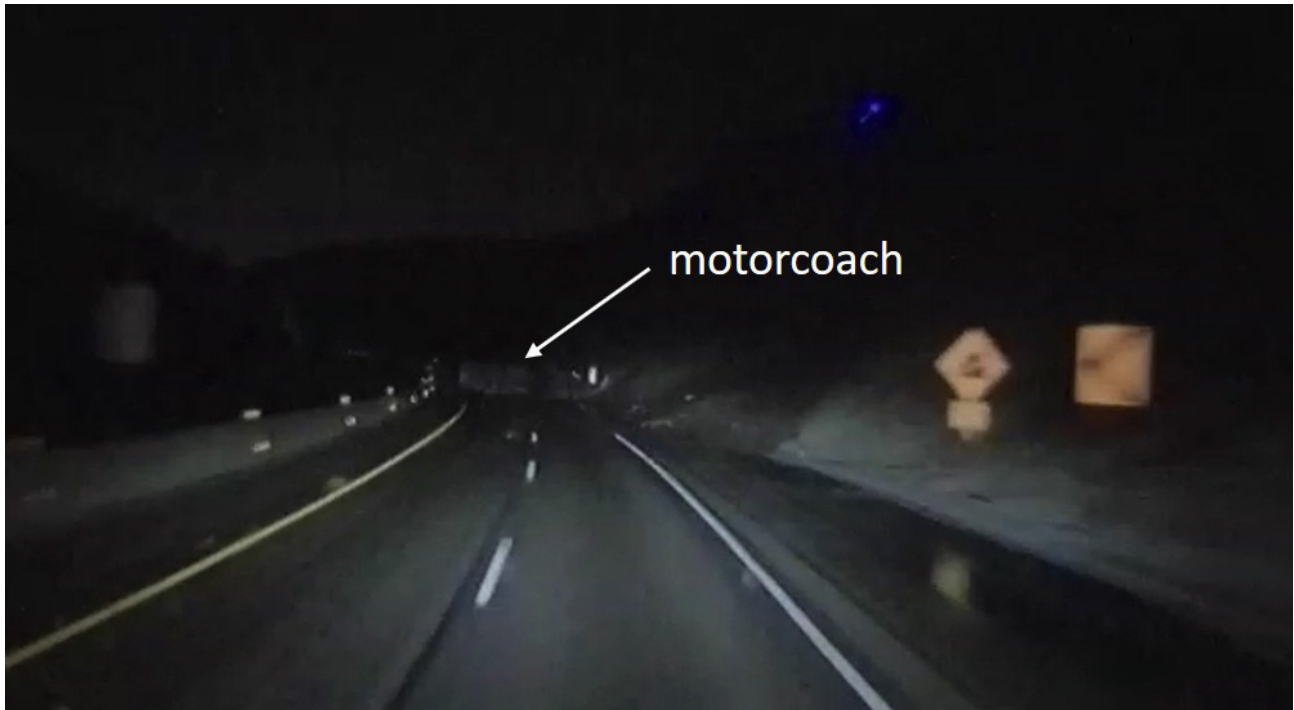
01:08	The motorcoach was no longer visible.
01:32	The semi-truck traveled around a curve toward the accident site.
01:35	The semi-trucks headlights illuminated the accident site and the motorcoach could be seen on its side blocking both westbound lanes. Debris were scattered in the roadway from the median to the shoulder. See Figure 4.

Figure 4. First View of Overturned Motorcoach – FFC.

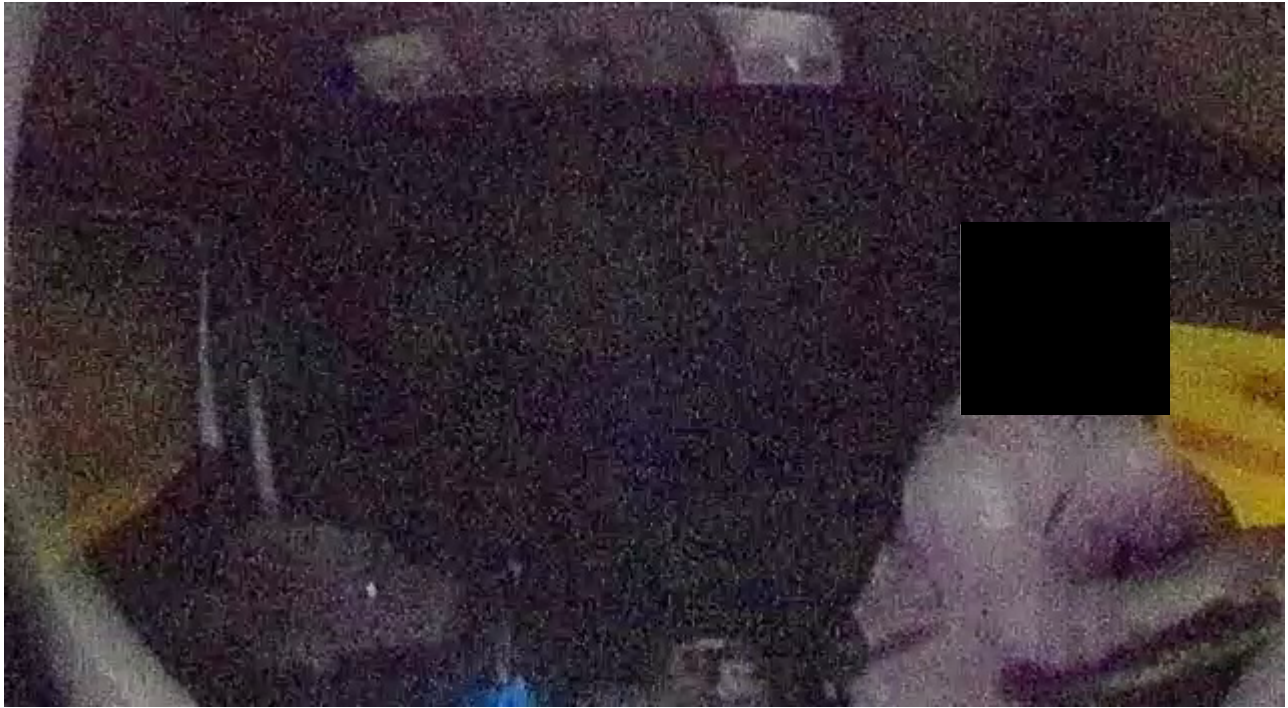
Video Elapsed Time (mm:ss)	Observations
00:19 to 00:21	The motorcoach was seen through the driver's side window passing the semi-truck. Headlights on the motorcoach were illuminated. See Figure 5.

Figure 5. View of Cab from IFC³.

³ Note: Motorcoach can be seen passing in the driver's window.
