**Highway Factors Photographs 1 through 6**

**Decatur, TN**

**HWY21FH001**

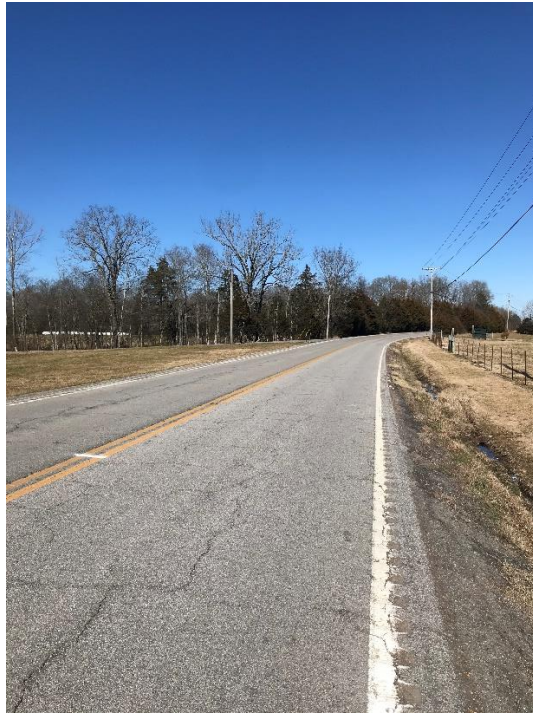
Highway Factors Photo 1 – View of SR-58 looking to the north standing on the solid white line separating the northbound lane from the paved shoulder (Source: TDOT)

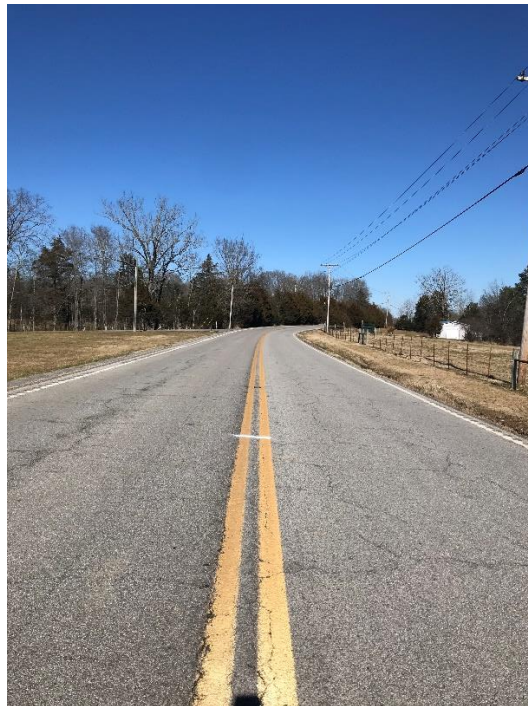
Highway Factors Photo 2 – View of SR-58 looking to the north standing on the solid double yellow lines separating the northbound lane from the southbound lane (Source: TDOT)

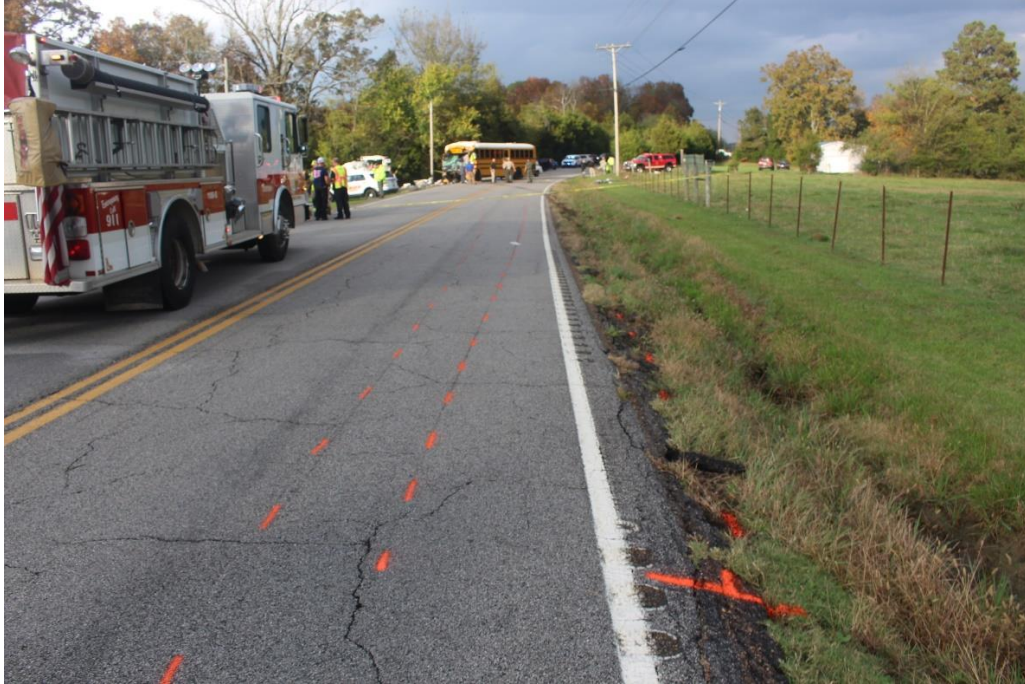
Highway Factors Photo 3 – View of SR-58 looking to the north standing in the northbound lane with the accident school bus located in the background. The orange dash lines denote the approximate location of the tire marks of the service truck (Source: THP)

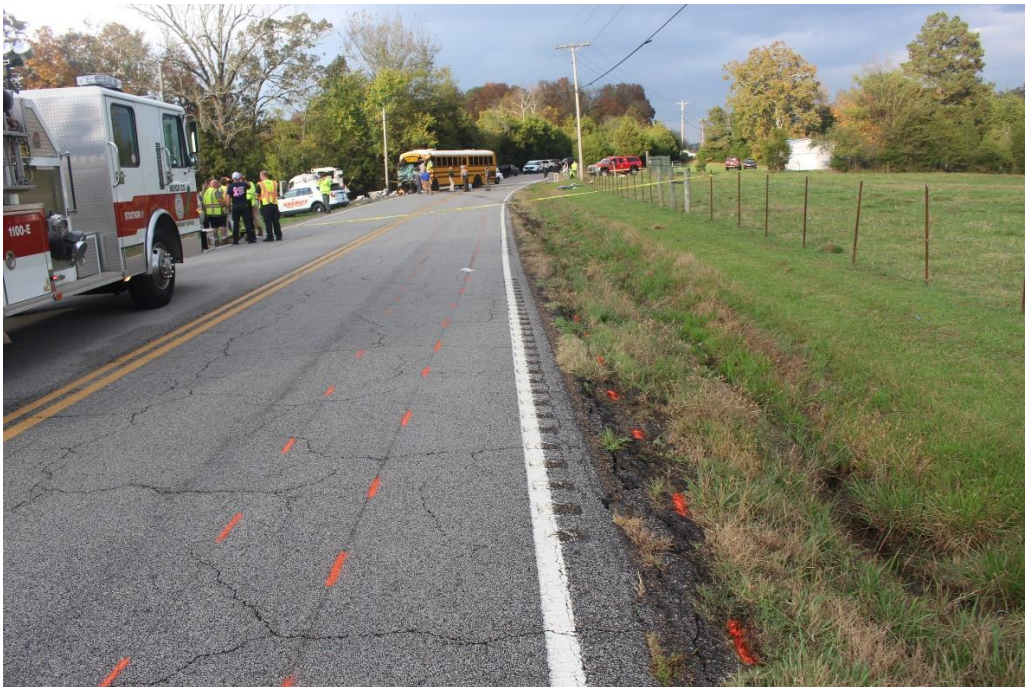
Highway Factors Photo 4 – Another view of SR-58 looking to the north standing in the northbound lane with the accident school bus located in the background. The orange dash lines denote the approximate location of the tire marks of the service truck (Source: THP)

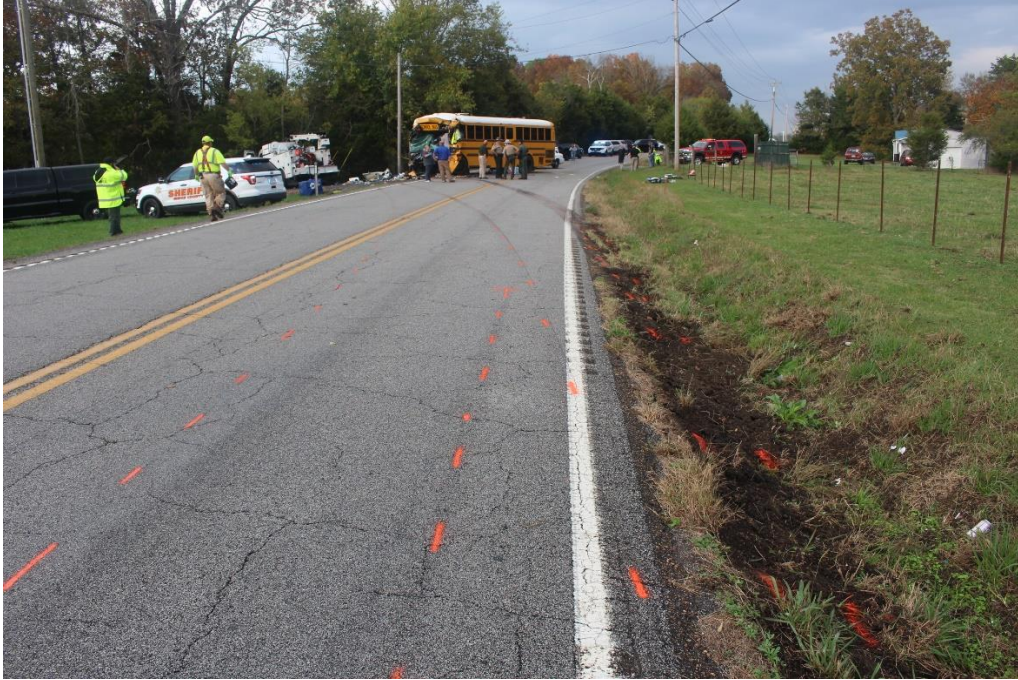
Highway Factors Photo 5 – Another view of SR-58 looking to the north standing in the northbound lane with the accident school bus located in the background. The orange dash lines denote the approximate location of the tire marks of the service truck (Source: THP)

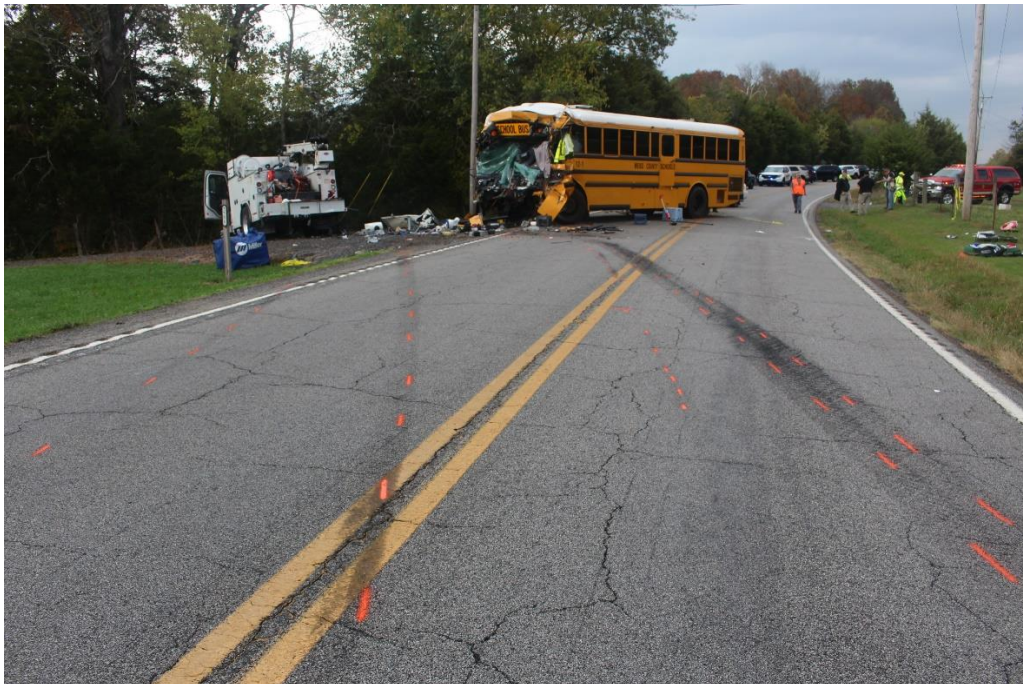
Highway Factors Photo 6 – Another view of SR-58 looking to the north standing in the northbound lane with the accident school bus and service truck located in the background. The orange dash lines denote the approximate location of the tire marks of the service truck (Source: THP)
