PRELIMINARY REPORT

HIGHWAY

HWY21FH001

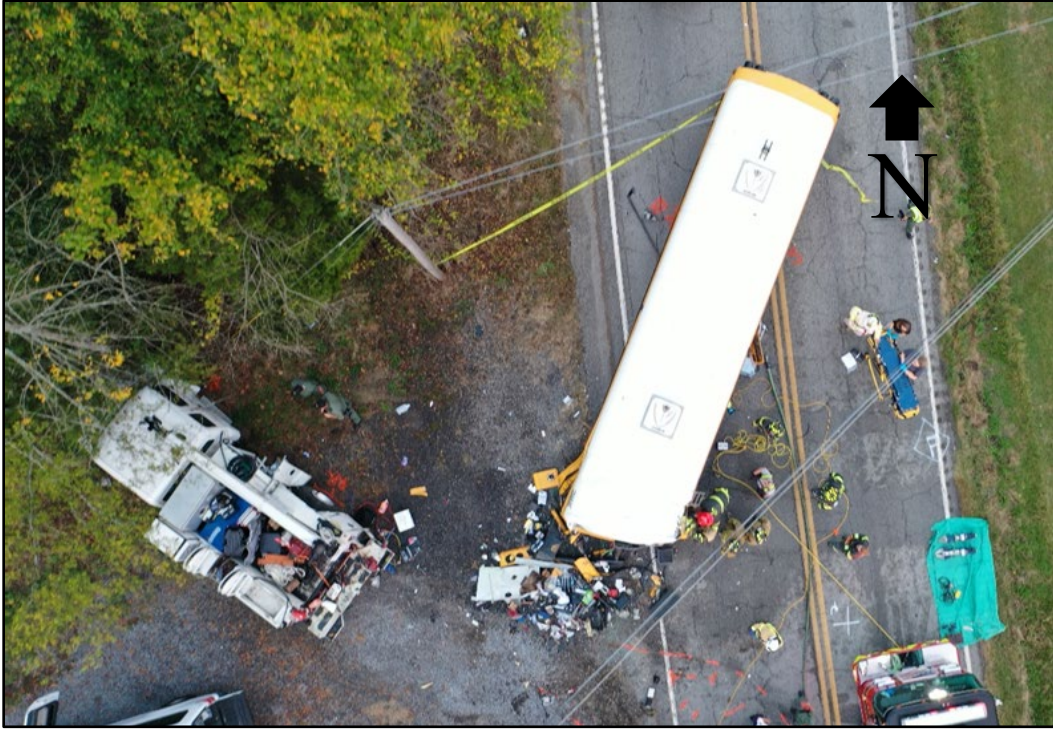
Figure 1. Bus and truck at final rest. (Source: Tennessee Highway Patrol)

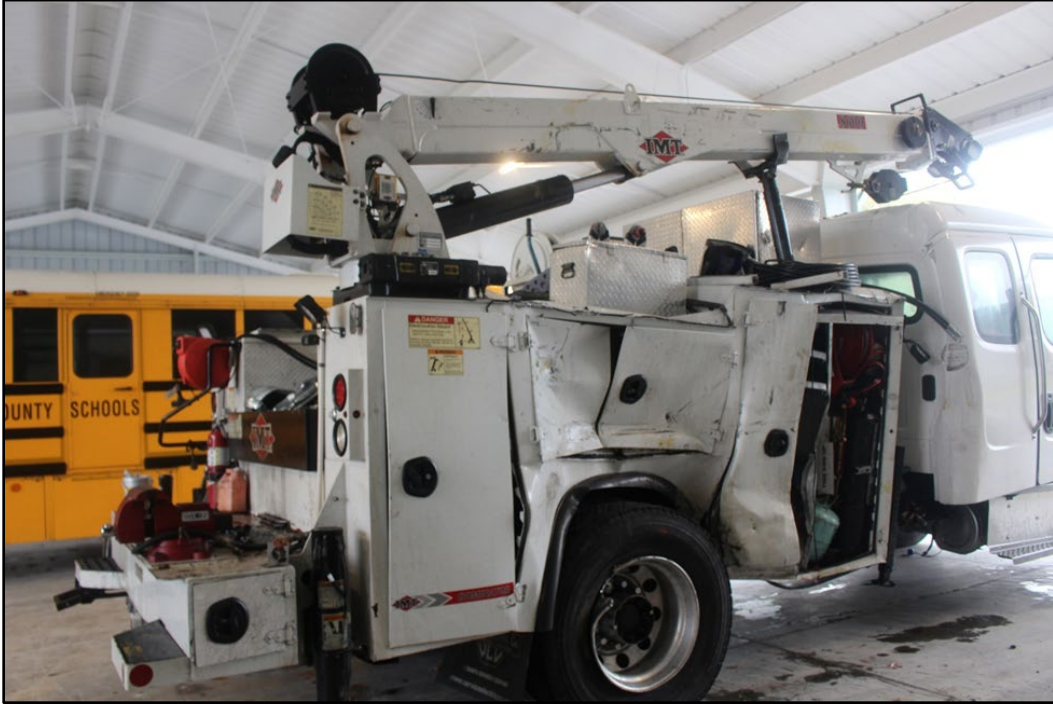
Figure 2. Damage to right side of truck. (Source: Tennessee Highway Patrol)
