NATIONAL TRANSPORTATION SAFETY BOARD

MATERIALS LABORATORY FACTUAL REPORT

Report No. 22-058

Place : Panama City, Florida
Date : June 6, 2022
Vehicle : Piper PA-28RT-201, N160LL
NTSB No. : ERA22FA261
Investigator : Heidi Kemner, AS-ERA

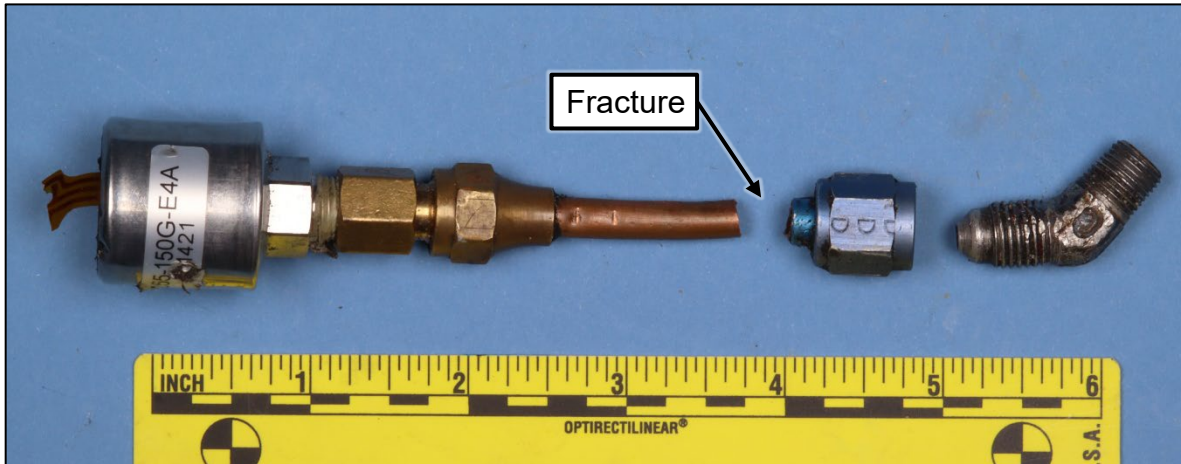
The oil pressure sensor with associated copper line and fittings are shown as received in figure 1. The copper line was fractured at the supply-side nut as indicated in figure 1. The supply-side nut had been disassembled from the 45-degree elbow fitting before the parts were submitted for laboratory examination.

Figure 1. Submitted components including fractured oil pressure sensor line.

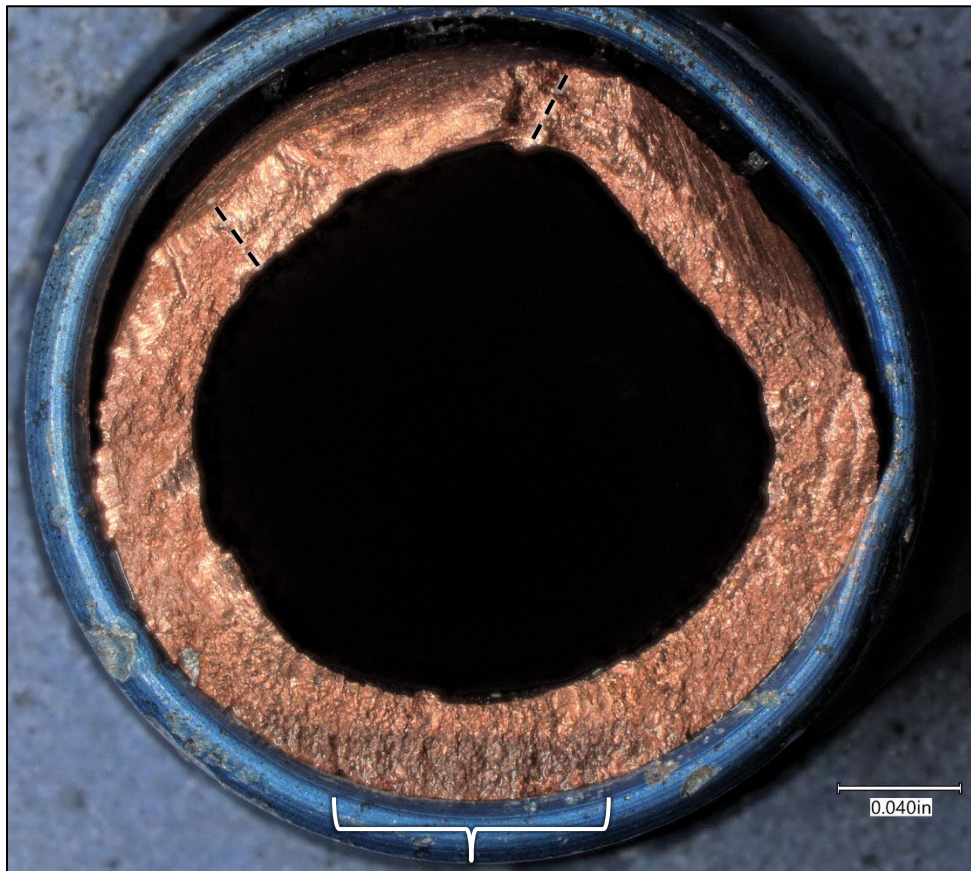
The nut side of the fracture was cleaned in a solution of Alconox detergent and water using an ultrasonic cleaner followed by an alcohol rinse. An overall view of the cleaned fracture surface is shown in figure 2 as imaged using a Keyence 7000 microscope with depth-up focus and HDR image settings. The fracture surface had a somewhat rough appearance, and much of the surface was damaged. However, most of the fracture occurred on a flat plane perpendicular to the tube axis, and a darker region with a smooth curving boundary was observed at one side identified as the origin area as indicated with a bracket in figure 2.

Figure 2. Oil pressure sensor line fracture surface after cleaning. Dashed lines indicate the approximate fatigue boundary from the origin area indicated with a bracket.

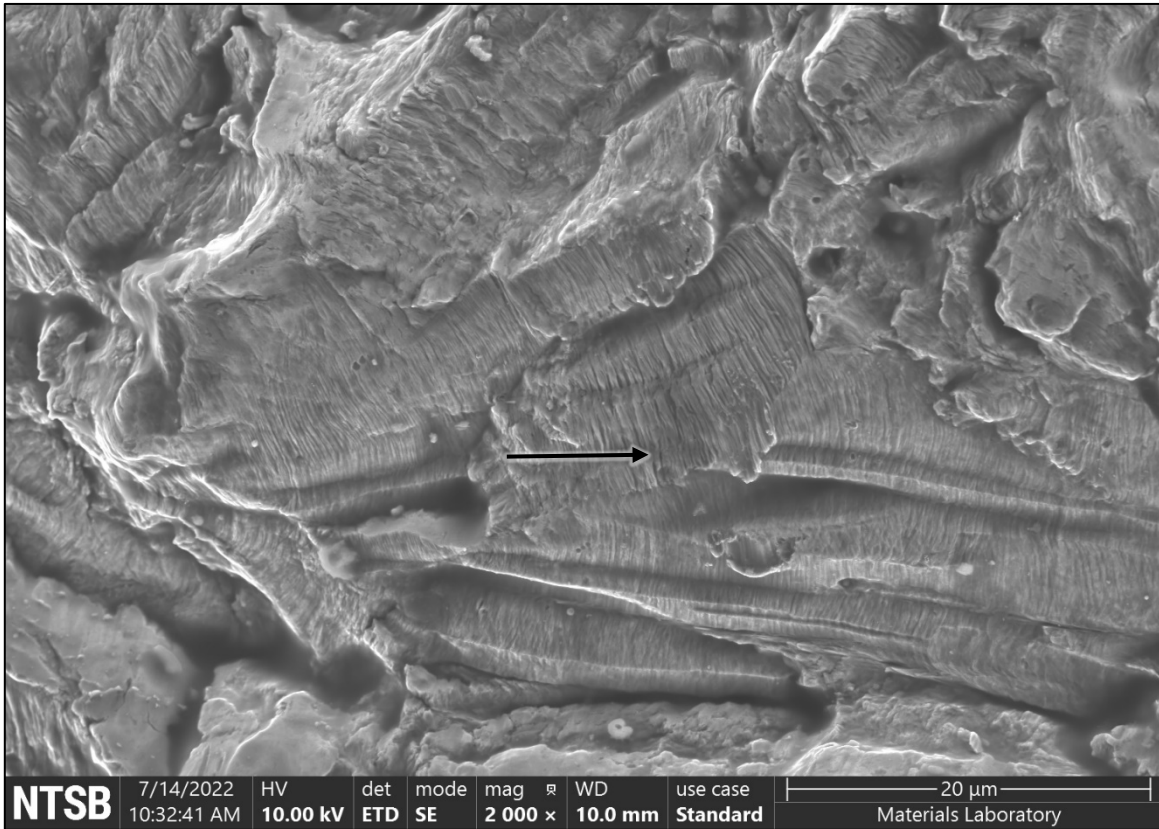
Next, the cleaned fracture was placed in a scanning electron microscope (SEM). Feathery transgranular features with fine striations were observed across much of the fracture surface, and an SEM image showing fatigue fracture features typical for the fracture surface in the fatigue region is shown in figure 3. Fatigue features emanated from the origin area indicated with a bracket in figure 3 and extended to the boundary approximately indicated with dashed lines. The remainder of the fracture surface showed a change in fracture plane with dimple features on the fracture surface, features consistent with ductile overstress fracture of the remaining ligament of the tube wall.

Figure 3. SEM image of typical fatigue striations observed within the fatigue region. An arrow indicates the direction of fatigue propagation in the image.
