NTSB/HIR-22/06

# Collision Between Service Vehicle and School Bus

Decatur, Tennessee

October 27, 2020

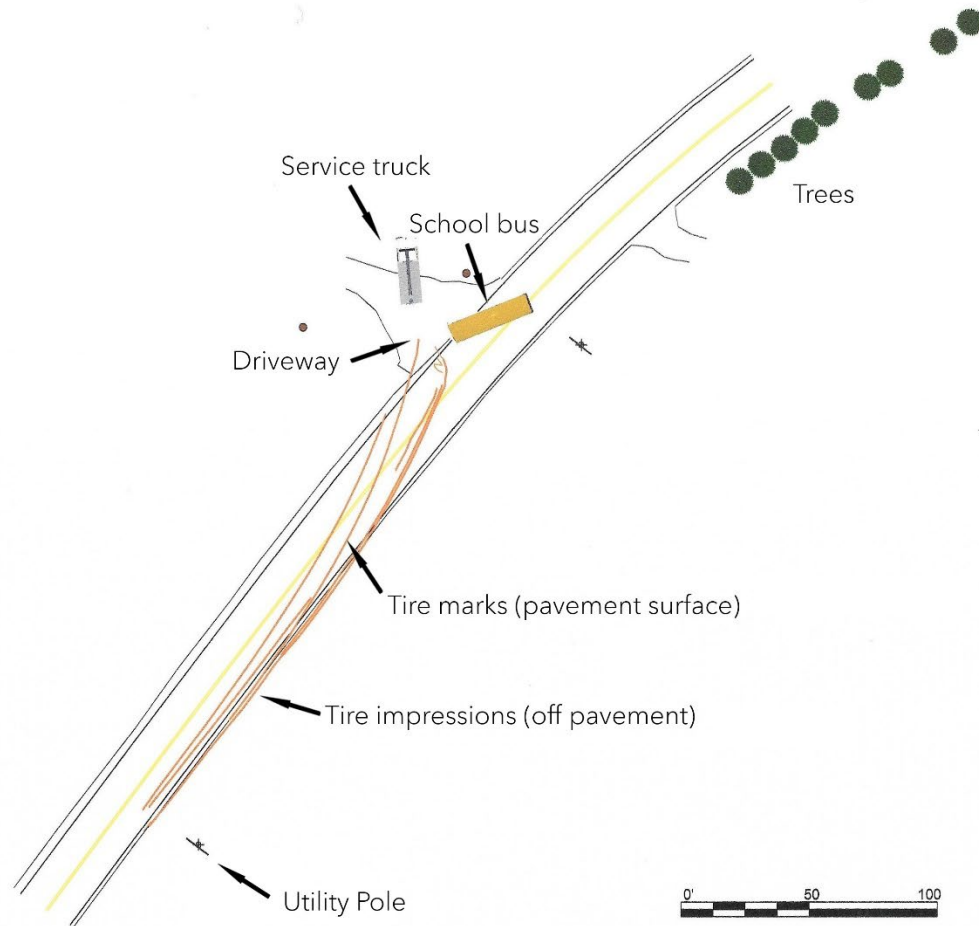
The impact occurred in the 7700 block of SR-58 about 66 feet from the south end of a 287-foot-long, 900-foot radius curve in the southbound lane (see figure 2).

**Figure 2.** Diagram depicting vehicles' postcrash positions of rest, with tire mark/impression evidence. (Source: Tennessee Highway Patrol. Trees and utility poles added by NTSB, based on Google Earth imagery.)

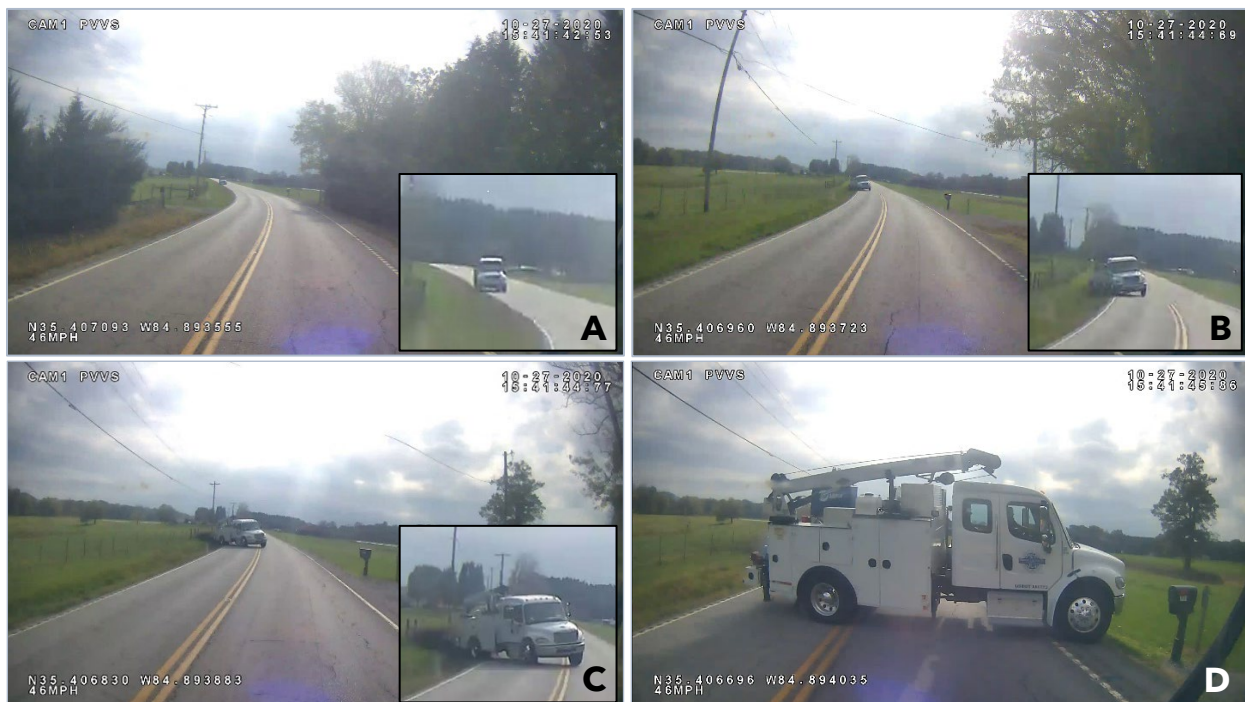
About 206 feet before the area of impact, the truck's right-side wheels departed the pavement at an estimated departure angle of  $1.5^\circ$  (see figure 3, picture A). The truck driver told investigators that he was looking behind the truck in his side rear-vision mirrors at a sheriff deputy's vehicle that had turned onto SR-58 heading north behind the truck.<sup>5</sup> Tire impressions in the soil, tire markings on the pavement, and video evidence from the outward-facing camera on the school bus

showed that only the right-side wheels departed the pavement area.<sup>6</sup> After 139 feet (about 67 feet before the impact area), tire impressions and video footage indicated movement of the steer (front) axle wheels to the left as the truck's right front wheel began to return to the roadway (see figure 3, picture B). Additionally, the video footage showed soil being displaced by the right rear tires and a loss of traction. Video from the school bus's outward-facing camera showed that the truck had substantially yawed and the left front wheel was across the highway centerline (see figure 3, picture C). About a second after the truck's right front wheel re-entered the roadway, the truck crossed the highway centerline into the southbound lane and yawed nearly 90° to be almost perpendicular to the roadway just before impact with the bus (see figure 3, picture D).

**Figure 3.** Video frames, captured by the outward-facing camera onboard the school bus, showing the truck departing the road (A), returning to the road (B), and crossing into the travel lane of the bus (C & D). The inserts are close-up images of the truck.

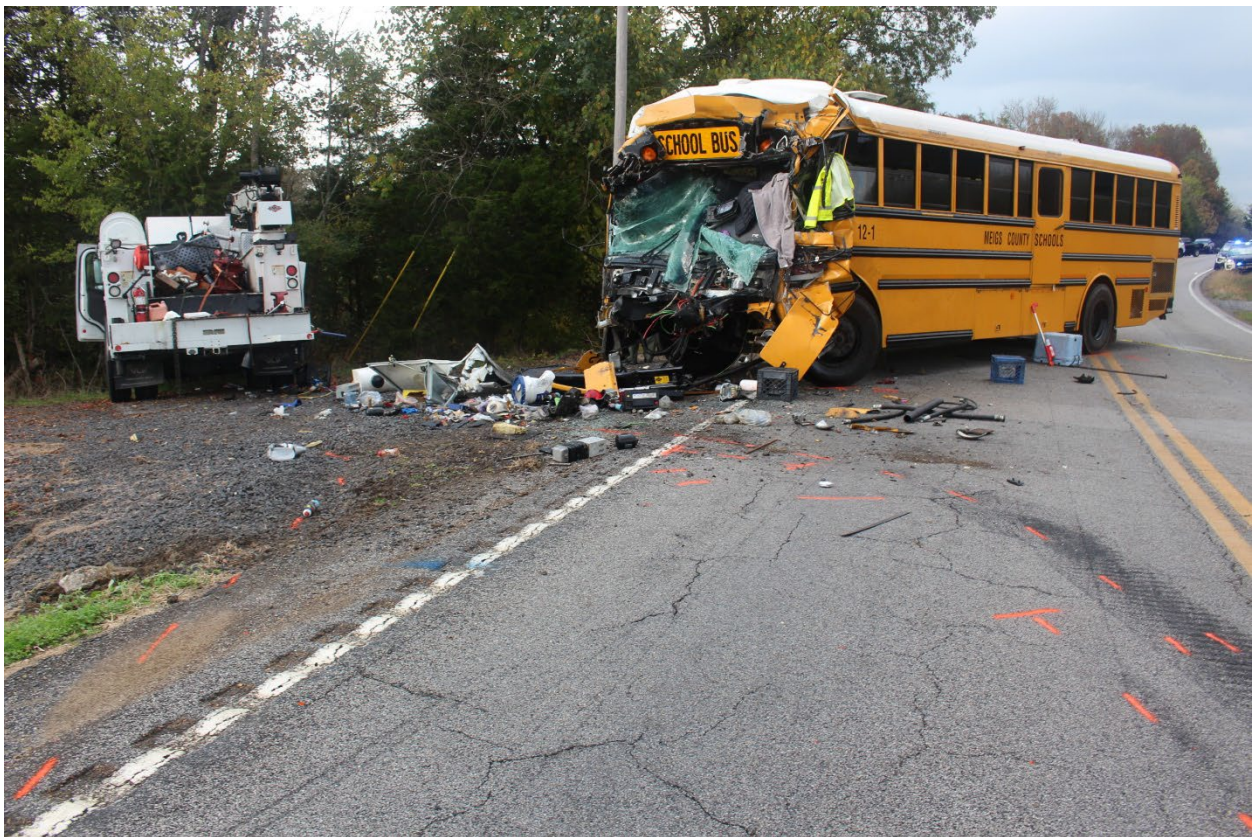
Postimpact, the bus was redirected northward about 10–12 feet and rotated clockwise about 22°, coming to rest in the southbound lane. At final rest, the truck had rotated about 35° clockwise from its impact with the bus and entered a driveway on the west side of the roadway. Figure 4 shows the final rest positions of the two vehicles.

**Figure 4.** Final rest positions of truck and school bus. (Source: Tennessee Highway Patrol)

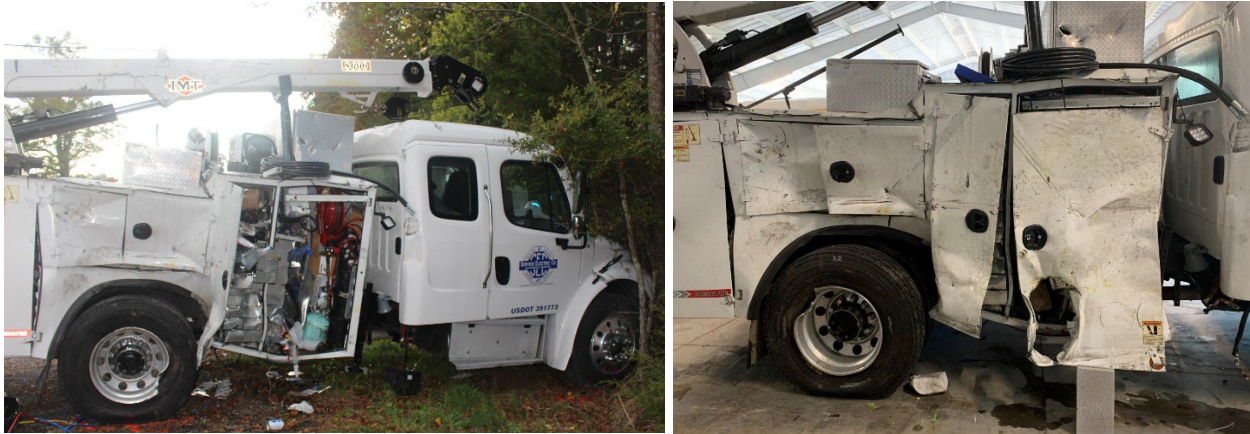
**Damage.** The damage to the truck was concentrated to the right side aft of the passenger compartment, as shown in figure 6.<sup>13</sup> Both right-side cargo doors of the truck's utility box were heavily damaged in the collision, and the forward cargo door separated from the truck. The left photo in figure 6 shows the damaged truck at the crash site without the cargo door; in the right photo at the garage, the damaged door is shown propped up in its original/intended position. The truck sustained a large hole below the forward cargo door latch assembly, and two circular imprints from the bus's right-side headlight assembly were located forward of the large hole on the cargo door. The wheel mounted on the right outside position of the second axle also

sustained crash damage. The rear cab supports and mounts were torn away from the bottom of the cab, and the right rear corner of the cab was dented.

**Figure 6.** Postcrash photos of right side of the service truck. (Source: THP)

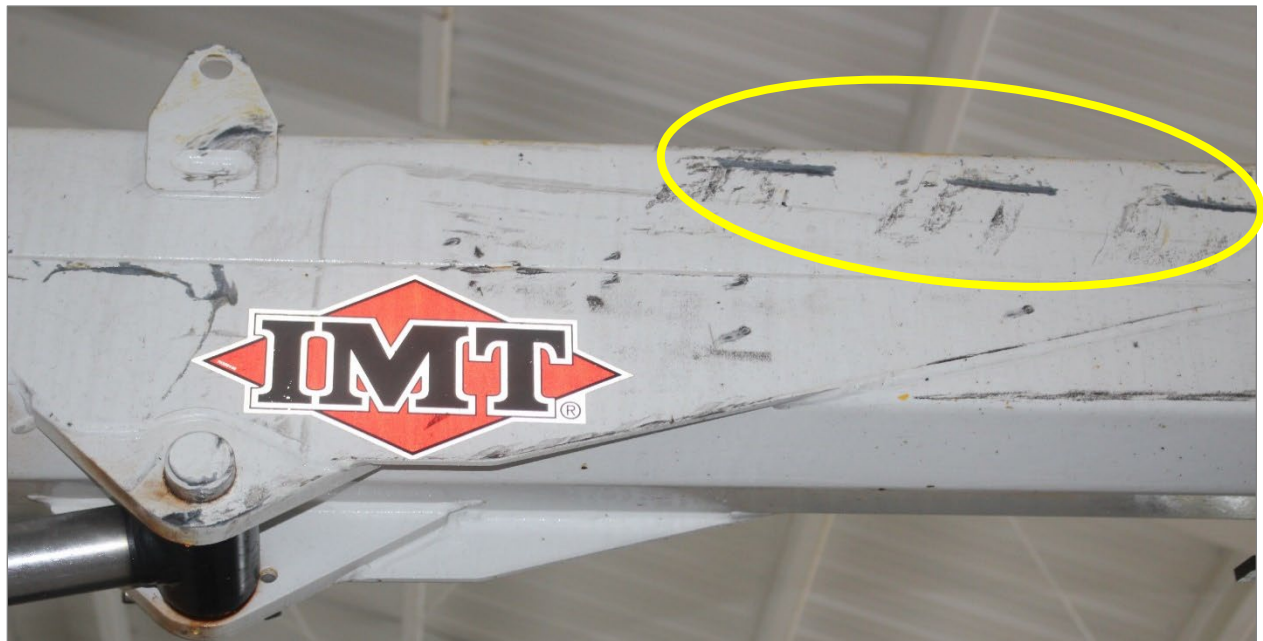
Figure 7 shows the abrasions and transfer marks on the right side of the crane arm located above and aft of the cargo doors. The crane arm had imprints from the bus's left-side amber and red crossover lights as well as imprints from the bus's center identification lights (circled in figure 7) and from the "school bus" sign, located above the bus's windshield.

**Figure 7.** Damaged crane arm of service truck.

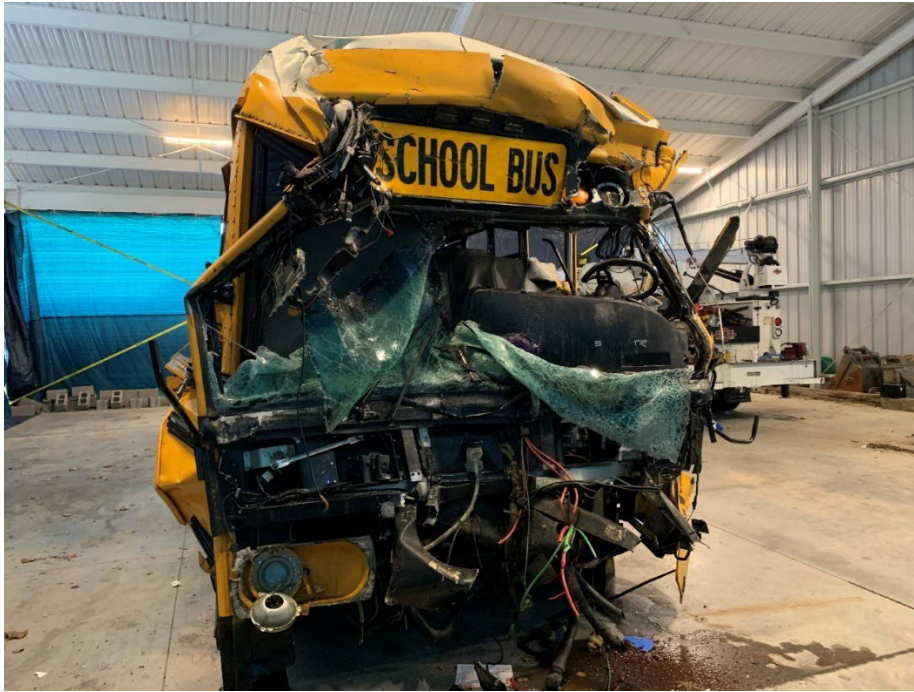
**Damage.** The bus had severe crash damage across the front, as shown in figure 8. Figure 9 shows that the damage on the left side of the bus was concentrated in front of the steering axle. The left A-pillar along with the top of the windshield were displaced rearward beyond the driver’s seating position. In addition, the driver-side window and the two front passenger windows on the left side were missing. On the right side of the bus (also figure 9), the entrance door and frame assembly were crushed rearward, preventing the use of the step well to enter or exit the bus. Glass panes were missing from the first and fourth passenger window frames on the right side. The rear of the bus was undamaged.

**Figure 8.** School bus front damage.

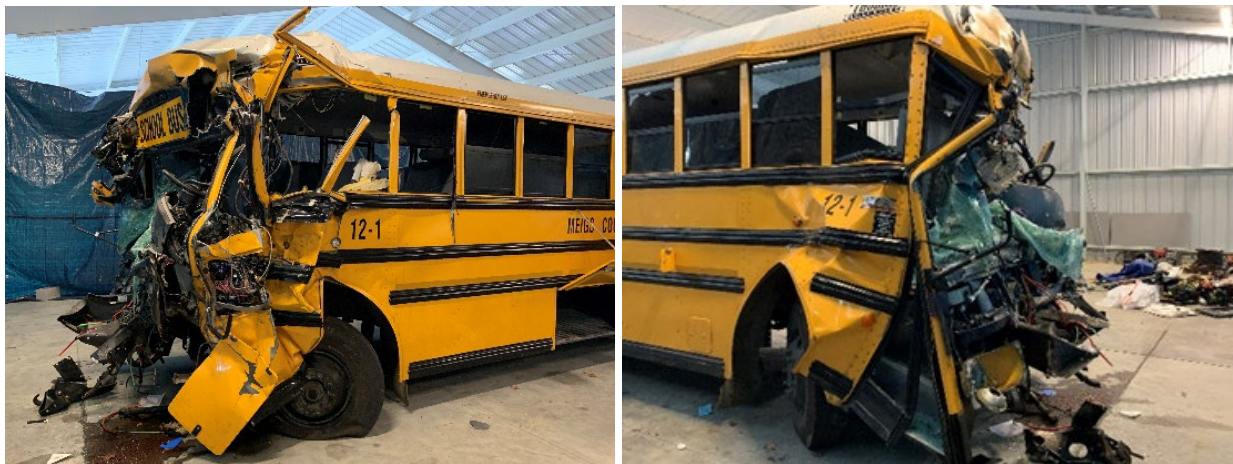
**Figure 9.** Crash damage to the driver side and right side of the school bus.

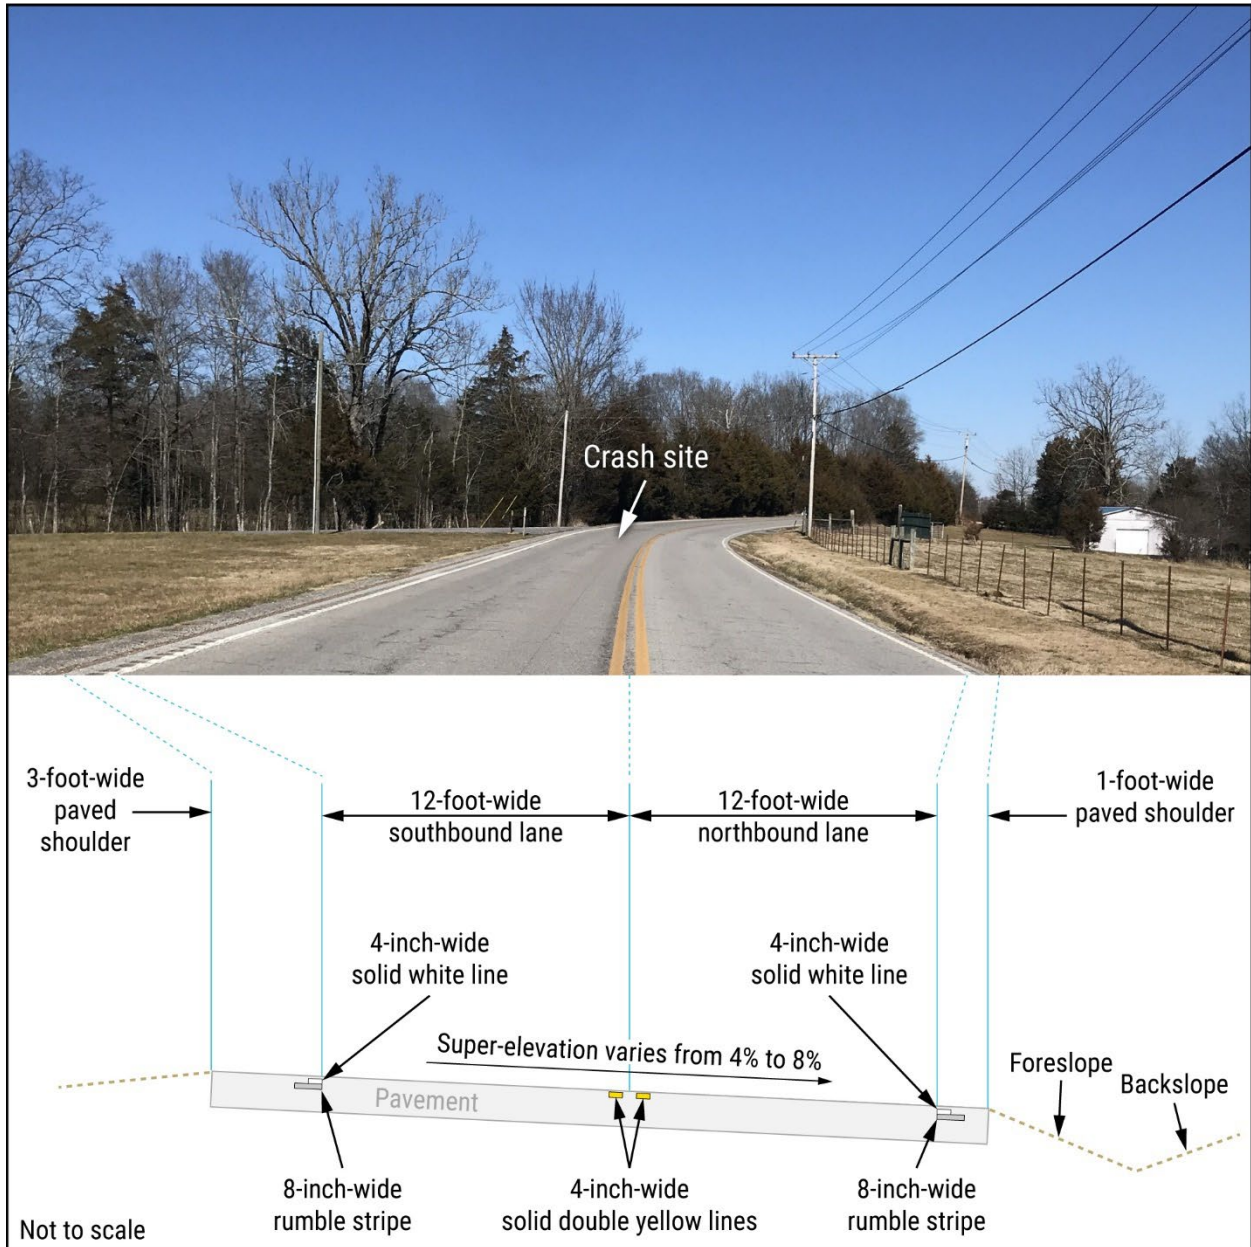
foreslope and backslope, which will be described in further detail later in this section. A curve right advisory sign was located about 1,320 feet before the crash site for the northbound travel lane and a curve left advisory sign was located about 422 feet before the crash site for the southbound travel lane. There was also a 55-mph speed limit sign next to the southbound travel lane. Figure 10 shows the view and cross-section of SR-58 in the northbound direction near the location where the truck's right tires left the roadway, with the crash site in the background.

**Figure 10.** View and cross-section of SR-58 in the northbound direction with the crash location in the background. (Photo source: THP)

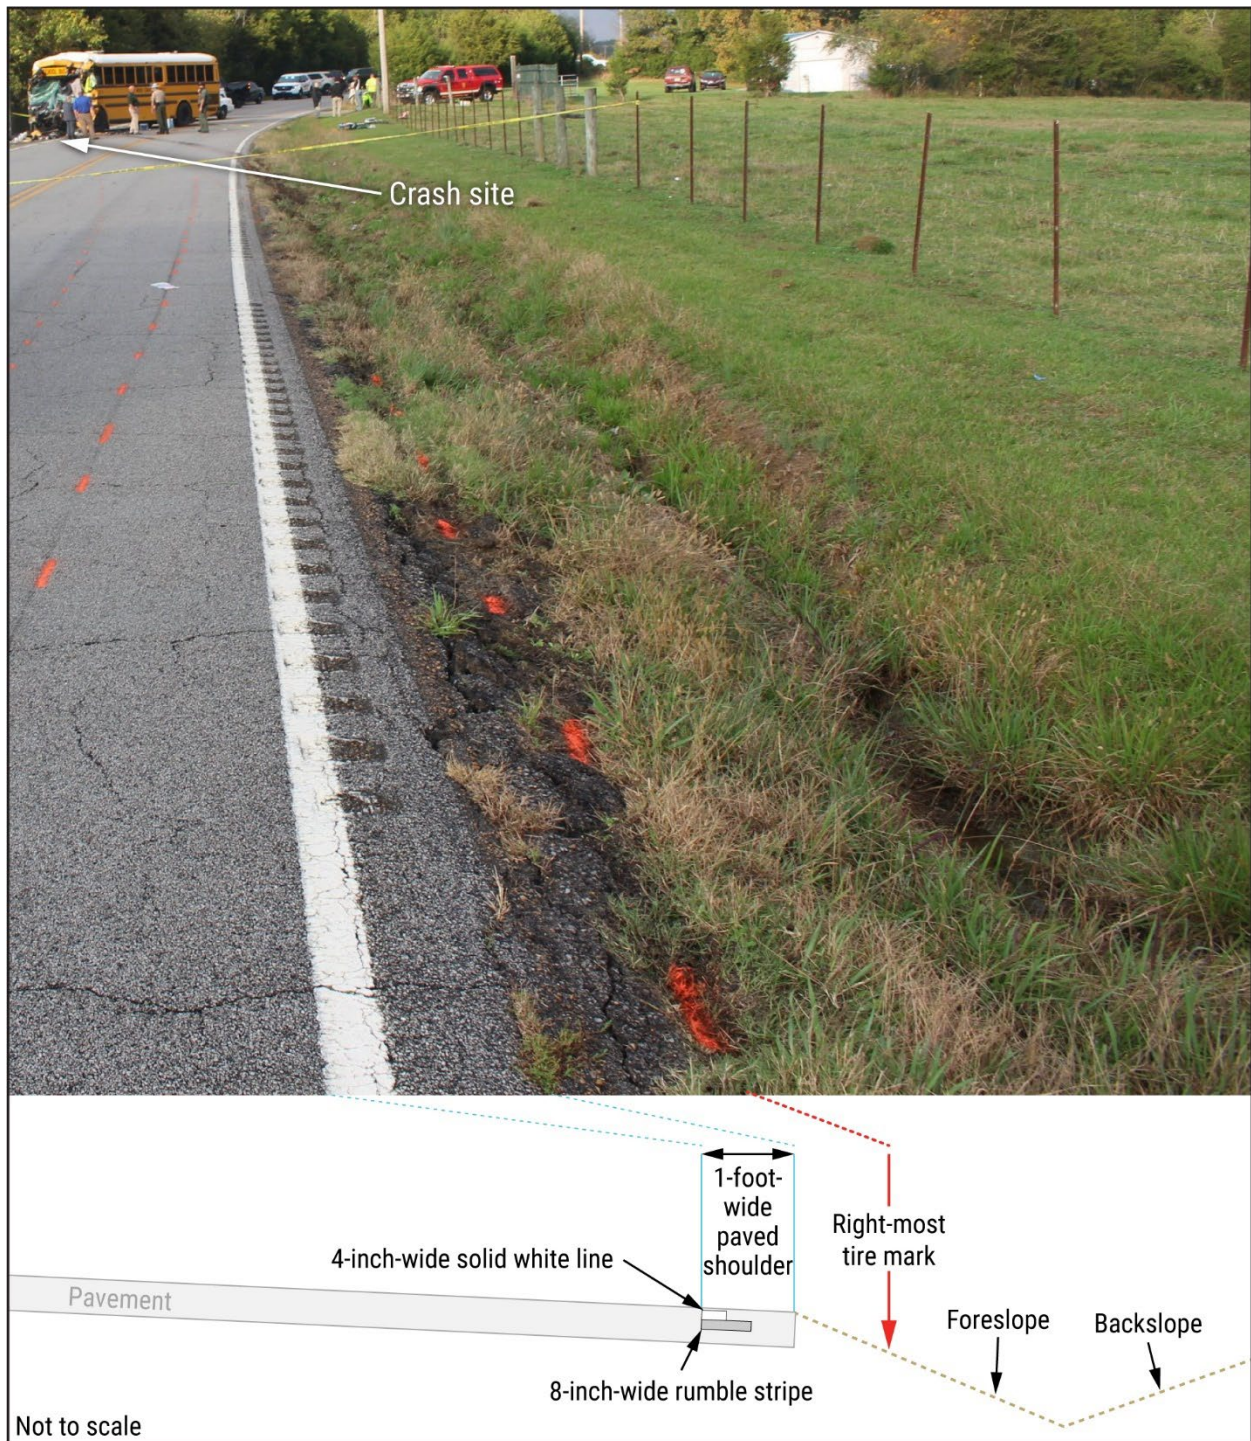
Figure 11 shows a close-up and cross-section of the earthen v-ditch with the truck's tire impressions on the foreslope, as shown by the red arrow.

**Figure 11.** Close-up of v-ditch. (Photo Source: THP)

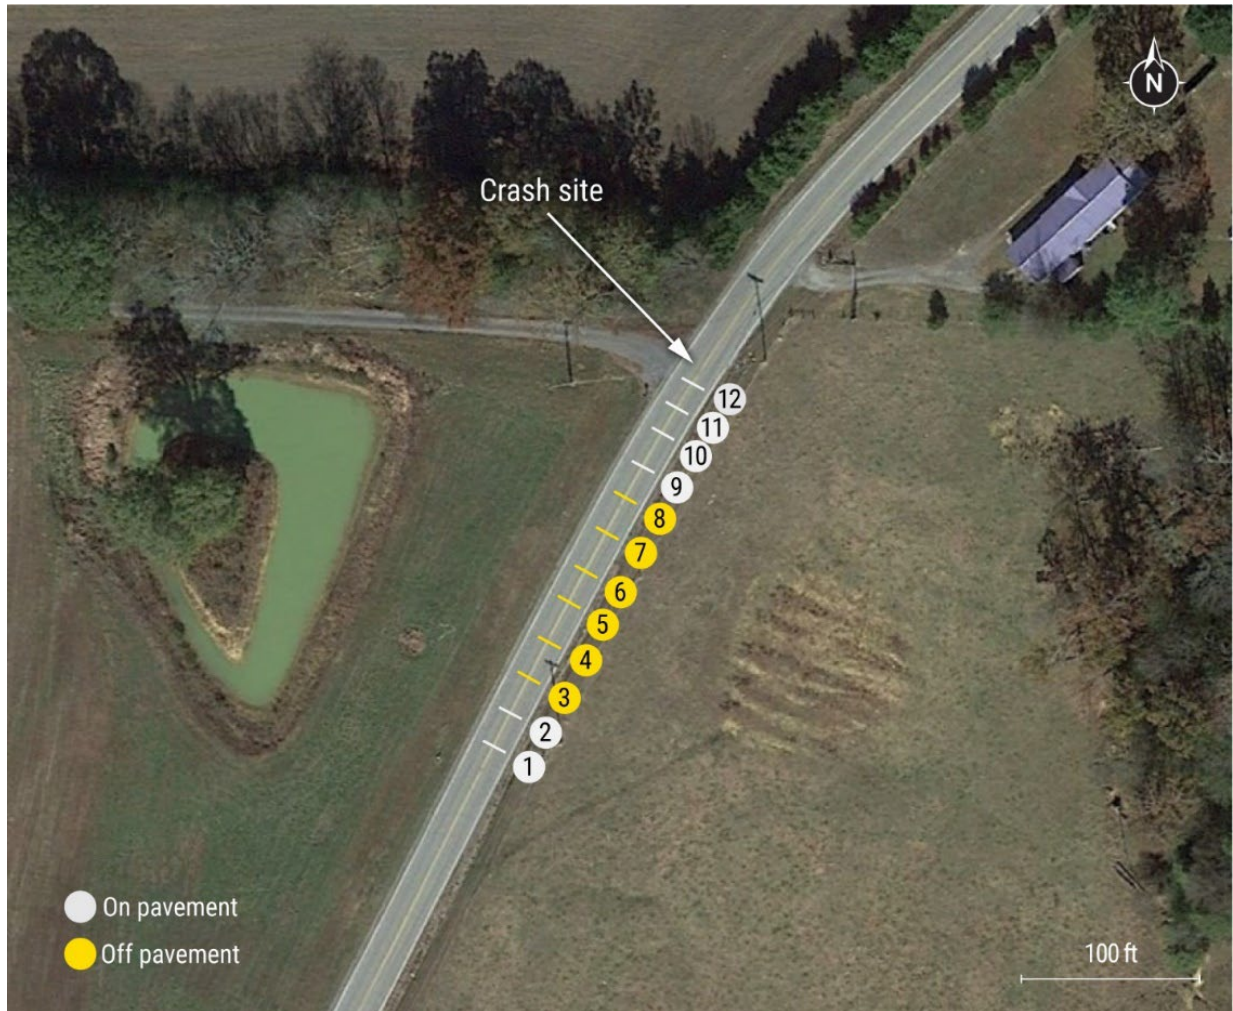
Postcrash, TDOT surveyed SR-58 at 20-foot increments to determine the approximate location of the truck's right-most tire mark, the classification of the foreslope, and the height of the pavement edge drop-off. The survey locations are shown in figure 12 (marked by numbers 1 through 12) and the corresponding information is summarized in table 2.

**Figure 12.** Aerial photo of SR-58 at the crash site, with overlaid markers. The yellow numbers indicate locations where the right-most tire mark was found in the earthen v-ditch, and the white numbers indicate that the truck's right-most tire mark was located on the pavement.

The pavement edge drop-off measurements refer to the vertical drop between the paved shoulder and the unpaved shoulder of the northbound travel lane. TDOT found that 5 of the 12 measurements were greater than 1.75 inches; all pavement edge drop-offs measured 2.5 inches or less.<sup>24</sup> Pavement edge drop-offs can make it difficult for drivers to return their vehicles to the pavement (also see section 1.9.3 Postcrash Actions in this report).
