# Electric Vehicle Run-Off-Road Crash and Postcrash Fire

Spring, Texas  
April 17, 2021

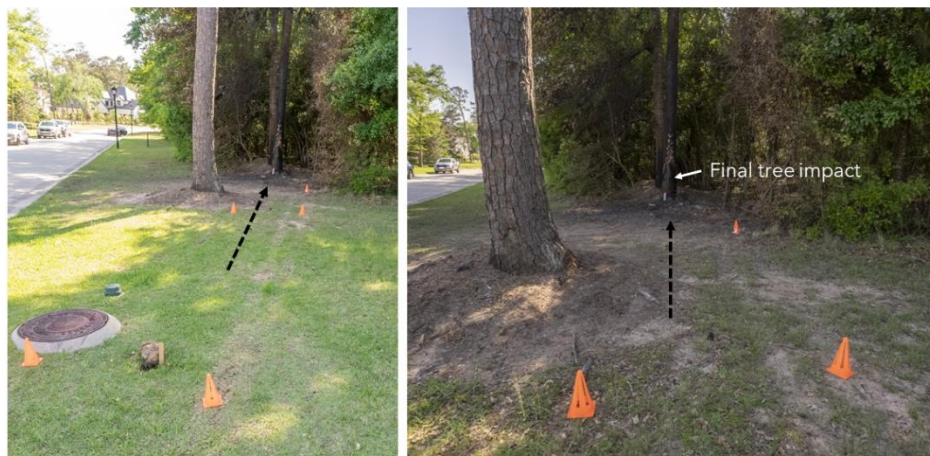
**Figure 1.** Car’s path after departing right-side roadway toward final tree impact, marked by cones (left). A closer view of the impact site is shown on the right, with the tree that was sideswiped by the car on the left side of the image. (Background source: Tesla)

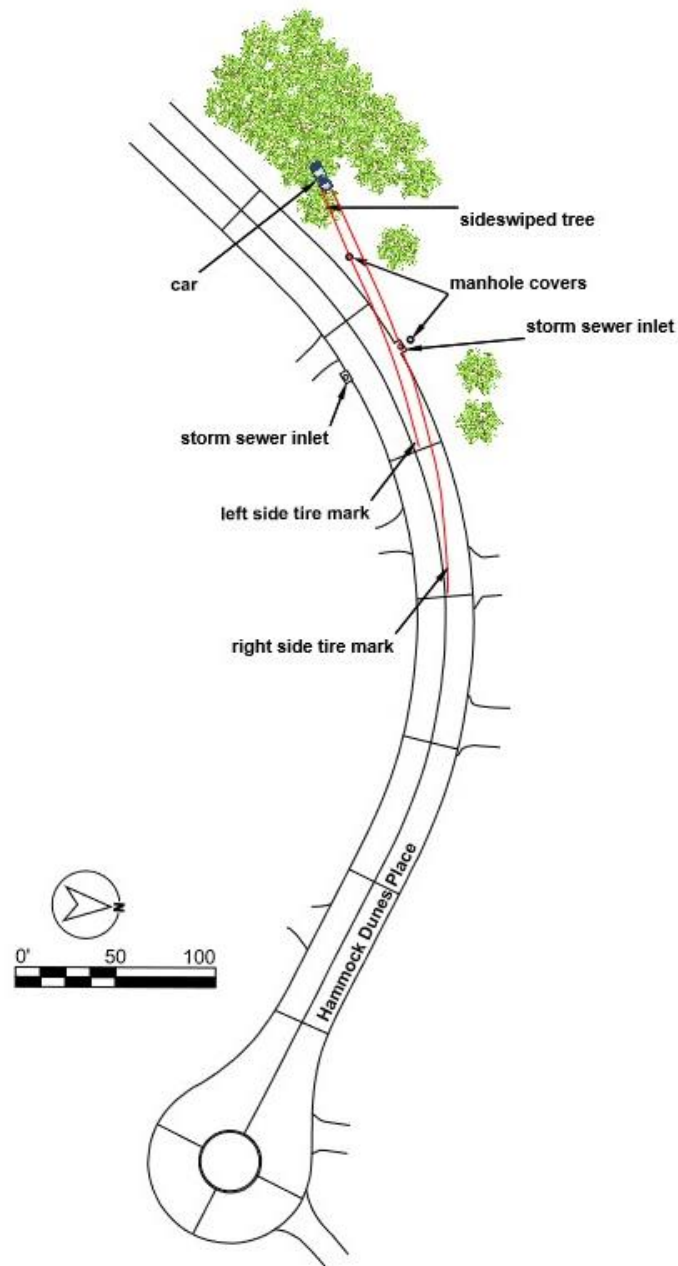
documented by roadway evidence, the car departed the roadway to the right, mounted the curb, traversed a storm sewer inlet, struck an elevated manhole cover, and sideswiped a tree (see figure 3). The car then impacted another tree before coming to final rest.

**Figure 3.** Crash diagram showing physical evidence and final rest position of car.

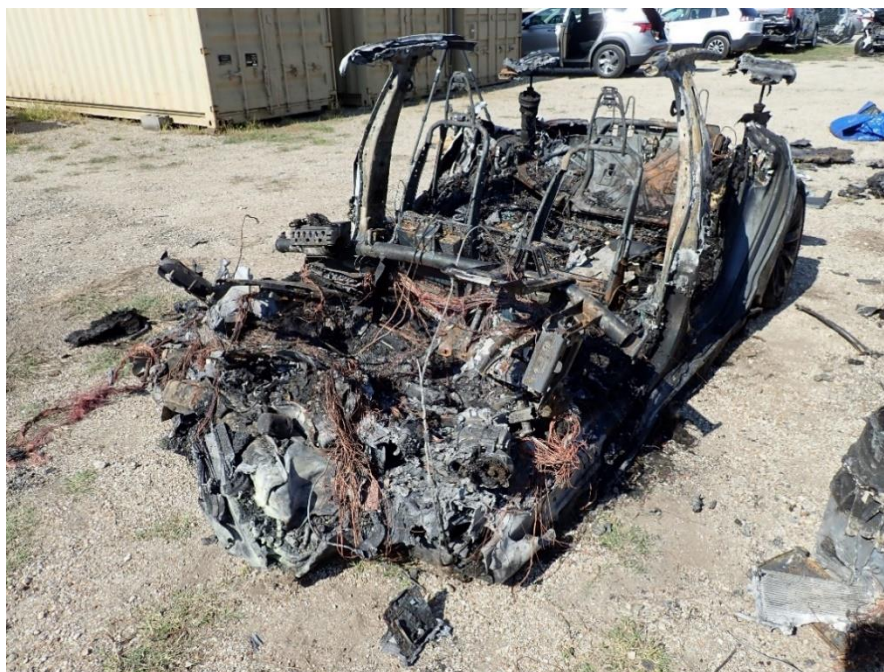
The postcrash battery fire consumed most of the interior occupant cabin of the car, which limited the on-scene inspection (see figure 4). The plastic and fabric portions of the seat belts were destroyed in the fire, but the seat belt connectors for both the driver seat and left rear seat were found near where they would normally be located for each seating position. Investigators removed the steering wheel from the wreckage and sent it to the NTSB Materials Laboratory in Washington, DC, for further inspection. Detailed evaluation of the steering wheel revealed that the top of the rim between the 9 o'clock and 3 o'clock spokes was bent forward, toward the dashboard. The spoke at the 9 o'clock position was fractured and separated from the hub.

**Figure 4.** Interior of fire-damaged car, looking front to rear.
