National Transportation Safety Board
Office of Aviation Safety
Central Region

CEN23LA068

WRECKAGE EXAMINATION SUMMARY

Location: Reserve, Louisiana
Date: December 21, 2022
Time: 1954 central standard time
Airplane: Grumman American AA-5B, Registration No. N321GD

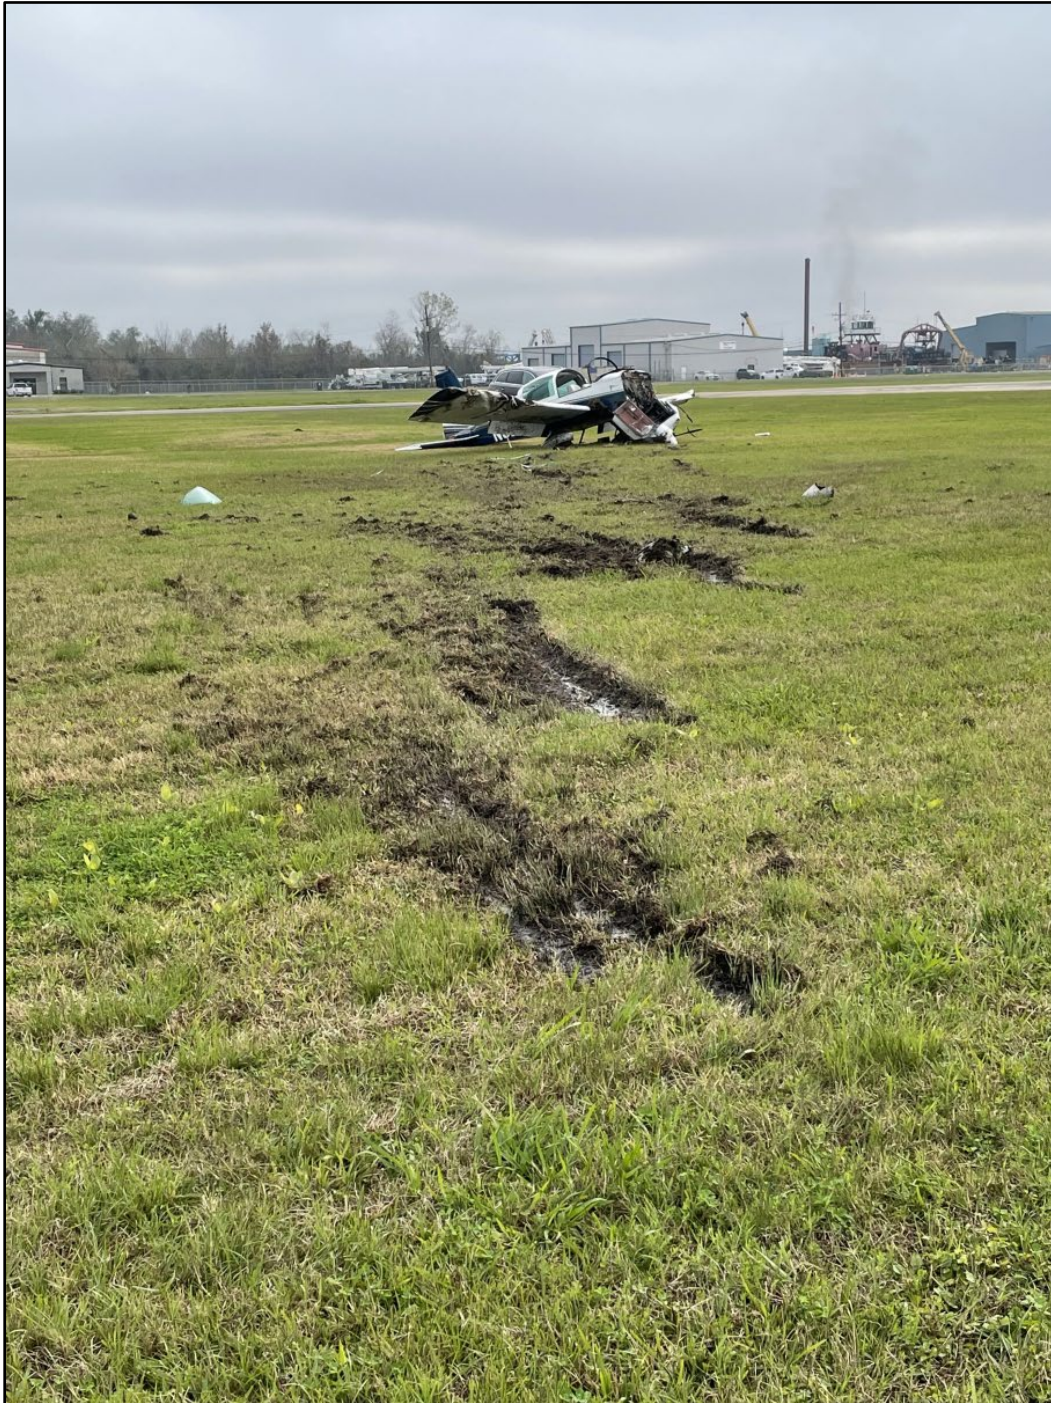
Figure 1 - Accident Site Overview (FAA Photo)

On the morning of December 22, 2022, FAA Inspector Burge conducted an on-scene examination of the airplane. The airplane came to rest upright in a grass area between runway 17 and the parallel taxiway about 600 ft from the end of the runway 17. The initial impact with the ground was about 32 yards northwest of the main wreckage. The left wingtip and portion of the left aileron separated during impact. The outboard 1/3 of the right-wing leading edge exhibited crush damage. The flaps were found fully extended. The airplane was facing 241° at the accident site. The engine and nose gear partially separated from the firewall during impact. There were no flight control anomalies observed during the onsite examination.

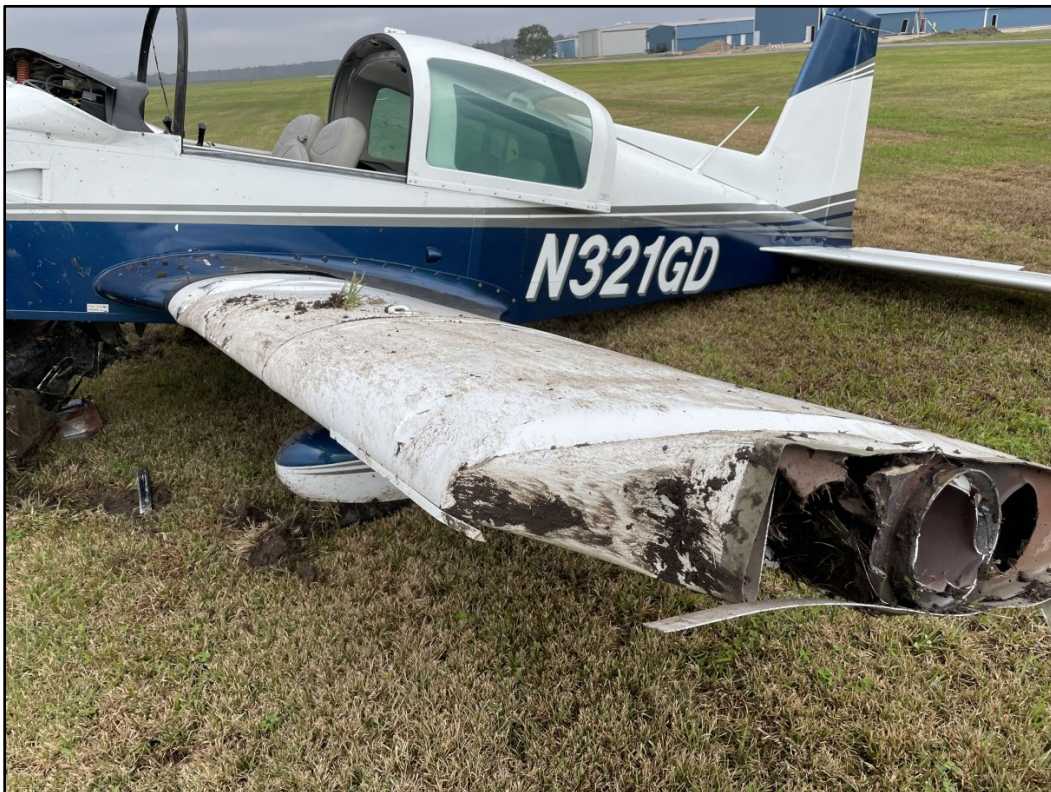
Figure 3 - Left Wing (FAA Photo)

The airplane experienced a partial loss of engine power during initial climb after takeoff from APS while in night instrument meteorological conditions (IMC). The flight instructor immediately made a left turn back to return to the airport and land. The airplane's left wing impacted the ground and the nose landing gear collapsed in soft terrain during the forced landing.

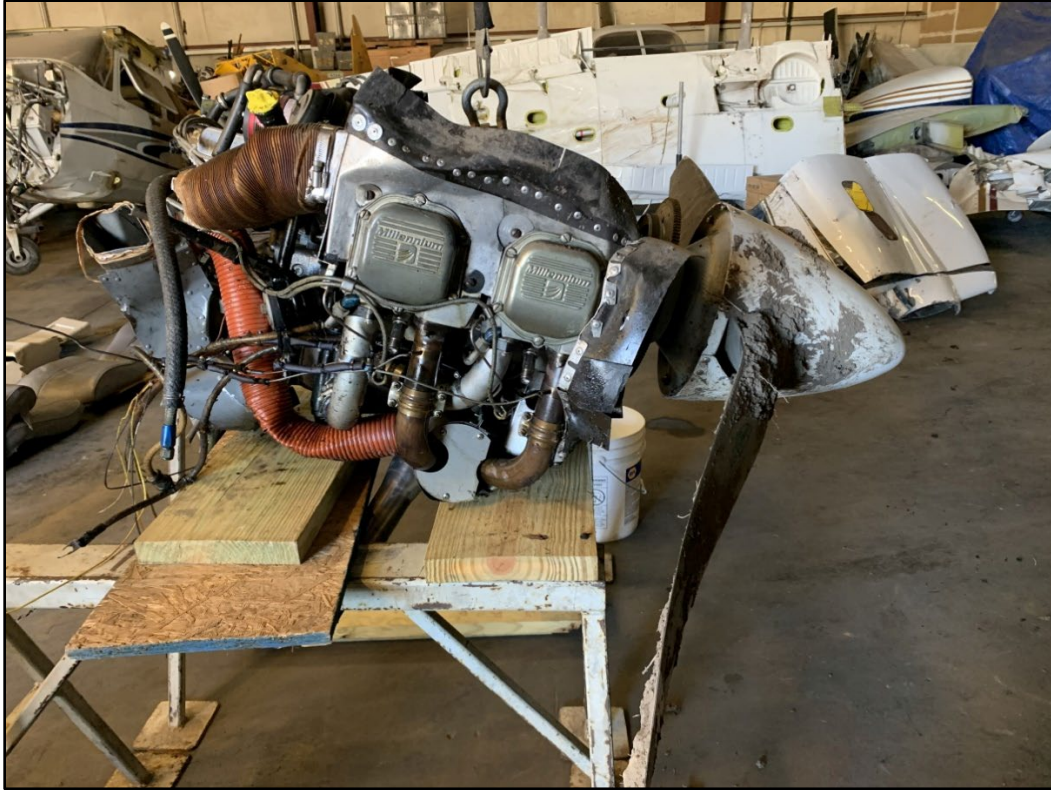
Figure 6 - Engine and Propeller (NTSB Photo)

Upon arrival, the engine and propeller were found separated from the remaining wreckage. The carburetor heat valve position at the time of the accident could not be conclusively determined due to impact damage. Internal engine and valve train continuity were confirmed as the engine crankshaft was rotated, and compression and suction were noted on all cylinders. The mechanical fuel pump and oil pump discharged fuel and oil, respectively, as the crankshaft was rotated. The left magneto, equipped with an impulse coupling, produced spark as the engine crankshaft was rotated. The right magneto was not equipped with an impulse coupling, but it produced spark when removed from the engine and was rotated by hand. The spark plugs exhibited features consistent with normal engine operation. Movement of the throttle arm discharged fuel from the accelerator pump into the carburetor venturi. The carburetor bowl remained intact and contained uncontaminated fuel. There were no anomalies noted with the carburetor. The propeller remained attached to the engine crankshaft flange. Both propeller blades were relatively straight and partially covered in dried mud. Neither propeller blade exhibited any appreciable chordwise burnishing or leading-edge damage. The postaccident engine examination did not reveal any evidence of mechanical malfunction that would have precluded normal operation.
