McLean, 8 July 2021

It was the third takeoff of the day. My non-pilot (but fellow aerospace engineer) friend and I had flown from Manassas, Virginia (KHEF) to Smyrna, Tennessee (KMQY) to pick up another friend to take her to the Outer Banks. Weather forecasted was severe clear with unusually low winds at altitude. Both the flight to Smyrna and the one from Smyrna to Manteo, NC were absolutely uneventful, with our new passenger in the copilot's seat and her 8-month old but 40 pound Golden Retriever puppy peacefully asleep in my friend's lap in the back.

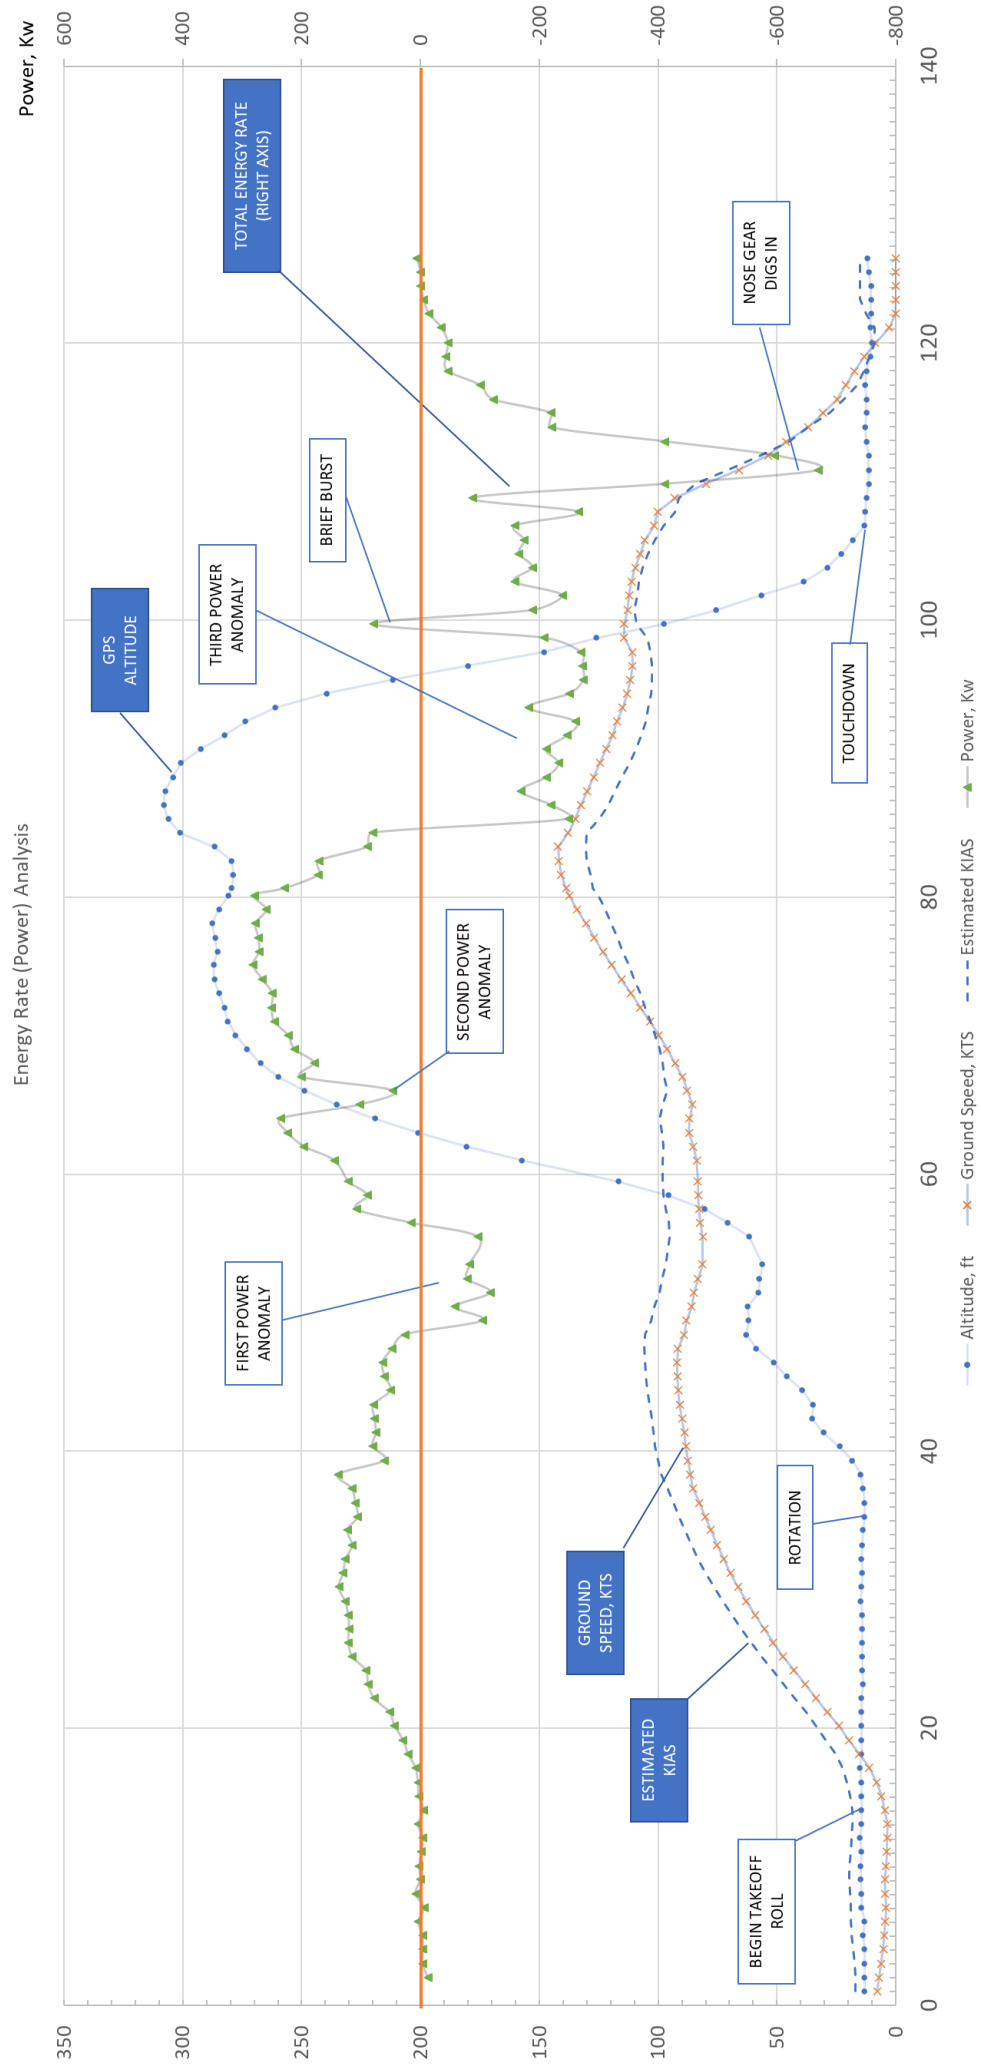
You could tell in the ForeFlight's simple plot when the first power reduction happened because the ground speed all of sudden went from increasing to decreasing. But we were not at 200 feet, the way we remembered it, we were only... FIFTY FEET or so above the runway. That power outage lasted about 8 seconds, during which I did all the throttle, MOR etc. shenanigans. And our altitude during the “downwind” was only 300 feet, not the 500-600 I remembered. Oh, and, by the way, while I remembered very clearly raising the gear, I still don't have any recollection of having LOWERED IT (I

Second Power Failure (3 sec)

Power Returns

First Power Failure

Third Power Failure

Brief Power Burst (3 sec)

Touchdown

Final Location
