From: [Furukawa Robert](#)
To: [munir.mourra](#)
Subject: FW: Phone Conversation of 01-Mar-2023; Question about anchor chain and Sector Miami Dead Ship Tow Plan & reminder to send marine salvage yard receipt - last dry dock report & diver's report
Date: Wednesday, March 22, 2023 11:29 00 AM
Attachments: [image001.png](#)
[image002.png](#)
[3 - Anchor n Mooring Chain - Washington Chain n Supply - 2023-02-27.pdf](#)
Importance: High

Safety Investigator

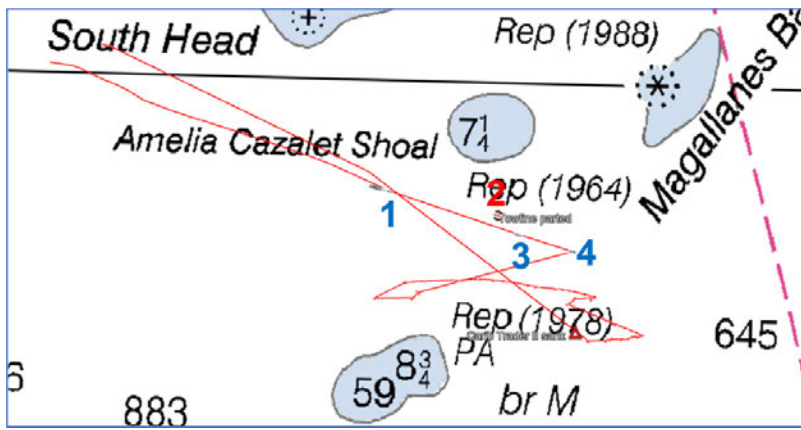
4 posits: #1 AIS, #2 reported posit when towline parted, #3 AIS & #4 AIS.

Capt. Beau reported 3/6/2022 0035 local at 21°55'N 076°15'W (Posit #2) time & posit when towline parted.

USCG NAVCEN sent AIS history report for Capt. Beau on 3/6/2022 beginning at 0137:44Z until 1143:17Z. During the 10hr-06min period, 178 AIS posits were received from the Capt. Beau. (Carib Trader II was deadship/no power – not transmitting an AIS signal).

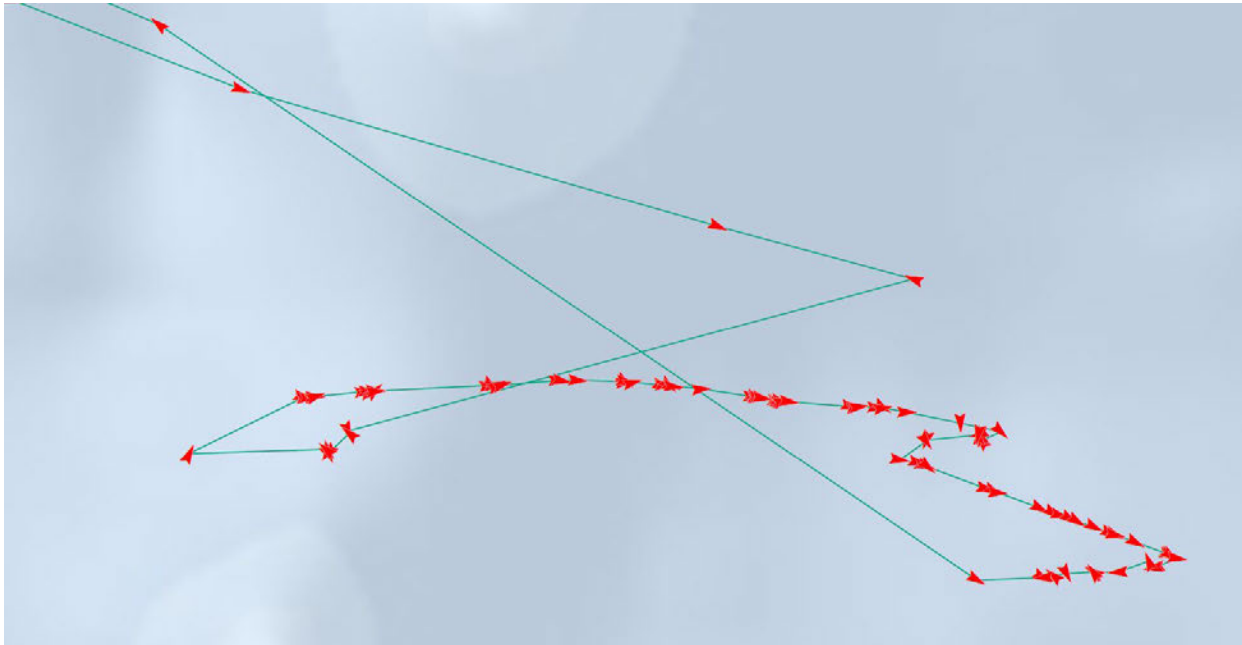
- #1 - 3/6/2022 0447:09Z (3/5 at 2347 EST), last AIS posit prior to reported time of towline parting, COG 108.3° SOG 3.4kt
- #2 - 3/6/2022 at 0535Z (3/6 at 0035 EST), time Capt. Beau reported on CG2692, the towline parted.
- #3 - 3/6/2022 0557:14Z (3/6 at 0057 EST), first AIS posit after reported time of towline parting, COG 112.7° SOG 4 6kt
- #4 - 3/6/2022 0641:45Z (3/6 0141 EST), next AIS posit, COG 290.5° SOG 0.7kt

Q: Why is COG & SOG at Position #3 is like COG & SOG at Position #1?

- If tow was lost at 0035, Capt. Beau could not turn around to chase the tow with towline trailing in the water.
- Capt Beau recover towline first – slowed speed & stayed on same course to recover towline while tow drifted to the west.

Q: COG & SOG at Position #4 is significantly different from COG & SOG at Positions #1 and #3.

- Capt Beau was recovering the last part of the towline around Position #4 and was turning to head toward the Carib Trader II, which had drifted to the west, to recover the tow.

The loop to the west must be the Capt Beau approaching and going along side the Carib Trader II to reestablish control.
The tow was recovered at 0400 [log book]

The many positions tracking to the west would be the Capt Beau towing Carib Trader II under bare steerage.
