National Transportation Safety Board

RRD22LR008

OPERATIONS

Group Chair's Factual Report

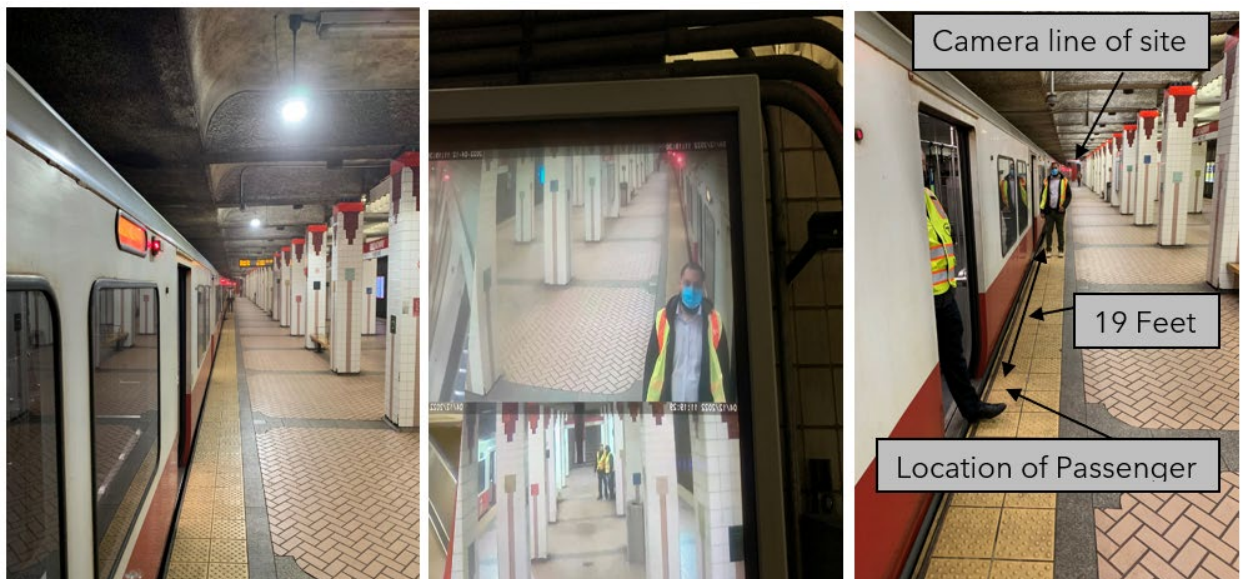
On April 12, 2022, the investigative team traveled on an exemplar Red line train (same 1500 Series) from JFK to Broadway station to conduct a reenactment/sight distance analysis. MBTA Transit Police cleared and closed the station to prevent observations. During the sight distance analysis/ partial reenactment, investigators conducted line-of-sight observations from the operator's cab window to recreate the view of operator at the platform during a station stop. A member of the investigative team stood with their foot out of the car door and reenacted the passenger's positioning as they exited the E doorway. An investigative team member wearing black shoes placed their foot just beyond the entrance of the E doorway on the yellow strip. It was approximately 105 feet from the operator's cab window to the E doorway. The line of sight from the operator's cab window to the E doorway was not obstructed and the door involved was not on a curve. During the site distance test, another investigator walked 19 feet away towards the rear of the train before they came into view on the SPTO monitor, therefore, revealing a 19-foot blind spot. As a result, of the testing it was determined that the SPTO monitor did not capture the passenger exiting the train at the E doorway.

Figure 2: Photos taken during the site distance test conducted at the Broadway station. Note: The photo on the left depicts the view from the operators cab with train stopped at the 6-car spot. The photo in middle shows the images displayed on the SPTO monitor. The image on the right shows the blind spot identified.
