# National Transportation Safety Board

RRD22LR012

## **SECURITY CAMERA AND ONBOARD VIDEO RECORDER**

Location: Chicago, Illinois  
Date: July 16, 2022  
Time: 01:50 a.m. central daylight time (CDT)  
Vehicle: Chicago Transit Authority (CTA) train #435

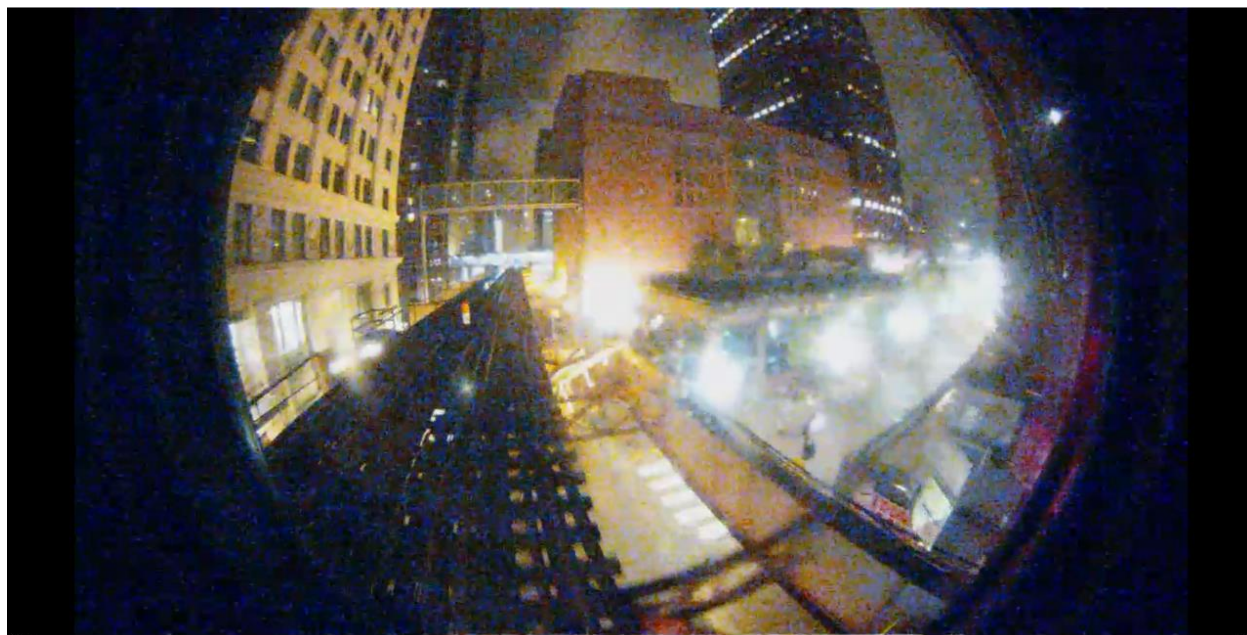
**Figure 1.** A screenshot shows the view of the onboard outward-facing video file.

00:20 - The accident train struck the CTA employee. Prior to the impact, the CTA employee was visible to the camera lying on the rail track without any movement.

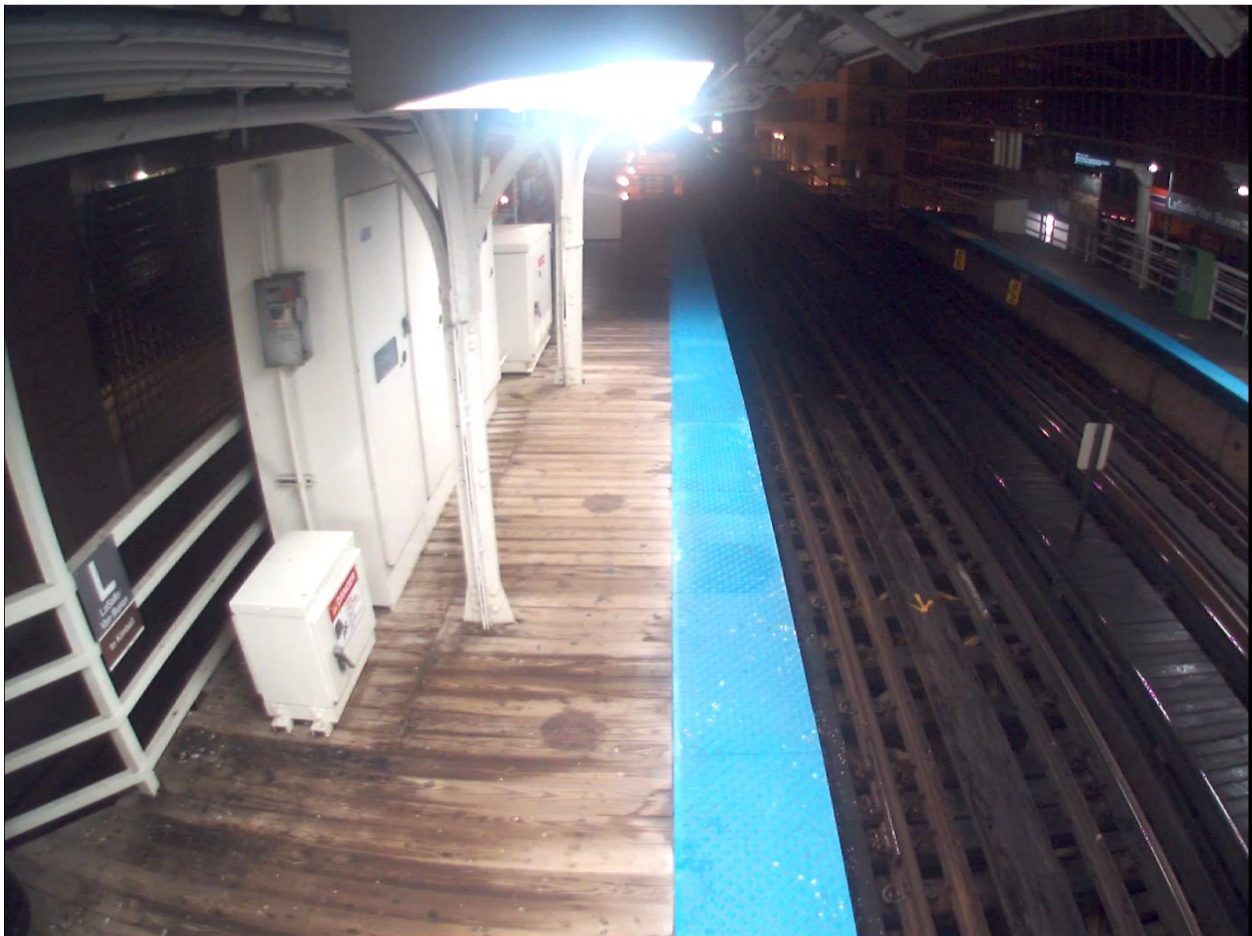
**Figure 2.** A screenshot shows the view of the security video file #1.

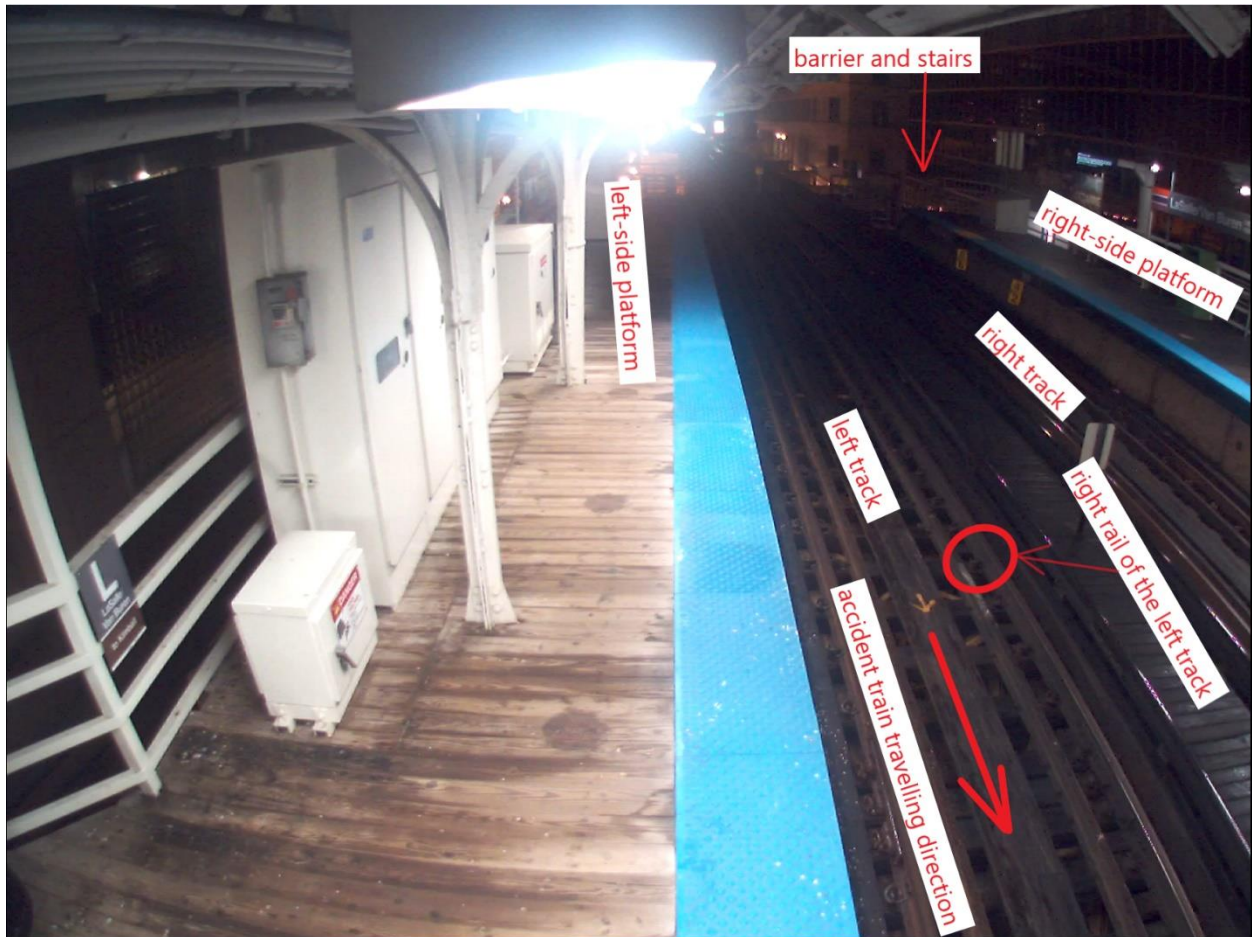
**Figure 3.** A screenshot of the view of the security video file #1 with labels.

11:44 - The struck CTA employee came into view on the right-side platform (refer to figure 3). The CTA employee was wearing an orange and yellow safety vest.

11:45 ~ 14:30 - The CTA employee walked on the platform toward a barrier, then crossed the barrier and walked down stairs to the rail tracks. The CTA employee attempted to cross the tracks towards the left-side platform. As the CTA employee nearly crossed the right track, the CTA employee fell. Then as the CTA employee slowly crawled onto the right rail of the left track, the CTA employee fell onto the rail abruptly. The CTA employees body went motionless as he fell. The CTA employee continued to be motionless in that position.

17:23 - The accident train struck the CTA employee. Prior to the impact, there were no motion detected from the CTA employee after the CTA employee fell onto the rail as described above.
