National Transportation Safety Board

ANC22FA018

COCKPIT VOICE RECORDER

Specialist's Factual Report

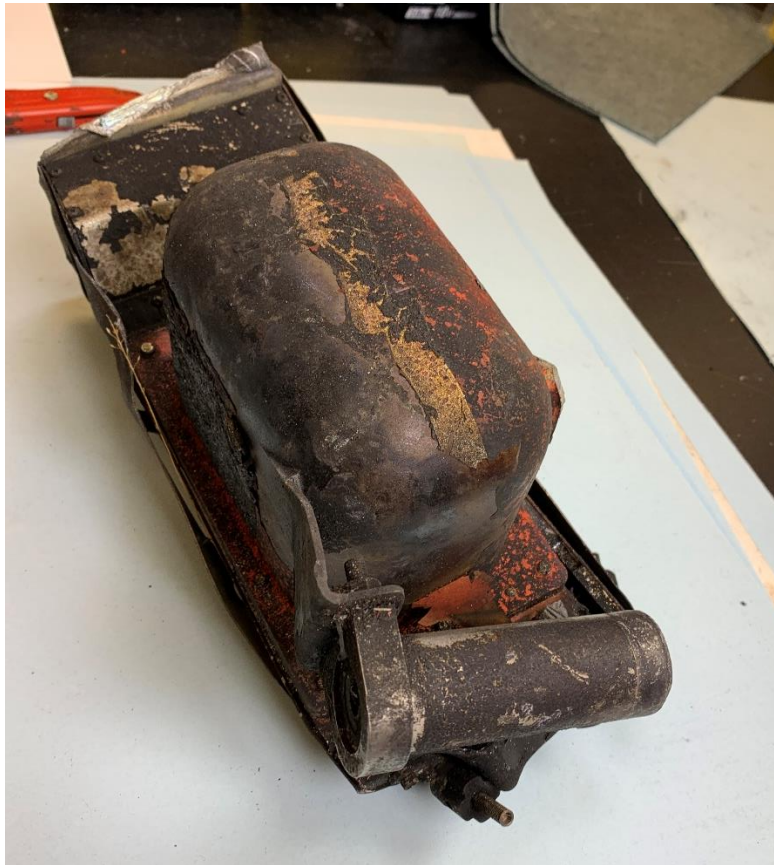
Upon arrival at the laboratory, it was evident that the exterior of the CVR had sustained heat and structural damage. The outer case was removed, and the interior crash-protected case did not appear to have any heat or structural damage (see figures 1 and 2). The memory board within the crash-protected case was checked for heat or structural damage, and none was found. The digital audio was successfully downloaded from the crash-survivable memory unit using a surrogate.

Figure 1. Exterior of the Universal CVR-30B, as received.

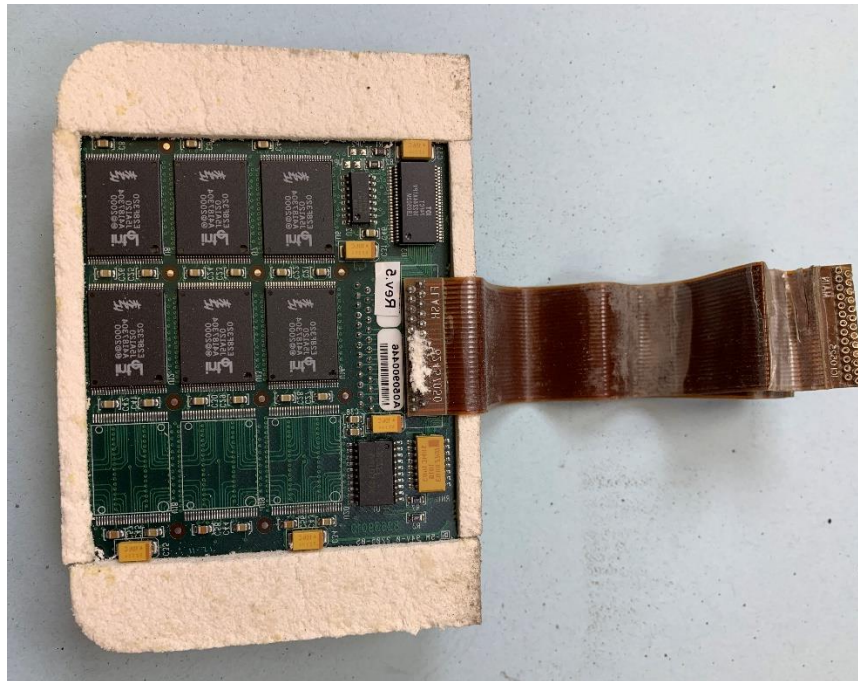
Figure 2. Memory board, removed from the crash survivable memory unit (CSMU).
