# National Transportation Safety Board

ANC21LA006

## **SYSTEMS**

Group Chair's Factual Report

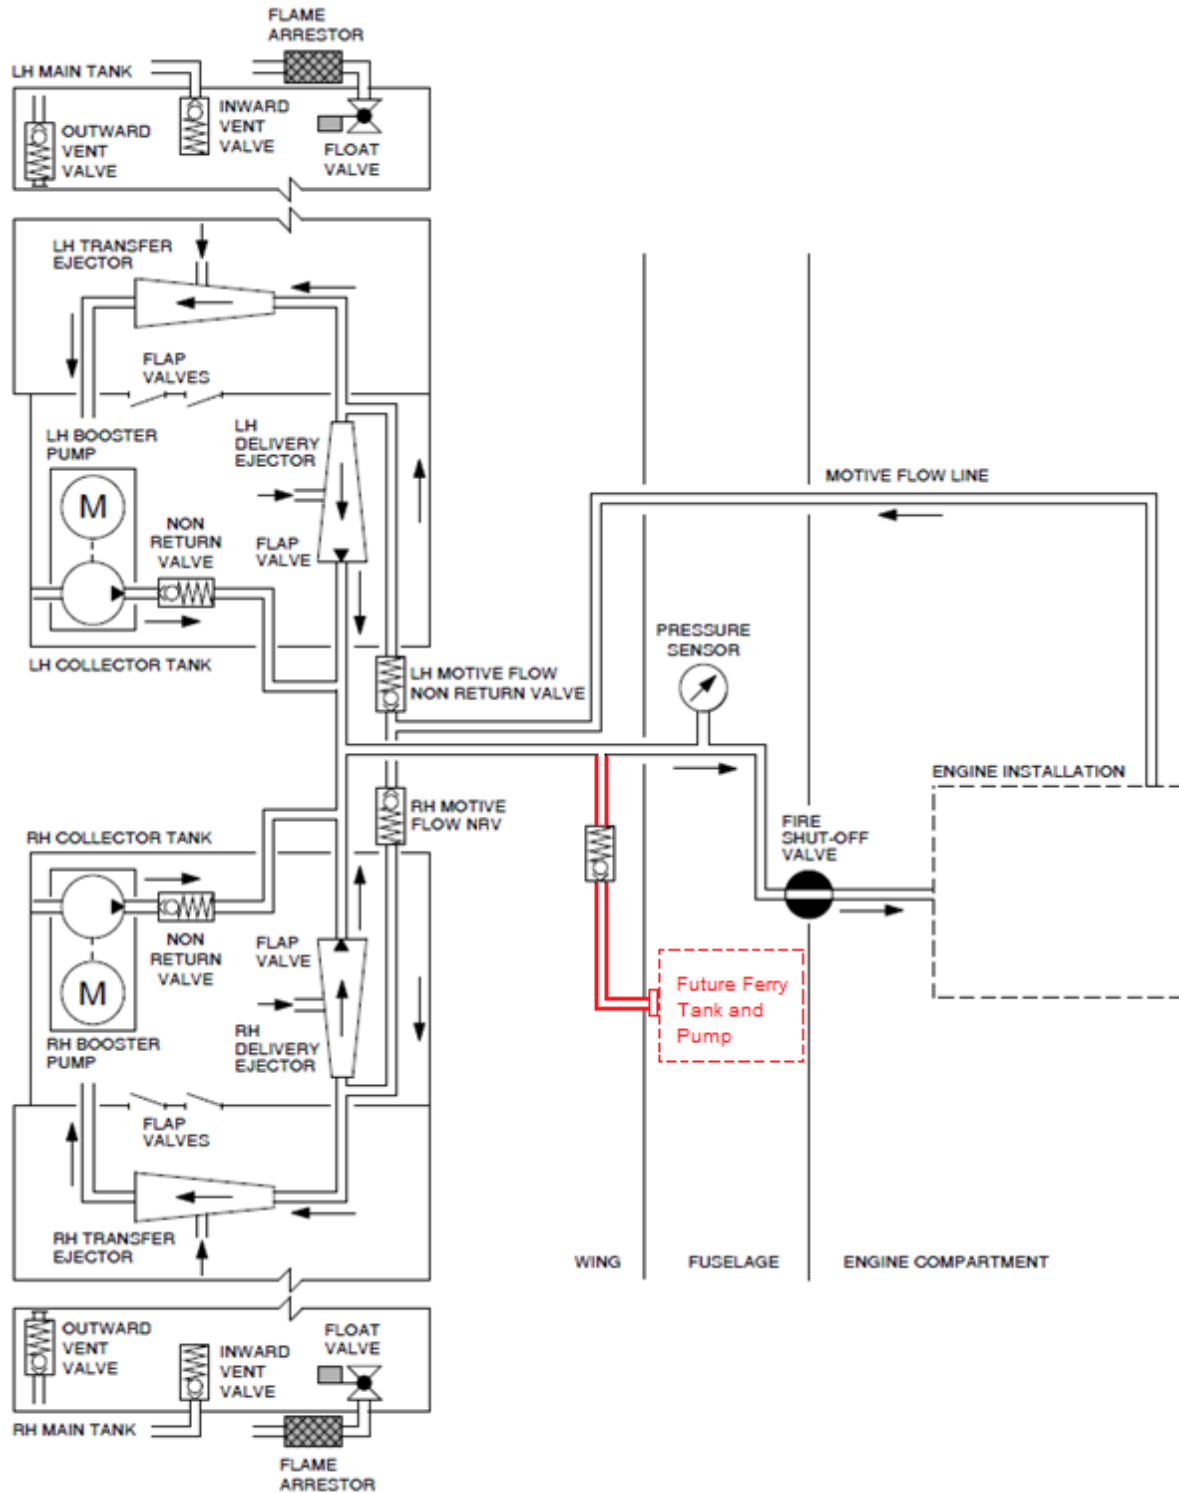
**Figure 3.** Fuel distribution and vent system schematic with ferry system provisions shown. (Courtesy of Pilatus)

The ferry fuel system provisions were designed and installed by Pilatus Business Aircraft, LTD<sup>1</sup> on June 9, 2020, as a major alteration per FAA Form 337. The fuel system was modified by installing a tee fitting (PN AN824-10D), check valve (PN 869A-10TT), fuel line assemblies (PN 2X-2000-30-0002), a fuel line bracket (PN 2X-2000-32-0003) in the left wing in accordance with Pilatus Business Aircraft, LTD drawings 2X-2000-30-0003 and 12-1305-32-0005, and a fitting elbow feed through (PN AN837-10D) in accordance with Pilatus Business Aircraft, LTD drawings 2X-2000-30-0002 and 2X-2000-30-0003 and document 2X-2000-61-0000. The fitting through the fuselage was capped and the fuel lines leak checked. A schematic of the provisions is shown in Figure 3.

The Pilatus Business Aircraft, LTD Form 337 that installed the ferry system provisions stated, "Ferry tank installations should ensure that no air is introduced into the fuel system.". This model PC-12 did not have an air-separator in the engine fuel feed line.

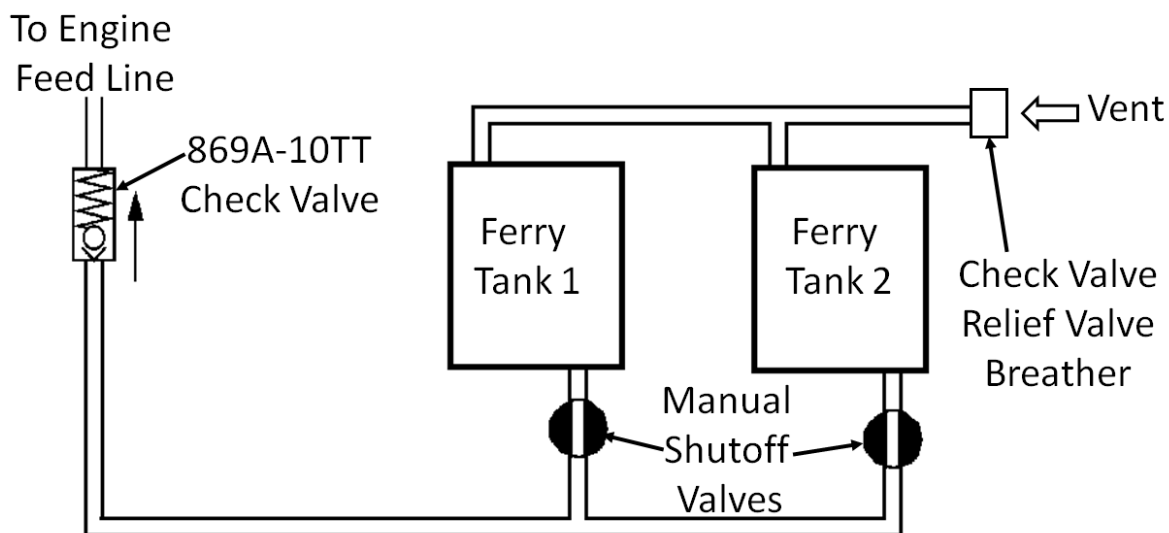
**Figure 4.** Schematic of ferry fuel system installed on 28 October 2020. (Created by NTSB)

October 28, 2020, Flight Contract Services, Inc. modified the aircraft fuel system by installing two auxiliary aluminum 120 gallon ferry fuel tanks in the cabin. The tanks included fuel level sight gages. The number one tank was located at station 255 and was limited to 100 gallons and the number two tank was located at station 275 and was limited to 60 gallons. The tanks were vented to the cabin. The breather vent contained a 0.5 psi check valve and a 3.5 psi relief valve. It would take a 0.5 psi pressure difference to vent to the tank. If the tanks over pressurized to +3.5 psi, the relief valve would let air out. The emergency backup for the breather vent was to loosen the fuel caps. The tanks were electrically grounded and mounted on ½ inch plywood pallets. Pallets were secured with four 2,000 pound straps to eight points of the cargo tie down rings located in the existing seat rails. The ferry fuel system was connected to the existing post-production installed AN837-10D bulkhead fitting in the left-wing root area. See Figure 4. The ½ inch, FLEXTRAL J3-8 fuel line, connected the fuel tanks to a ½ inch on/off in-line ball valve for each tank, then to the fuselage bulkhead fitting and through a one-way check valve to the main fuel supply line.

The FAA Form 337 submitted by Pilatus Business Aircraft, LTD for the ferry system provisions described in section 2.0, states "The ferry tank provisions feed directly into the engine's fuel supply line.". In addition, the drawings and schematics showed the ferry system connected directly to the engine's fuel supply line. The FAA Form 337 submitted by Flight Contract Services, Inc. for the ferry system installation described in section 3.0, states "The ferry fuel feed is directly to the left main tank."

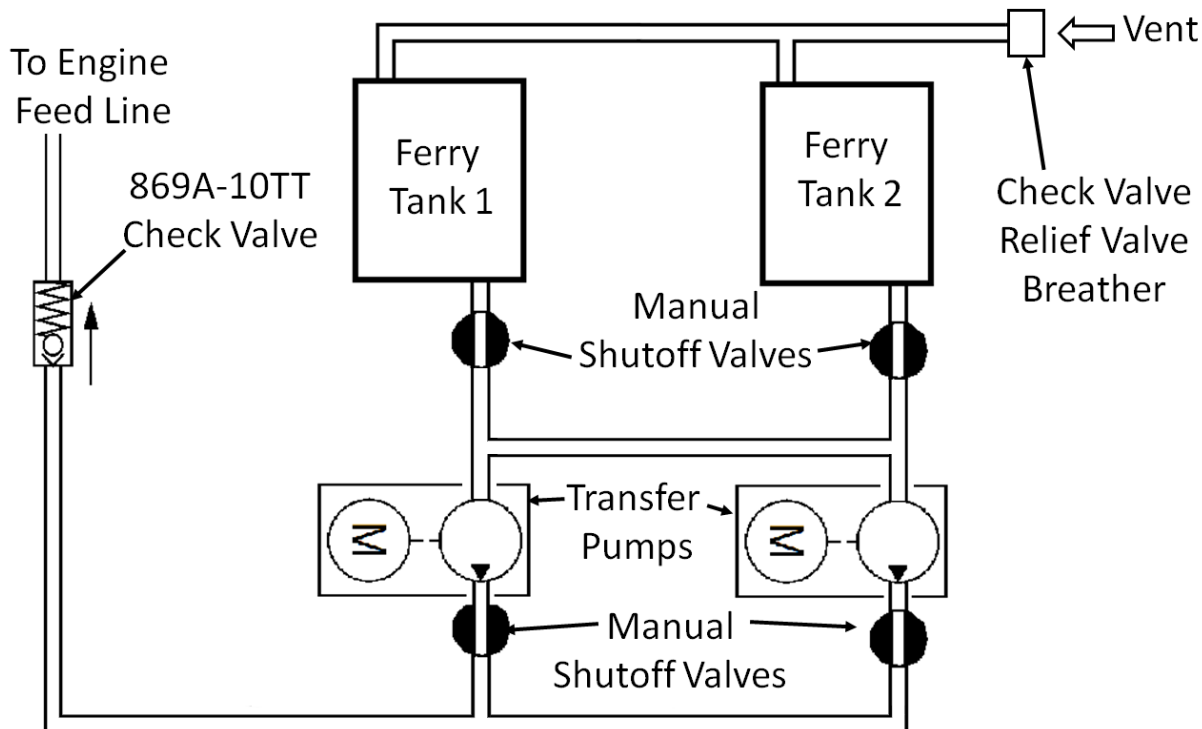
**Figure 5.** Schematic of ferry fuel system as modified on 05 November 2020. (Created by NTSB)

During a positioning flight on 01 November 2020 and an attempted ferry flight on 02 November 2020, the ferry fuel system would not transfer any fuel from the ferry tanks. Between 02 and 05 November 2020, Gateway Air Center along with assistance from Flight Contract Services further modified the ferry fuel system by installing two FASD08100G<sup>2</sup> pumps to provide enough fuel pressure to overcome the delivery ejector pump pressure and supply fuel to the engine fuel supply line. The pumps were installed so that either pump could transfer fuel from either ferry tank. See Figures 5 and 6.

Neither a new nor revised Form 337 was produced to document the installation of the ferry system pumps. The installation and operation of the ferry system changed the operating characteristics of the production fuel delivery system. No testing or evaluation was completed on how the ferry system would impact the expected system operation.

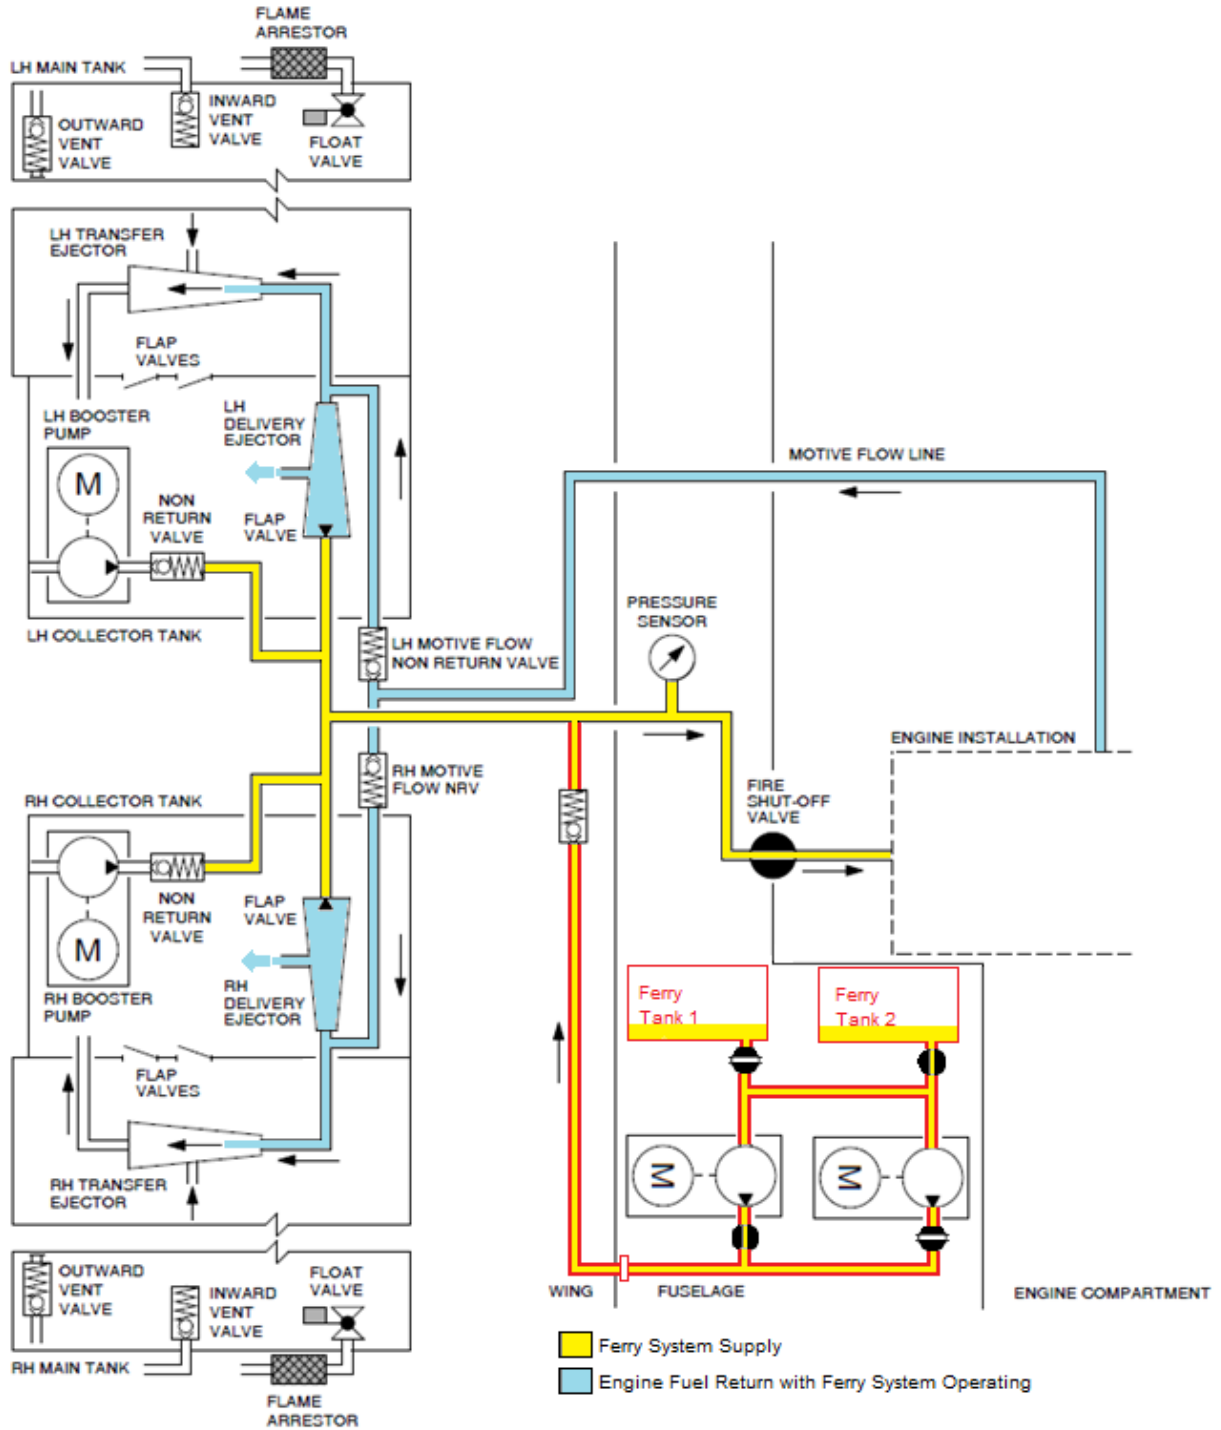
**Figure 7.** Schematic showing ferry system operation. Note: Source was Figure 3 and then modified by NTSB.

The ferry fuel system moves fuel to the engine feed line from ferry tanks through the 869A-10TT check valve. The ferry system transfer pump provides fuel at a higher pressure than the delivery ejector pumps which results in the closing of the flap valve in the delivery ejector pumps. The ferry system provides fuel to the engine. The excess fuel is then returned to the wing tanks through the motive flow circuit. The left and right transfer ejector pumps would operate as normal (transferring fuel to their respective collector tank). The motive flow fuel going to the delivery ejector pumps would flow out the pump inlet because the flap valve is closed. The ferry system flow rate would be what the engine burns plus the motive flow. The motive flow would be what refills the wing tanks. See Figure 7.

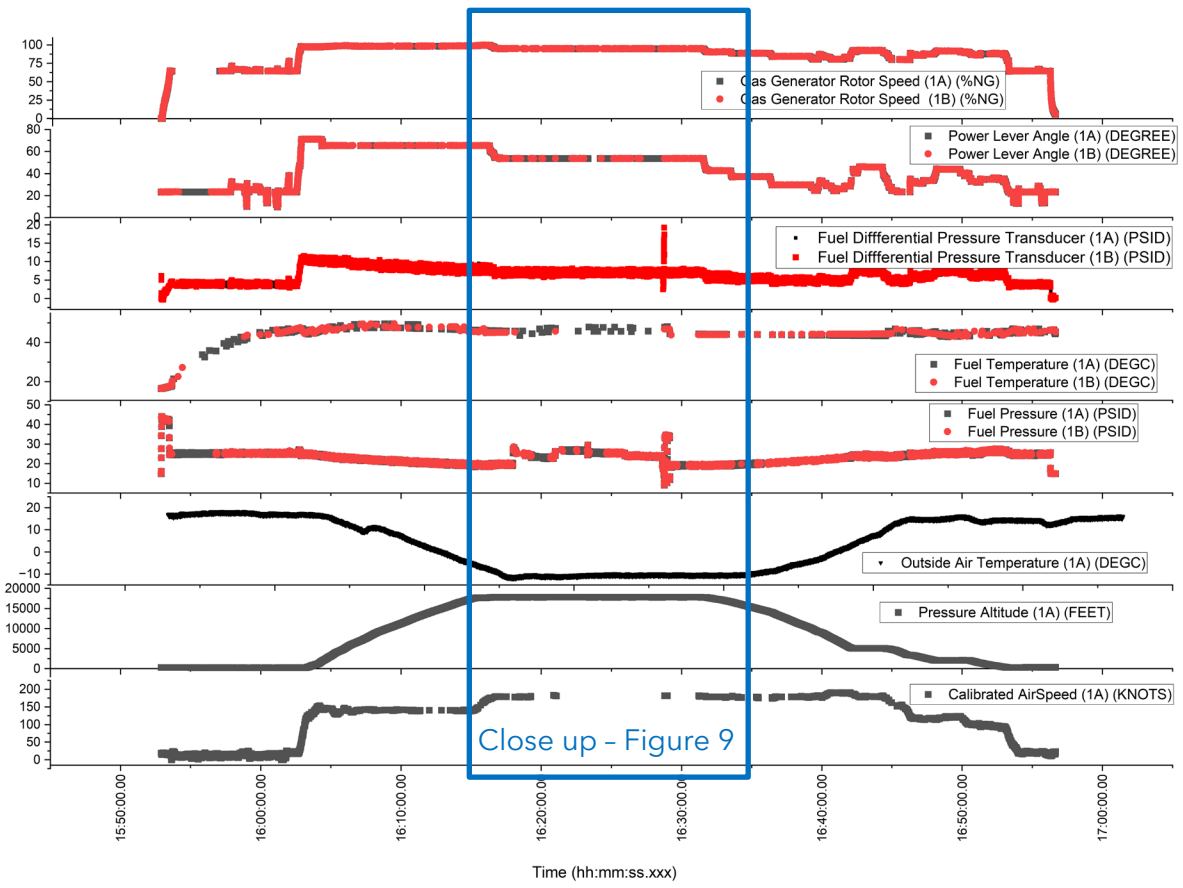
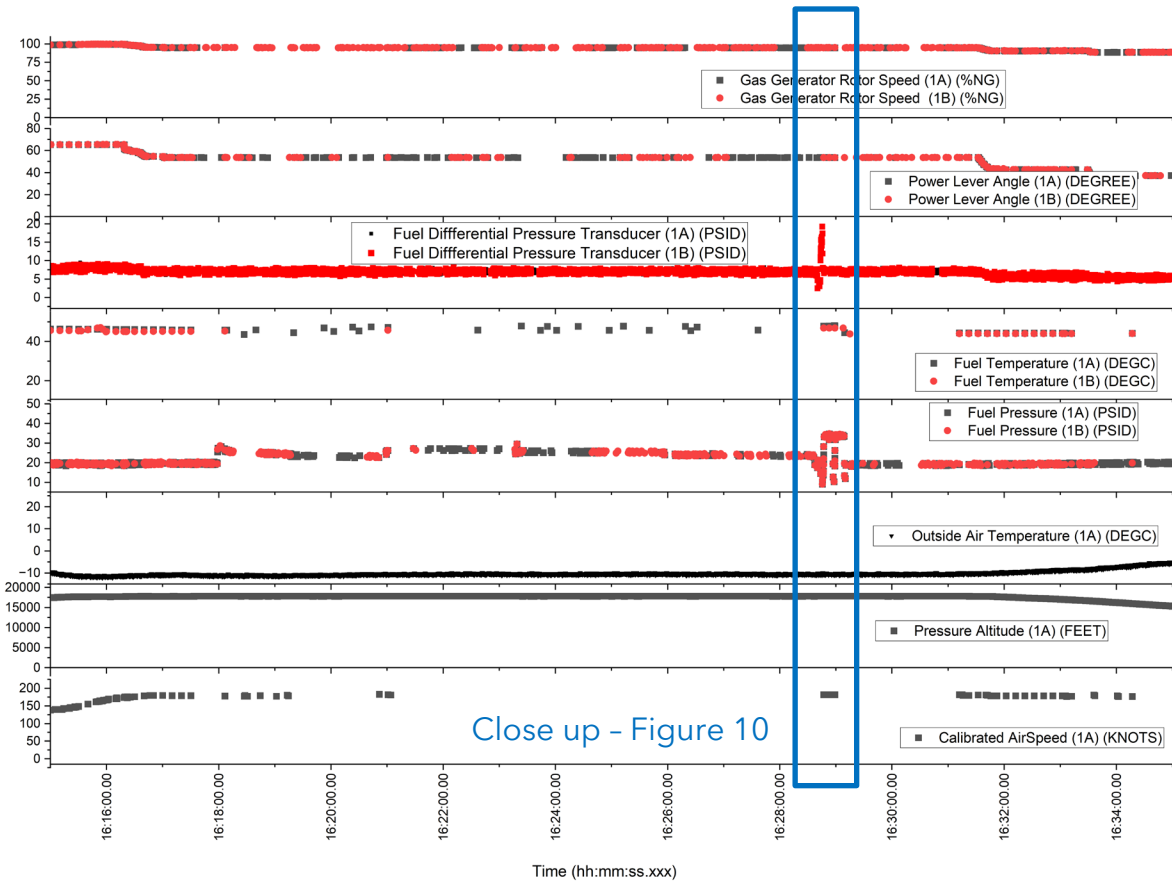
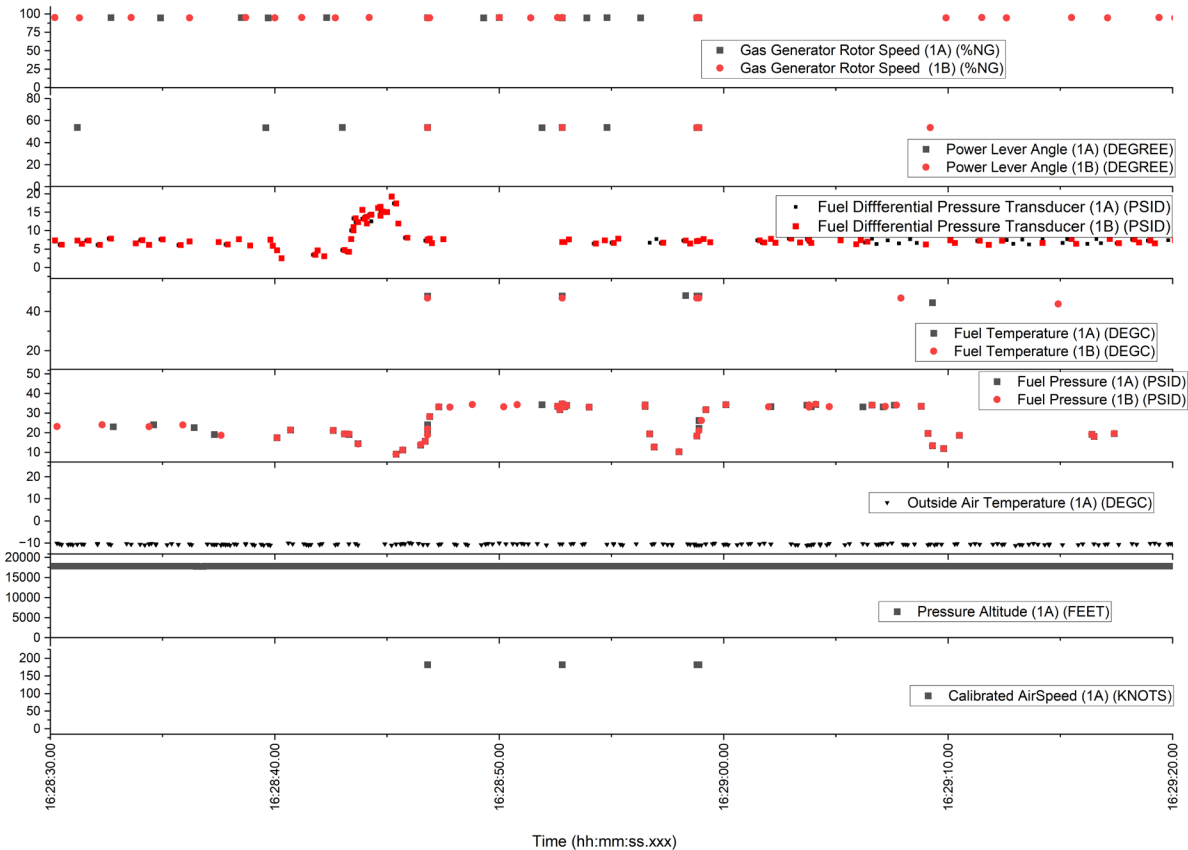
On the morning of 06 November 2020, the aircraft was flown from Merced Airport (KMCE) to Santa Maria Airport (KSMX). The ferry fuel system was operated and successfully transferred fuel to the aircraft fuel system. After switching off the ferry system transfer pump(s), the aircraft experienced a low fuel pressure condition at the same time as the fuel differential pressure increased. Twice the aircraft boost pumps cycled ON for 10 seconds before the fuel pressure returned to motive flow fuel pressure. See Figures 8-10. Neither pilot mentioned the cycling of the boost pumps in their statements. The fuel temperatures at the high pressure pump inlet remained above 40°C during the ferry system operation. The fuel temperatures upstream of the firewall shutoff valve was not measured.
