## Crane Fire on board Barge *Kokosing V*

On October 4, 2022, about 2230 local time, the spud barge *Kokosing V* was dredging the James River near Newport News, Virginia, when the dredging crane on board the barge caught fire.<sup>1</sup> The four crewmembers fought the fire unsuccessfully and abandoned the barge to the accompanying tug, *Justin*. Crews from responding fireboats extinguished the fire later that evening. There were no injuries. The barge and crane held fuel and hydraulic fluid, but no sheen was reported. Damage to the crane was estimated at \$1.4 million.

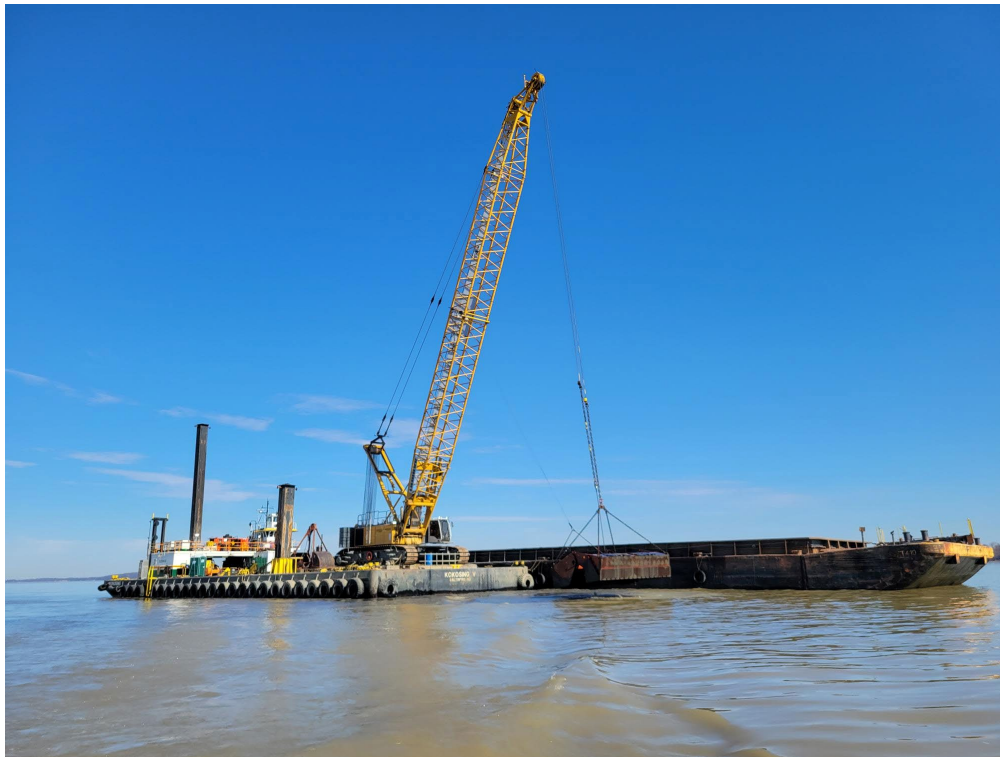
**Figure 1.** The barge *Kokosing V*, with crane. (Source: Kokosing Industrial)

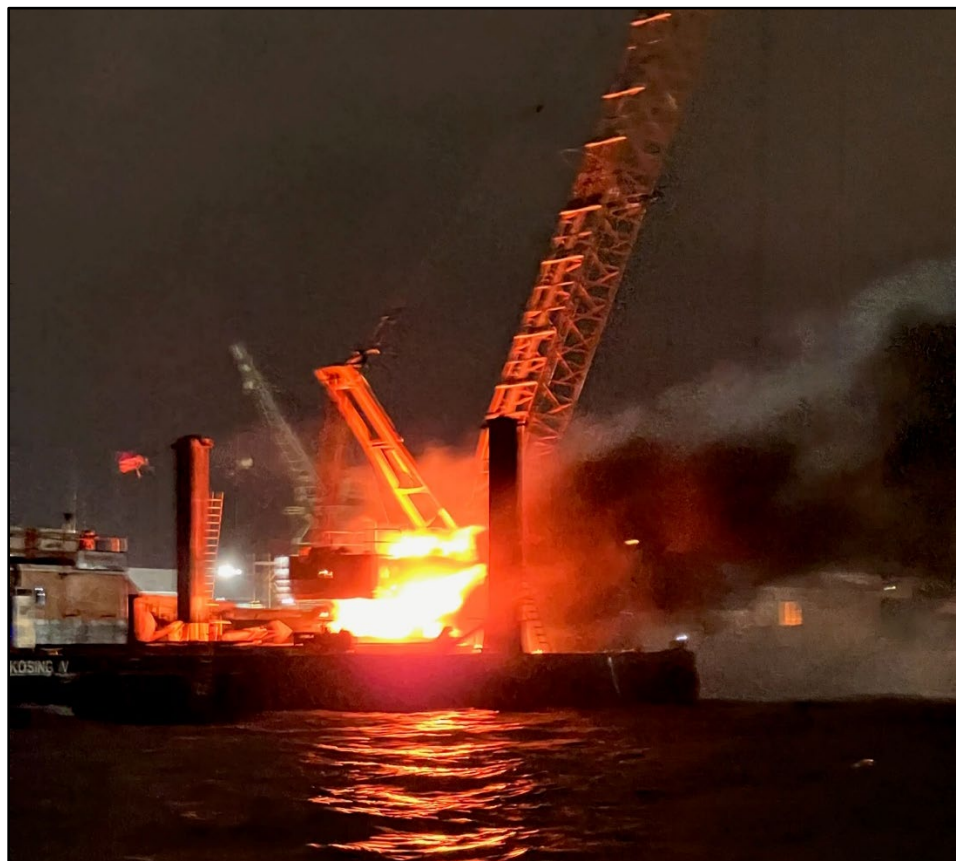
Eleven days later, about 2230 on October 4, the barge was dredging about 75 yards off the shipyard, with the tug *Justin* still nearby, when the foreman stepped out of his office on board the barge and saw a burning liquid fire dripping from underneath the crane. He signaled the crane operator to stop work and exit the crane cab. The crew discharged several extinguishers on the fire without effect. They also

**Figure 4.** The *Kokosing V's* crane ablaze about 2240. (Source: Coast Guard)

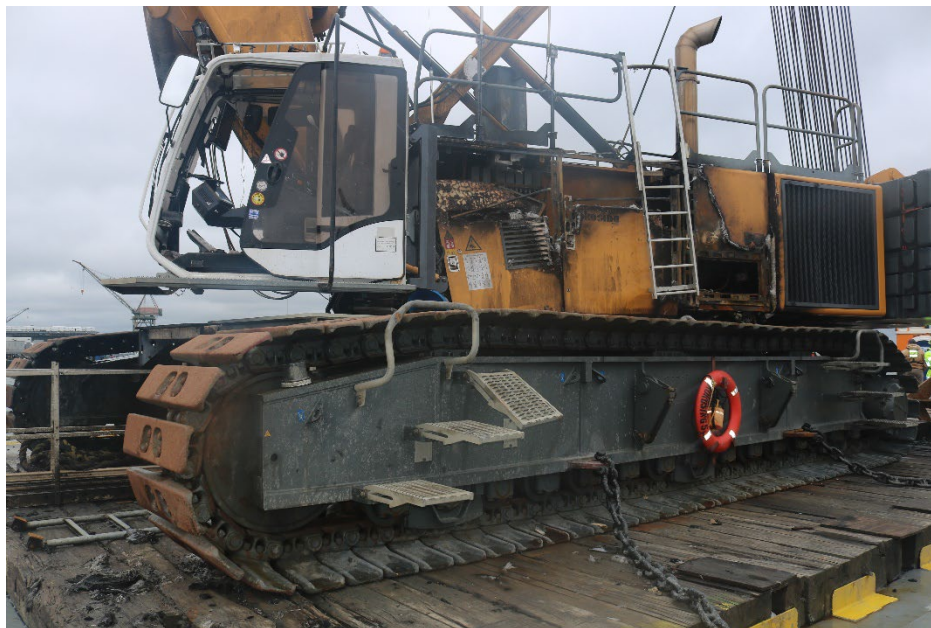
Investigators from the barge’s insurance company found significant smoke and heat damage to the crane’s underside and rear sections. They reported fire and burn patterns that were directional toward the right side of the crane near the fuel, hydraulic lines, and exhaust system.

The crane, valued at \$1.4 million, was a total loss. The *Kokosing V*’s wooden deck mat was also destroyed, and subsequently replaced.

**Figure 5.** The damaged crane postfire. (Source: Coast Guard)

Investigators could not rule out a hydraulic or fuel leak as a cause of the fire. However, the crane's battery compartment, located behind the driver compartment on the left side of the crane, was destroyed, and fire patterns indicated that the fire spread from the left side under the crane. There were no signs of fire around the crane's engine. Further, fire marshals also documented electrical "beading and fusing," indicating arc damage on the electrical cables under the crane. Therefore, it is likely that the fire originated in the crane's battery compartment and was electrical in nature. Potential ignition sources within the battery compartment include loose electrical connections and chaffed or damaged wiring. The extensive damage to the compartment precluded examination of components, and therefore the ignition source could not be determined.

The National Transportation Safety Board determines that the probable cause of the crane fire on board the spud barge *Kokosing V* was an undetermined electrical ignition source in the crane's battery compartment.
