National Transportation Safety Board

CEN23FA071

Group Chair's Factual Report

Location: Galliano, Louisiana
Date: December 29, 2022
Time: 0834 central standard time
Helicopter: Bell 407, registration N595RL

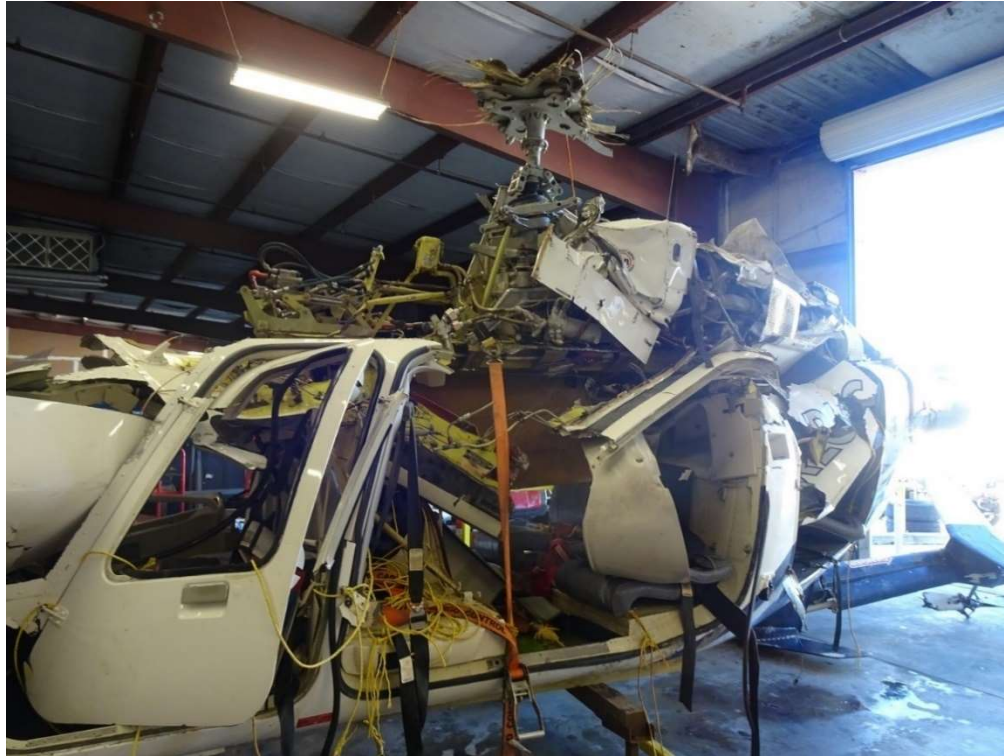
The main fuselage was recovered as a single piece except for the landing gear, which had separated from the main fuselage (**Figure 1**). The main beam was present and attached to the control column (broom closet), but the broom closet was fractured and partially separated near its upper end. The tail boom had fractured and separated near its forward end, about a foot aft of the tail boom attachment point. The left cockpit door remained installed, but its frame was partially detached from the airframe. The right cockpit door was not present. None of the windows in the cockpit were present.

Figure 1. The recovered main fuselage.

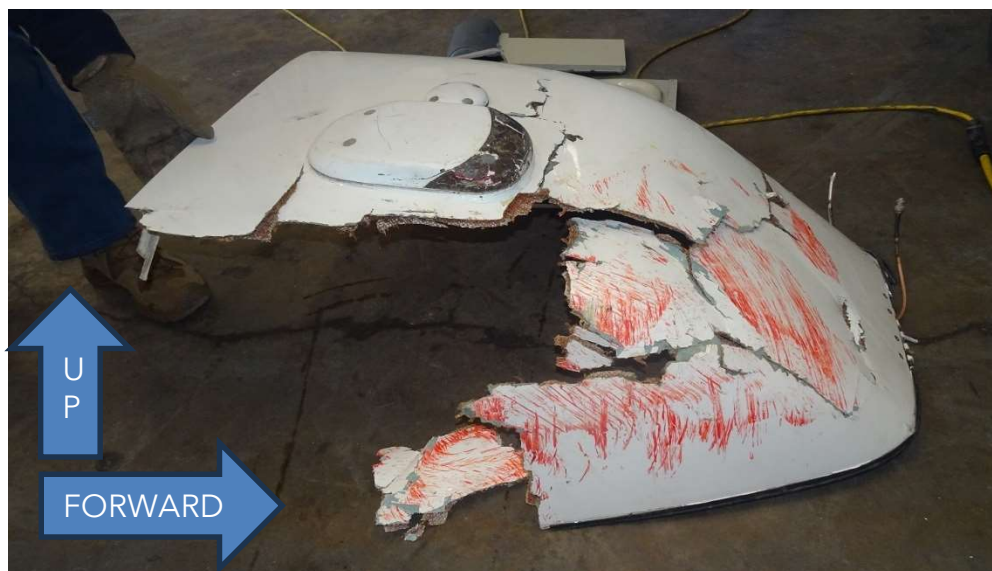
The forward upper cowling, covering the main rotor servo actuators, had fractured into multiple pieces and was retained with the airframe via wire bundles. Significant areas of red paint transfer markings were observed on the forward upper cowling (**Figure 2**). Red paint transfer was also observed on the upper-right side of the airframe near the forward-upper corner of the right cabin door. The roof shell assembly was present but crushed and partially separated at the upper portion of the left-side cabin door frame and the forward and aft upper-corners of the right-side cabin door frame. In the intermediate fuselage, the deck between the engine pan and the baggage compartment had deformed downward (into the baggage compartment). The engine cowlings were present but exhibited deformation.

Figure 2. The forward upper cowling exhibiting red paint transfer.

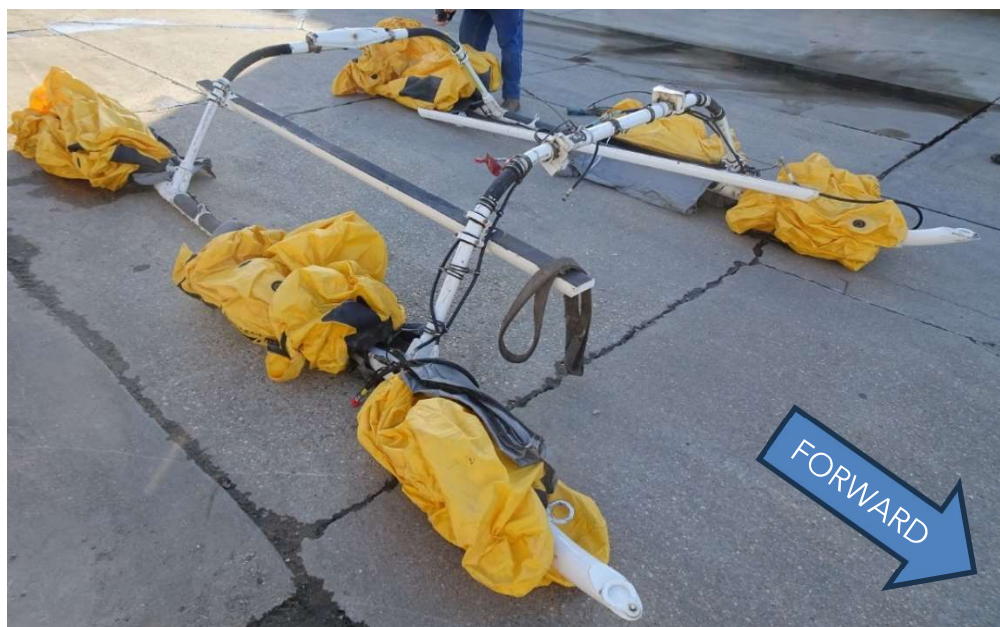
The high-skid landing gear had separated from the main fuselage due to fractures on all four saddle mounts (**Figure 2**). The forward-left mount plate had fractured with three of the four bolts still installed with remnants of the mount plate attached. The fourth bolt had fractured with remnants of the bolt still within the bolt hole. The forward-right mount plate was present, and its four bolts remained installed, but the plate had fractured where it mounts to the landing gear. A portion of the aft-left mount plate remained installed with four bolts, but the aft portion of this plate had fractured and separated along with its two aft bolts. The aft-right mount remained installed on the fuselage but had fractured at the mount.

Figure 2. The recovered landing gear and floats.

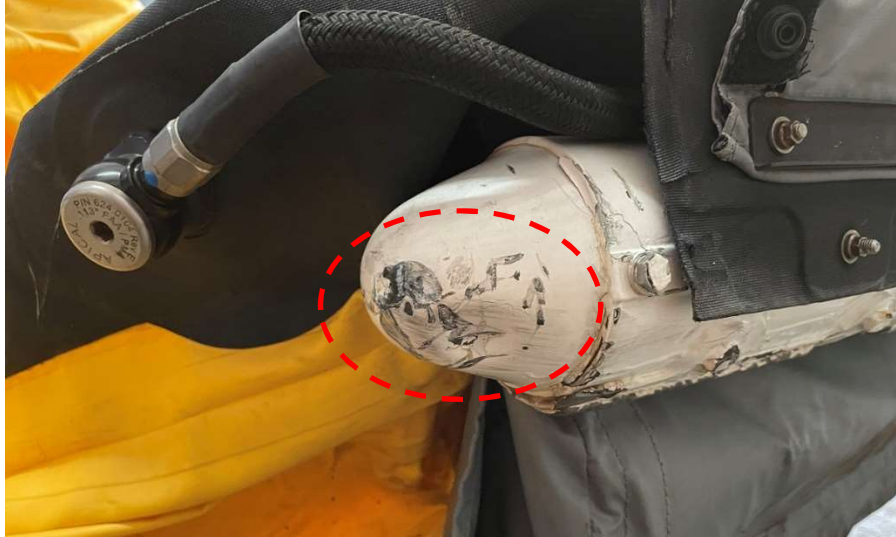
The forward and aft crosstubes did not exhibit significant deformation. The two forward mounts remained attached to the forward crosstube. The two aft mounts were not present on the aft crosstube, but the pivot plate, located at the center of the aft crosstube, remained installed. The left skid was generally [longitudinally] straight but exhibited impact deformation where the left skid is attached to the aft crosstube. The right skid toe (forward) section was laterally bent outboard while the right skid heel (aft) section was laterally bent inboard. The conical end cap of the right skid had impact damage (**Figure 3**). No other significant impact damage was observed on the remainder of the left and right landing skids.

Figure 3. Damage to the conical end cap on the aft end of the right landing skid.

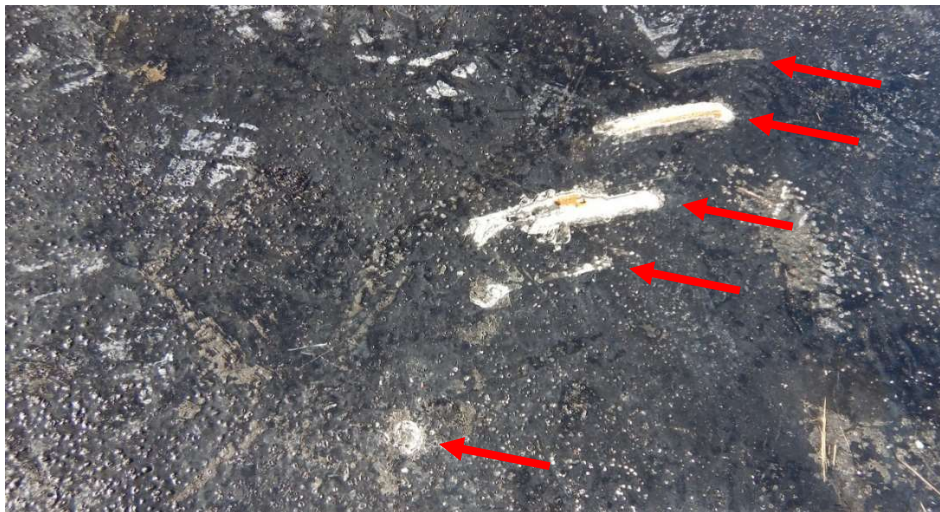
Two distinct groups of impact marks were present on the accident helipad. One group of impact marks exhibited an arc-like appearance (**Figure 4**). The second group of impact marks exhibited a linear appearance (**Figure 5**). The spacing of these arc and linear impact marks were consistent with the spacing of the bolt heads on the right skid that attach the skid shoe to the skid starting at the forward crosstube (**Figure 6**). The white-colored paint on these skid shoe bolt heads was not present, but white-colored paint was present on adjacent bolt heads.

Figure 4. A group of impact marks on the helipad with an arc-like appearance.

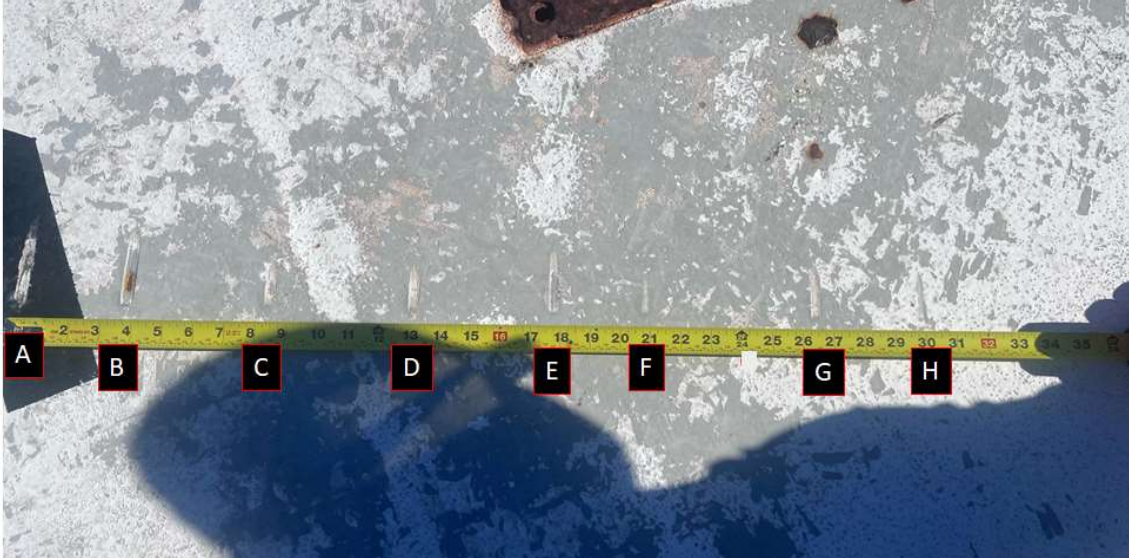
Figure 5. A group of impact marks on the helipad with a linear appearance.

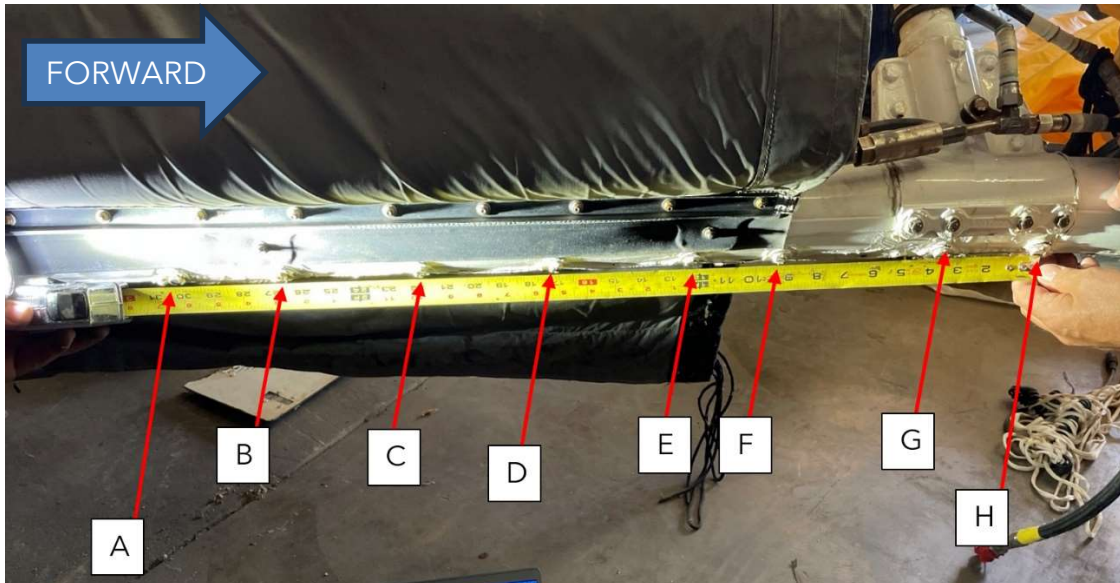
Figure 6. Damage seen on the bolt heads on the right skid.

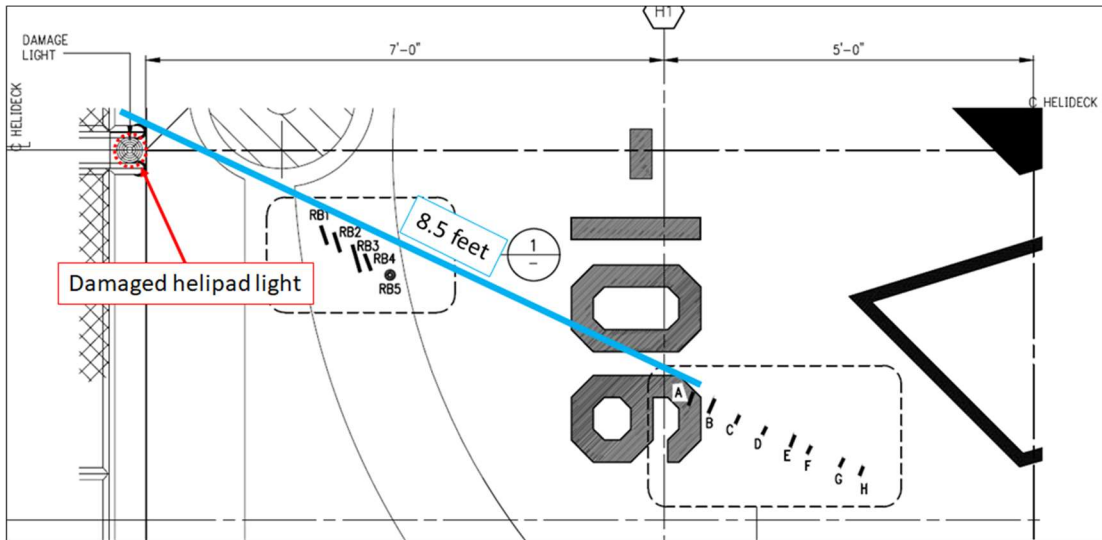
The distance from the aft end of the right skid to the skid shoe bolt head that matched impact mark "A" (from Figure 6) was about 104.5 inches, or about 8.5 feet. Based on this distance and the platform dimensions provided by the platform operator, the aft end of the right skid (the conical end cap) would overlap with the blue-colored light near the northwestern edge of the helipad and whose light housing exhibited impact deformation and its blue-colored glass globe was shattered (**Figures 8, 9, and 10**).

Figure 8. A diagram of the distance between impact mark "A" and the damaged blue-colored light on the helipad. (Image courtesy of Walter Oil and edited by the NTSB)

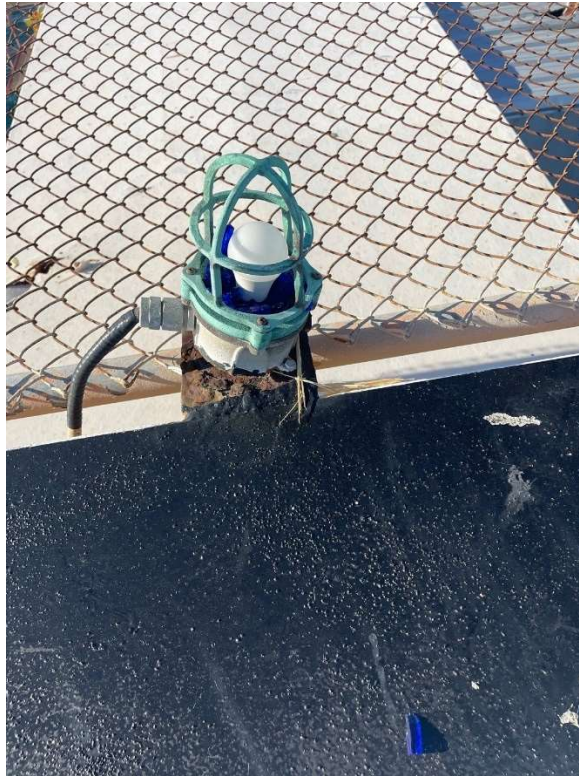
Figure 9. The damaged blue-colored light found at the helipad. The platform operator stated they had cut the light housing's installation bolts to facilitate its removal from the helipad. (Image courtesy of Walter Oil)

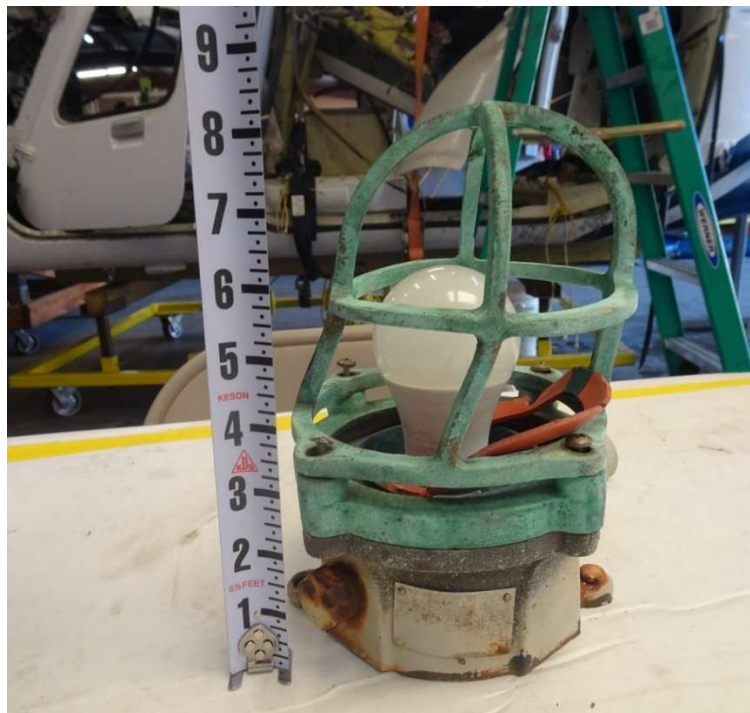
Figure 10. The damaged blue-colored light.

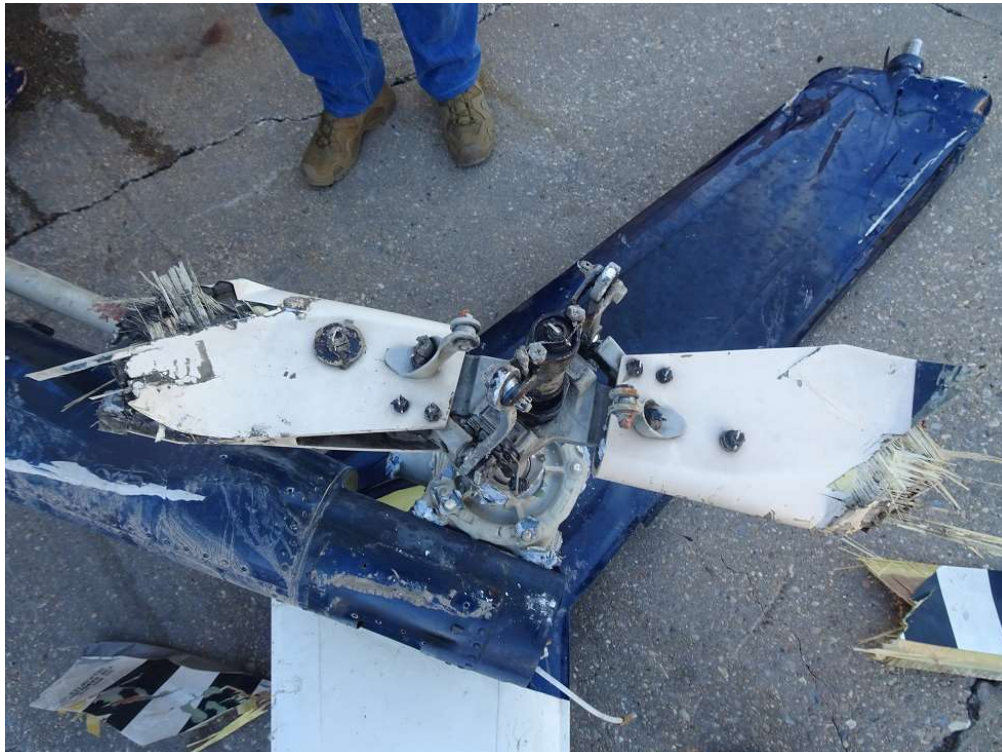
Both tail rotor blades was fractured just outboard of the tail rotor yoke (**Figure 11**). The inboard ends of both tail rotor blades remained retained within the yoke. Both tail rotor blades exhibited fractures of the composite material with a broomstrawed appearance. Fragmented portions of the outboard sections of the tail rotor blades were observed at the helipad.

Figure 11. The tail rotor and pitch change links.

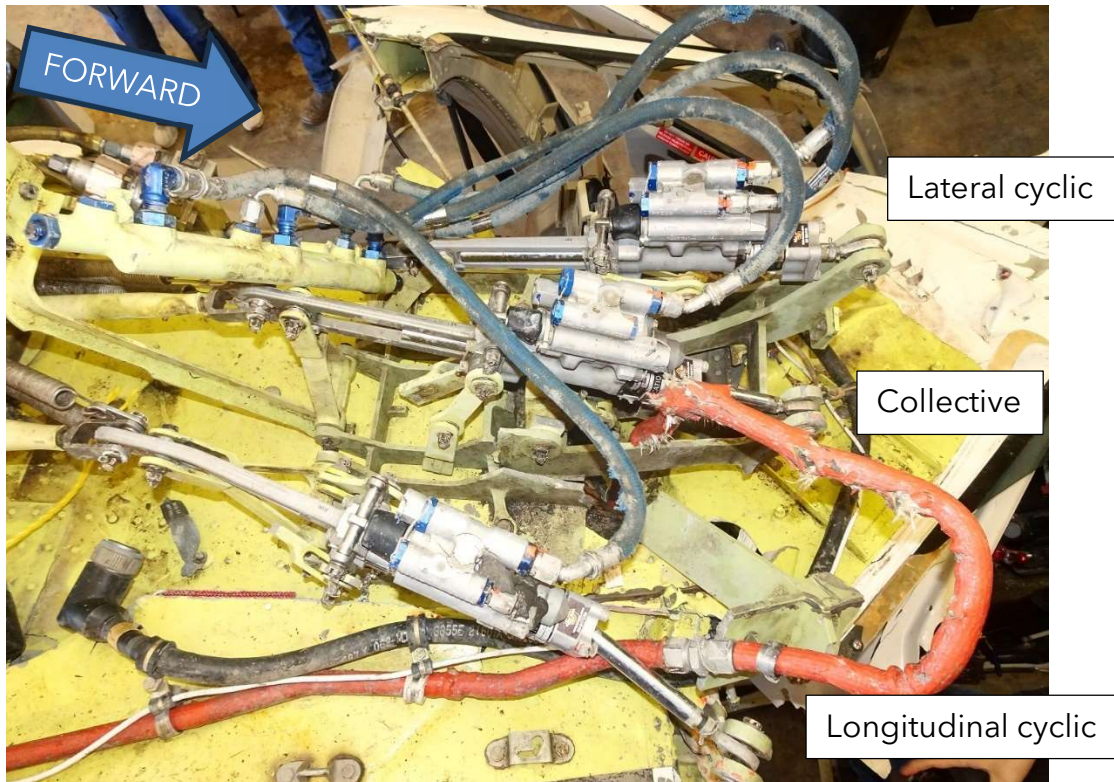
The servo support assembly remained partially installed and exhibited multiple fractures (**Figure 12**). The lateral cyclic and collective servo actuators remained installed. The longitudinal cyclic servo actuator was present near its normally installed location but separated due to fracturing of the servo support structure. The pressure lines to the right cyclic and collective servo actuators were fractured at their respective pressure ports, but all remaining hydraulic lines remained installed on the three servo actuators. The left servo actuator appeared to be fully retracted and the right servo actuator appeared to be fully extended. The collective servo actuator appeared to be mid-extension. The input valve for all three actuators exhibited play when manipulated by hand. Red paint transfer was observed on the forward attachment bellcranks of the collective and right cyclic servo actuators. All observed fractures in the servo support assembly area exhibited signatures consistent with overload.

Figure 12. The servo support assembly and the three main rotor servo actuators.

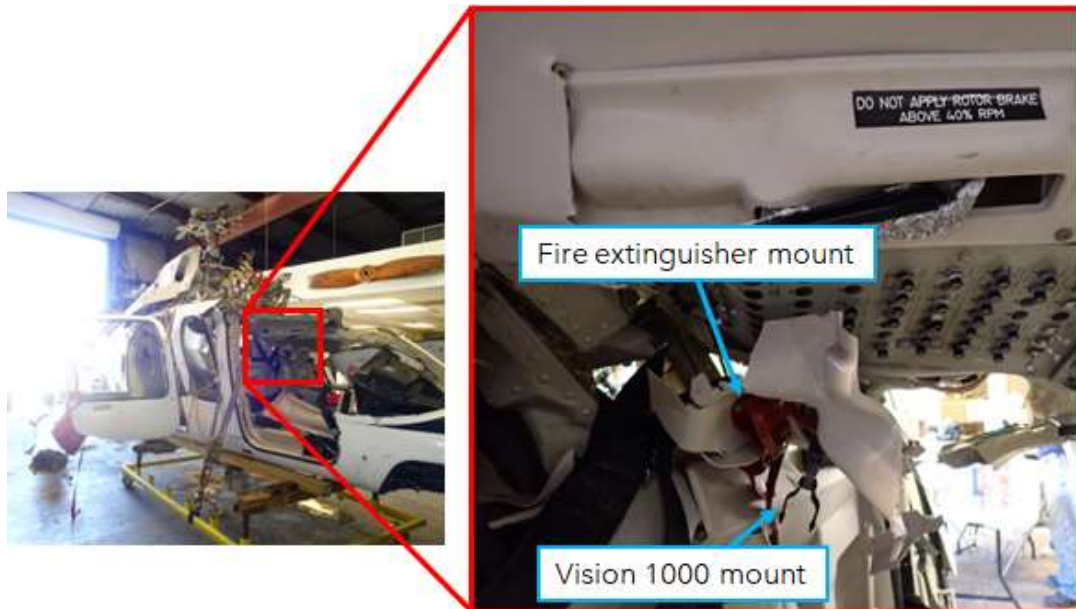
The operator had previously installed an Appareo Vision 1000 cockpit image recorder on the accident helicopter.³ The Vision 1000 was normally installed on the right side of the broom closet structure such that the recorder was behind the [right-seated] pilot's left shoulder (**Figure 14**). On the accident helicopter wreckage, the structure to which the Vision 1000 mounted was partially fractured. The Vision 1000 mount was present, but the image recorder itself was not present on the mount and was not found in the recovered wreckage (**Figure 15**).

Figure 15. The Vision 1000 mount as seen on the accident helicopter.

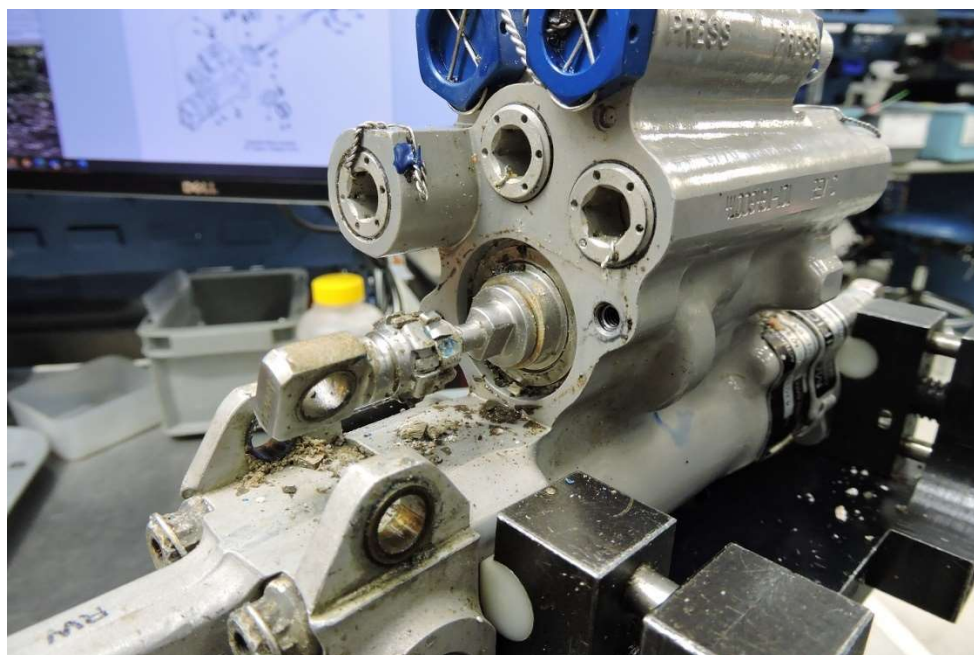
did not exhibit anomalous damage. Silt-like debris was present underneath the rubber boot of the input linkage.

Figure 16. The input lever after removal of its rubber boot.

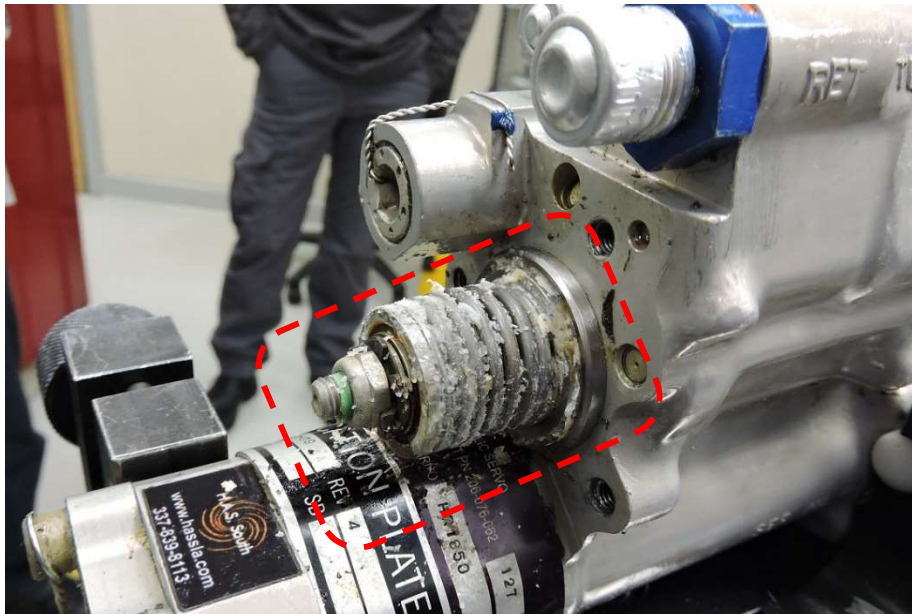
anomalous behaviors except for the bypass valve test. The bypass valve's secondary spool showed normal displacement in the retract direction, but did not show displacement in the extend direction; however, bypass functionality was achieved in both directions. The spring cover was removed, revealing the springs for the spool which contained a white-colored material that had the appearance of salt or aluminum oxide (**Figure 17**).¹⁰

Figure 17. The white-colored material visible after removal of the spring cover.

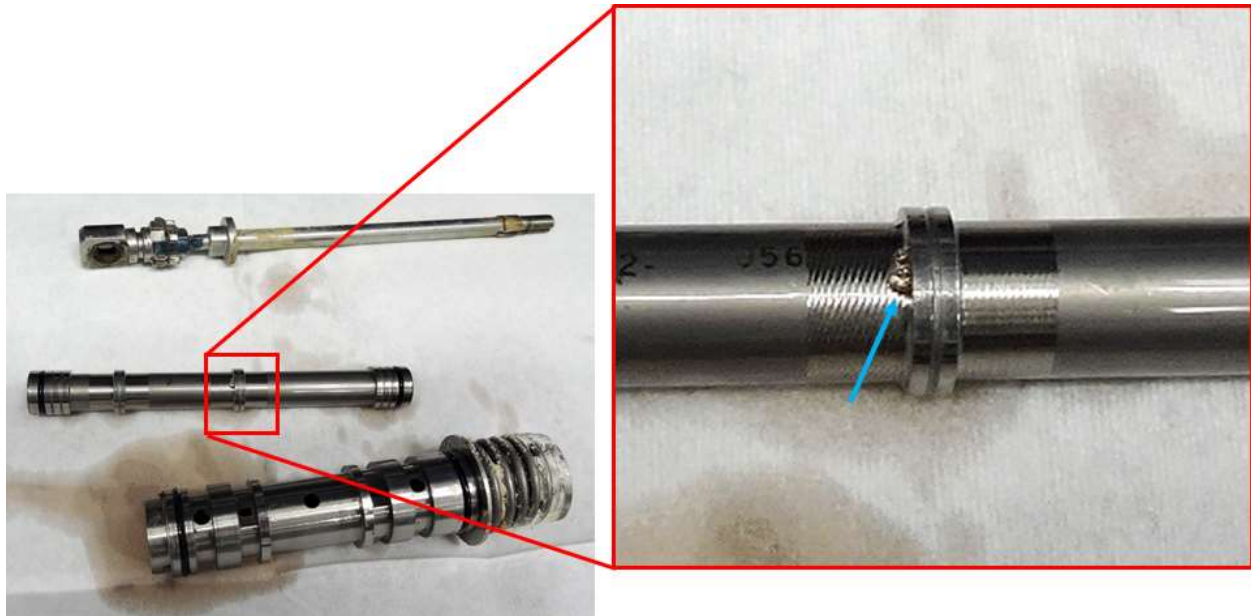
The actuator was removed from the test bench for limited disassembly. The actuator's main control valve assembly was removed to inspect its condition. The spool and sleeve exhibited no anomalous damage. All O-rings and backup rings were intact. Three specks of debris were present near the center land of the spool (**Figure 18**). The debris was clear (no color) and had the appearance of glass under magnification. The clear debris from the spool, the debris collected from filtration during flushing of the actuator, and a hydraulic fluid sample from the actuator were retained for further analysis. Analysis of the hydraulic fluid sample found it to be consistent with MIL-H-5606 hydraulic fluid in addition to high sodium content, likely from saltwater contamination.¹¹

Figure 18. Clear debris (blue arrow) near the center land of the spool from the lateral servo actuator.
