National Transportation Safety Board

WPR23LA003

ENGINE EXAMINATION

Location: Boulder City, Nevada
Date: 10/02/2022
Time: 2000 PDT
0300 UTC
Airplane: Cessna 182C

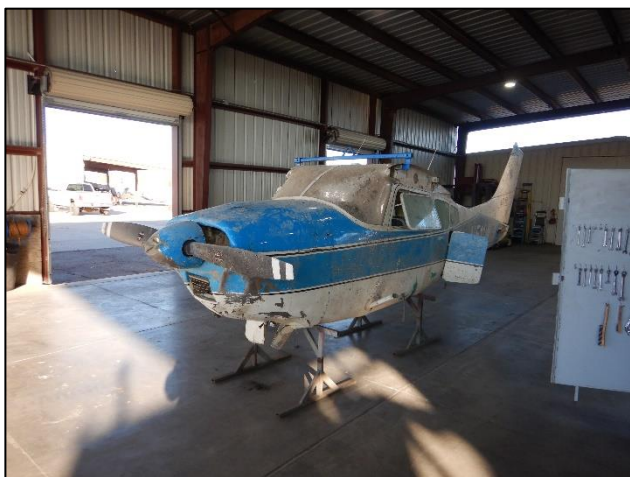
Figure 1-Left view of the wreckage.

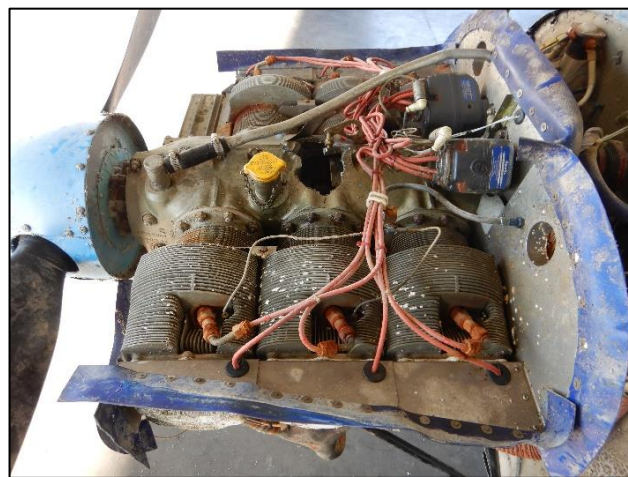
The Continental Motors O-470-L engine, serial number 69446-70-L-R, was secured to the airframe and no damage was noted to the engine mounts or engine mounting carriage. A large hole was located in upper side the crankcase halves between cylinders No. 3 and 4 and was about 3 to 4 inches wide. Water was visible in the crankcase about 3 inches from the top of the crankcase. The crankshaft was visible and the No. 4 connecting rod bearing journal was visible. The induction and exhaust assemblies were undamaged.

Figure 2-Left upper view of the engine.

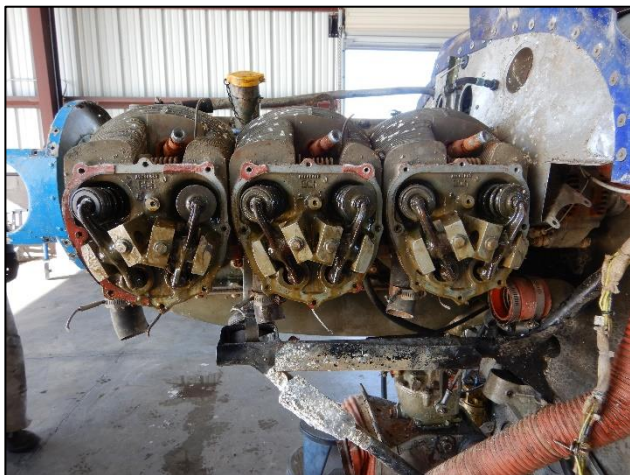
Control continuity between the cabin engine controls and the engine were verified. The engine was removed from the airframe and the propeller was removed from the engine. The cylinder rocker covers were removed, and the cylinder overhead components were undamaged and had a layer of residual oil.

Figure 3-Left cylinders, view of overhead components.

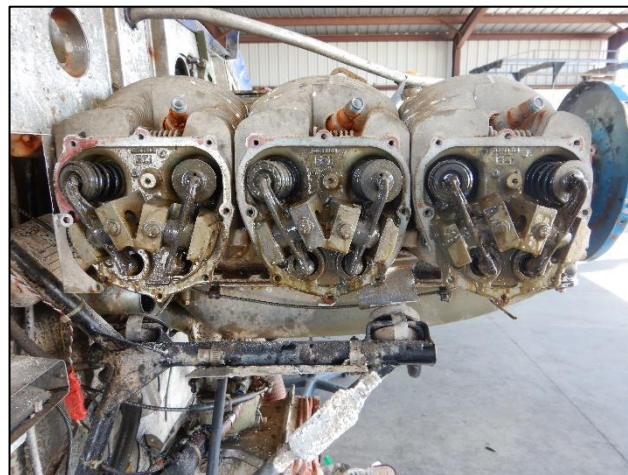
Figure 4-Right cylinders, view of overhead components.

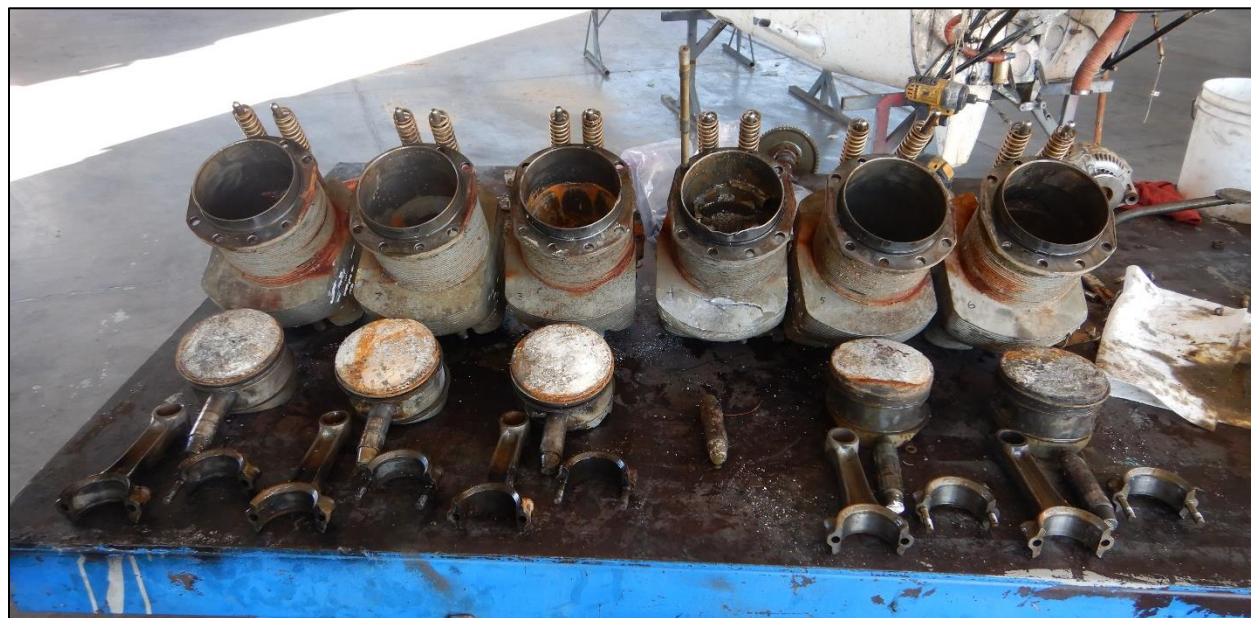
The cylinders were removed, and internal mechanical damage was noted on the skirt areas on No. 3 and 4 cylinders. The No. 4 piston was found in the No. 4 cylinder and had damage to the wrist pin attachment area.

Figure 11-Cylinders, pistons and connecting rods.

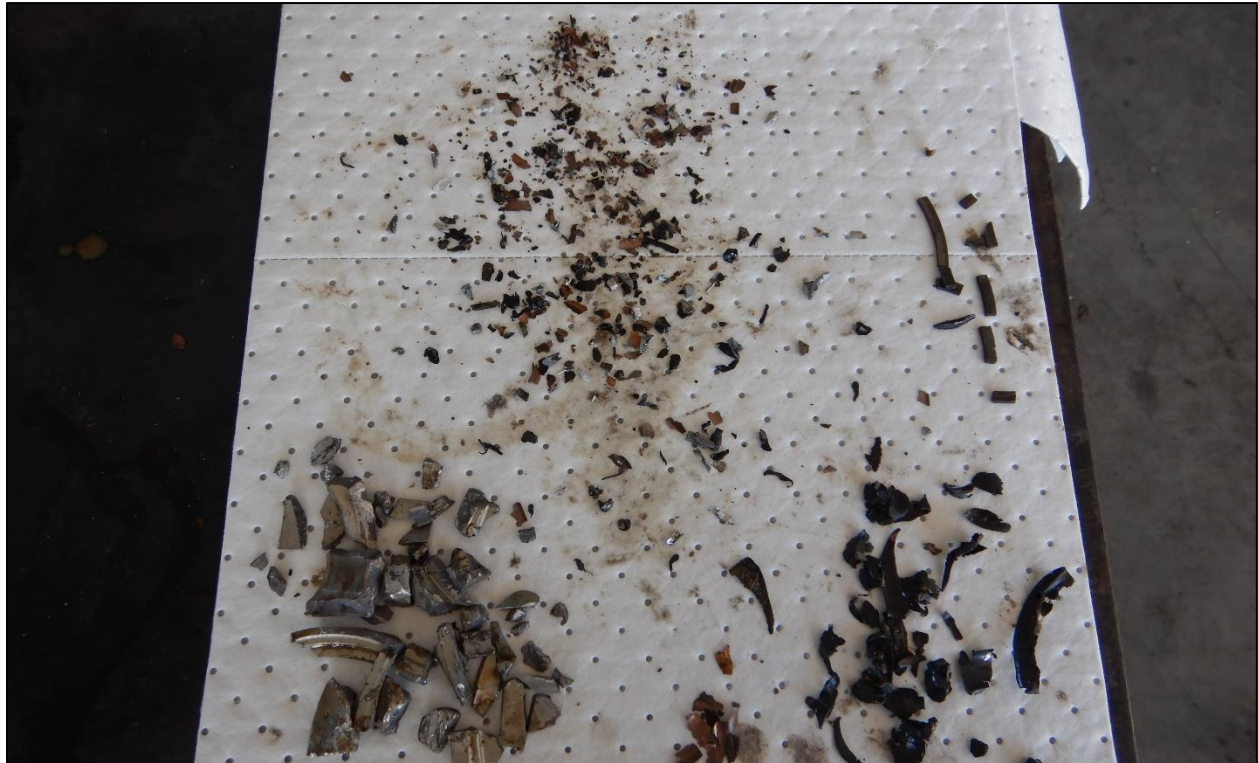
The oil sump was removed and contained residual oil and metallic fragments. The metallic fragments were identified as cylinder and bearing material. Two pieces were identified as the portion of the head side of a connecting rod bolt and a small section of connecting rod bolt nut. No cotter pins were found in the debris.

Figure 7-Oil sump debris

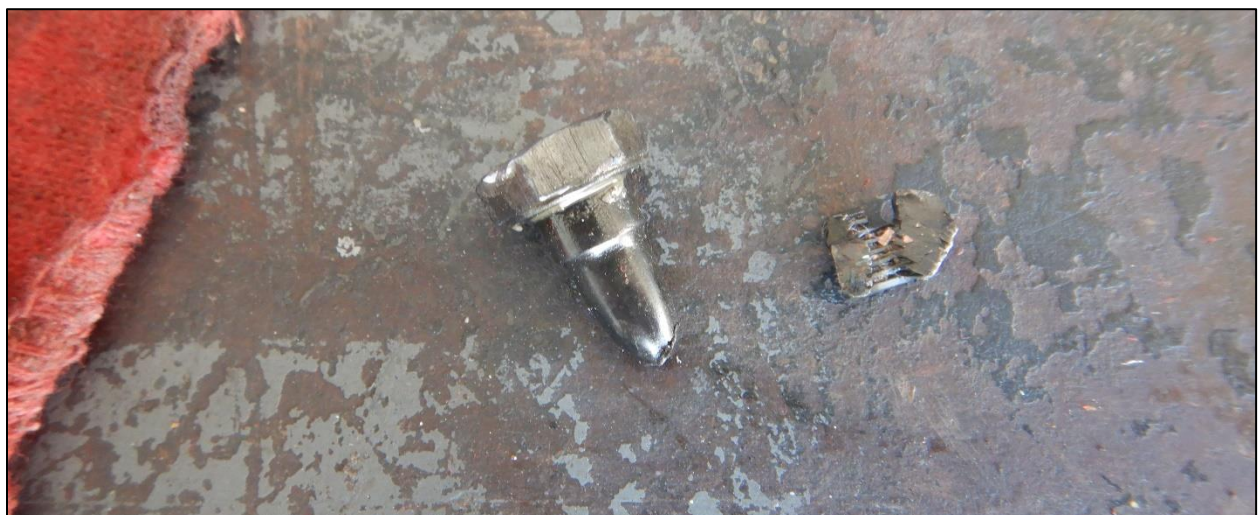
Figure 8-Portions of the connecting rod bolt and nut.

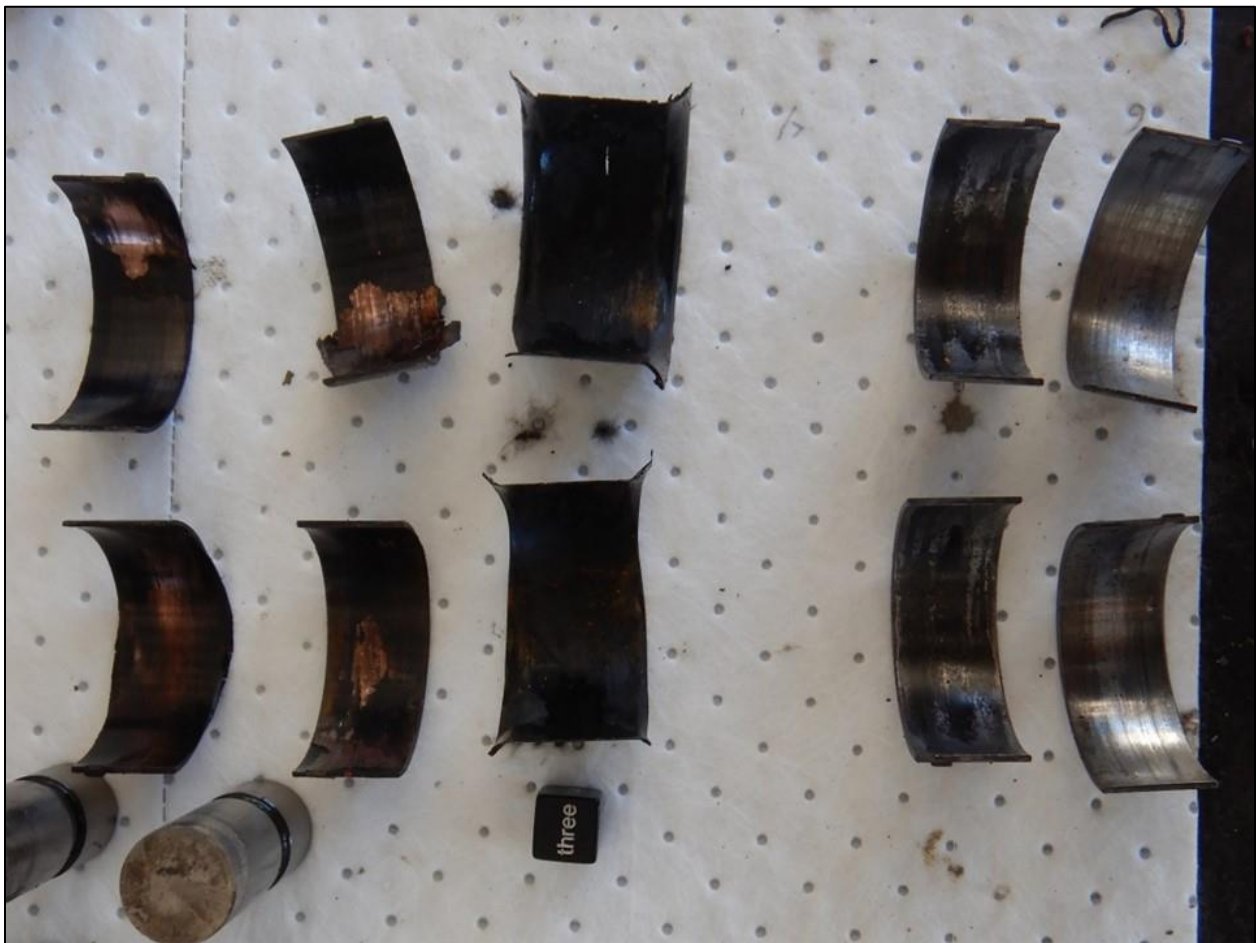
The connecting rods were removed from the crankshaft and the connecting rod bearings were displayed out on an examination table. The No. 1, 2 and 3 connecting rod bearings had thermal discoloration and metal deformation. Fragments of bearing material were found in the oil sump. The No. 5 and 6 connecting rod bearings had thermal discoloration.

Figure 9-Connecting rod bearings.

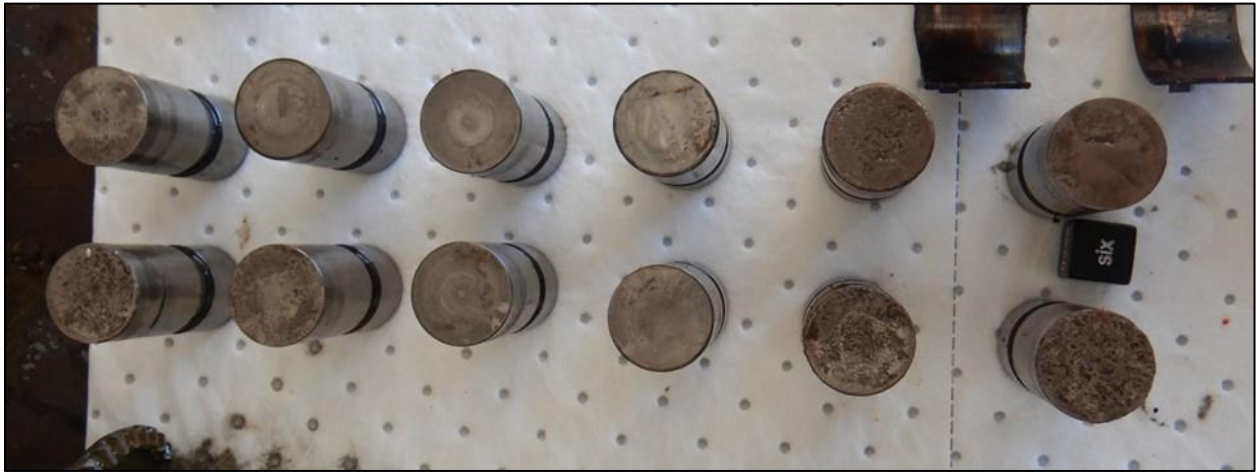
The lifters were removed and several showed pitting on the head surfaces.

Figure 10-Lifters

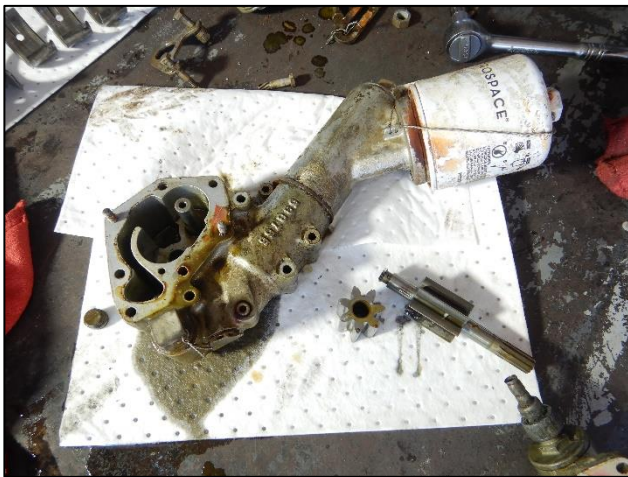
The oil filter and the oil pump were removed as one unit. The oil filter adapter housing spool and the filter element were safety wired securely to the adapter housing. The oil pump housing and oil filter adapter sleeve had a loose fit and could be rotated freely by hand. The fiber gasket between the oil pump and the oil filter adapter sleeve was protruding on the forward upper side. The oil filter adapter housing was disassembled, and the fiber gasket was found damaged. The oil filter adapter housing components were undamaged including the copper crush gasket located on the spool. The oil filter was disassembled and contained small amounts of metal debris.

Figure 11-Oil filter adapter housing and filter.

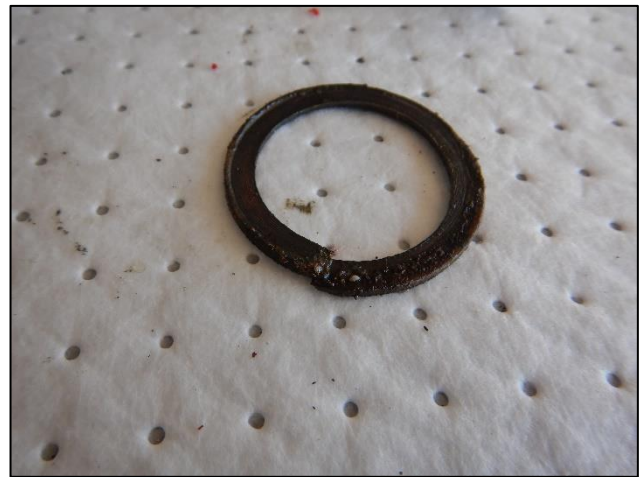
Figure 12-Oil filter adapter housing gasket.
