Preliminary Report RRD23FR017

CSX Transportation Employee Fatality

Walbridge, Ohio

September 17, 2023

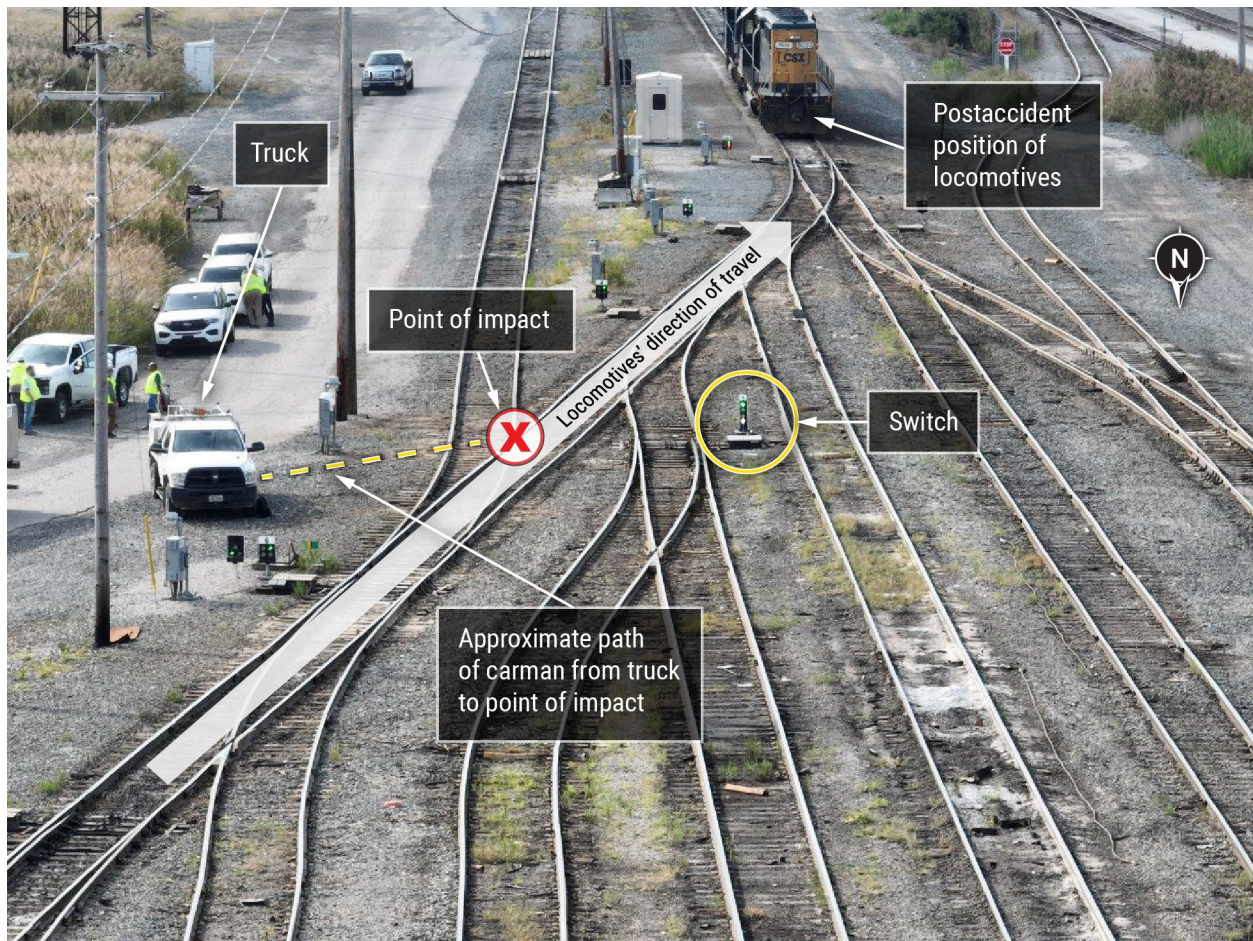
On September 17, 2023, about 3:24 a.m. local time, a member of a CSX Transportation (CSX) mechanical department crew (the accident carman) was struck and killed by a pair of CSX-owned remote control locomotives on the Walbridge Yard lead track in Walbridge, Ohio.¹ At the time of the accident, the accident carman was walking from a parked truck across multiple tracks to line and lock a switch to prepare for railcar inspections.² As he began crossing the lead track to access the switch, he was struck by the locomotives, which were traveling south about 10 mph. (See figure.) Visibility conditions at the time of the accident were dark and clear, but the area was illuminated with overhead lighting. The weather was 63°F with no precipitation.

Figure. Accident scene. (Source: CSX.)

As a result of this accident, CSX issued a safety alert to all employees emphasizing safety briefings, situational awareness, and knowledge of emergency action plans.
