National Transportation Safety Board

RRD23FR011

MECHANICAL

Group Chair's Factual Report

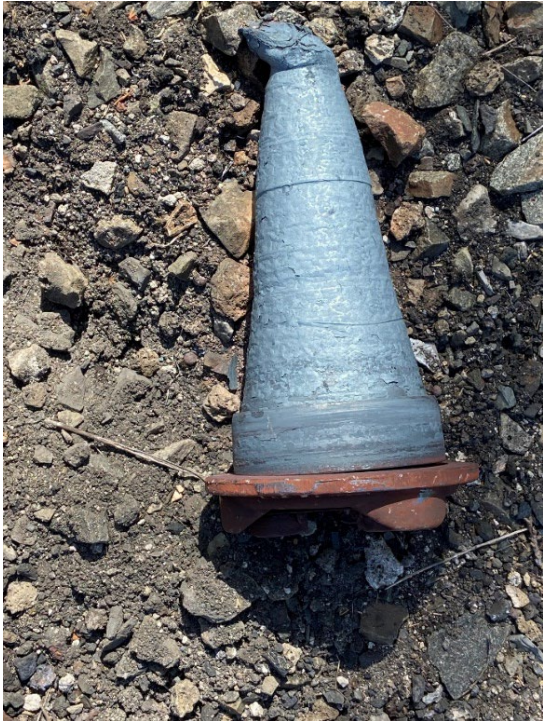
Leading axle 1 of car CRDX 3017 the first car to derail was found underneath the car with the L1 journal burnt off located just approx. 2 ½ car lengths north of the

bridge at YG 74.9. The burnt off journal and bearing segments were located near the POD at YG 76.56 on main 1 track.

Figure 1 - Car CRDX 3017 - L1 Journal bearing.

The L1 bearing journal portion of the axle still had the end cap and locking plate installed, which were removed to expose manufacturer identification numbers on the axle. The reconditioned L1 bearing that failed had extensive thermal damage, and no traces of the polymer seals remained. The steel components within the reconditioned bearing had evidence of melting, portions of components galled and melted together, and extensive rub damage and plastic deformation. The rollers still assembled within the bearing were flattened and fused to the mating components.

The cages for both the inner and outer roller assemblies were comprised of steel. Spalling damage (imperfections on the surface due to cyclical loading resulting

in component fatigue damage) that occurred prior to the accident was observed on some areas of the bearing cup.

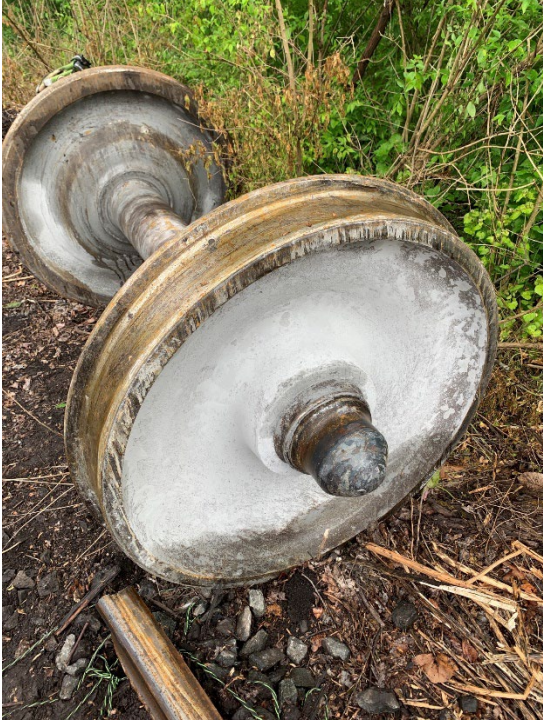
Figure 2 - Car CRDX 3017 - #1 Wheel set showing L1 wheel.

Wheel set 1: L1 burnt off journal, R1 bearing cap missing.
 #1 Wheel set applied 3/23/2008 - 99731 miles
 Reconditioned Brenco bearing dated 03/2008
 PCX-K- A. Stucki Company KY Elizabethtown - Bearing reconditioner (previously Precision Roller Bearing at the time of reconditioning).
 MWSI - Greenbriar Rail Services, Chicago Heights, IL - Bearing mounting shop.
