National Transportation Safety Board

RRD23FR012

IIC FACTUAL REPORT

CSX Transportation Employee Fatality During Switching Operations
June 26, 2023

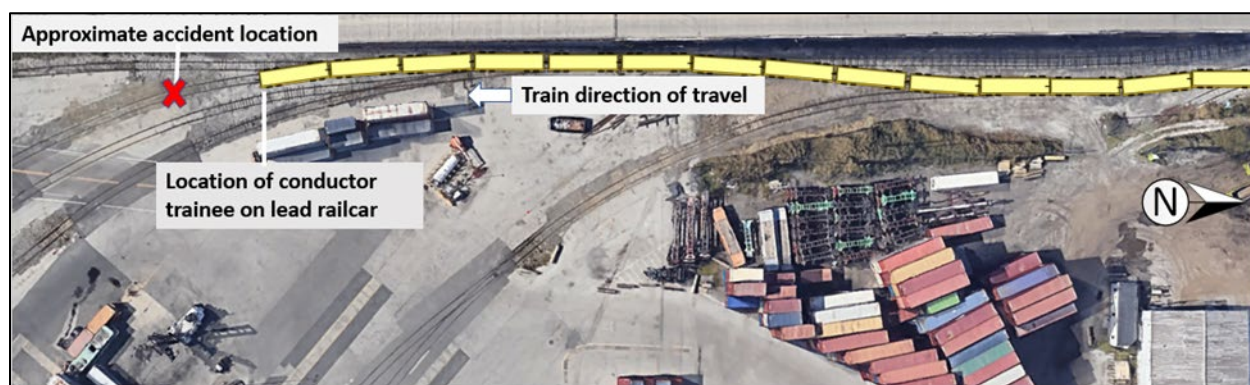
Figure 1. Accident overview illustration.

After the trainee fell into the gauge, the equipment continued to move for another 34 feet as the slack ran out of the train and before the conductor could initiate a train line emergency. During this time, the trainee became pinned at the mid-section of his torso between the eastern leading wheel of the car and the rail, sustaining fatal injuries (figure1).

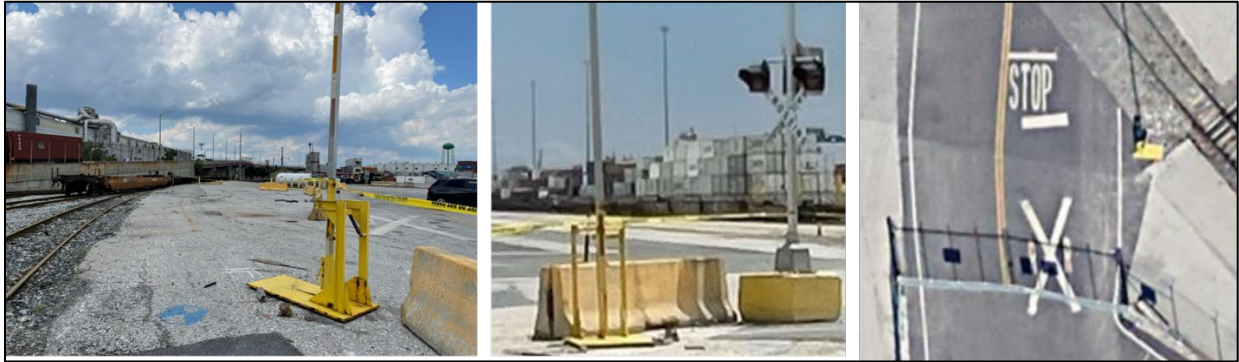
Figure 3. Seagirt vehicle crossing.

On the western most portion of the Penn Mary end, tracks 3, tracks 5 and track 8 have a privately marked crossing for vehicles and equipment to cross (Figure 3). This private crossing was installed by the Ports of America and is equipped with manual gates, standard flashing light signals¹⁵ and railroad crossing signage (Highway-Rail Grade Crossing¹⁶). This crossing is not equipped with any type of train detection circuit and is activated manually by Ports of America employees who activate this crossing when they view train movements approaching the crossing through security camera's mounted on poles overlooking this crossing.

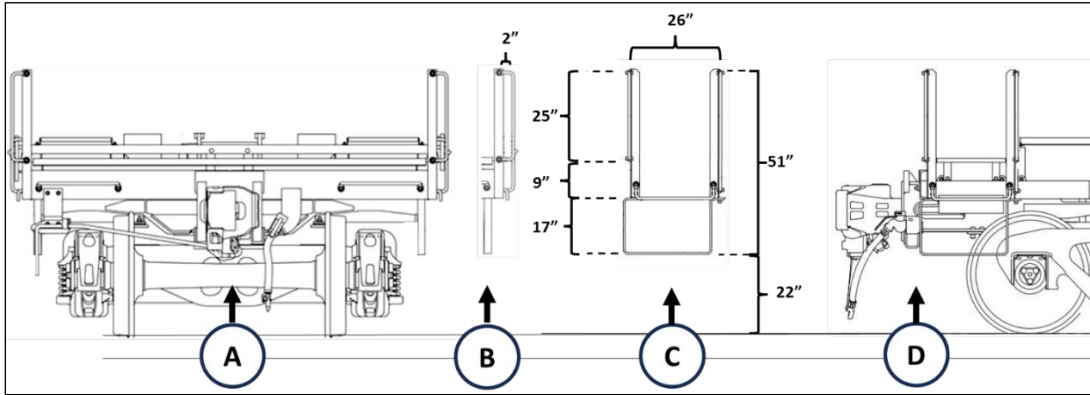
Figure 3. Schematic drawing of the DTTX 475890 intermodal car.

On June 27, 2023, investigators inspected the safety appliances of the accident car (DTTX 475890). Figure 3 with a descriptive table details the measurements of the various safety appliances measured.

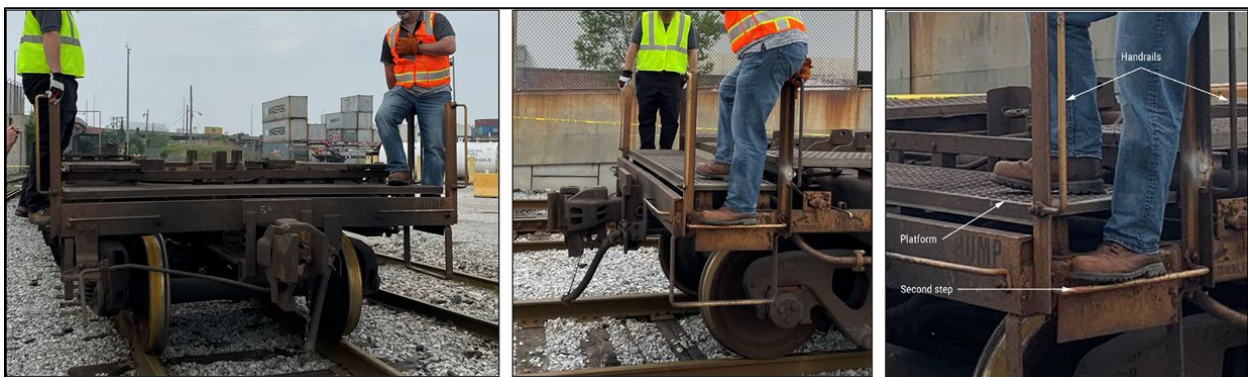
Figure 4. Investigator re-enactment on accident car.

Investigators performed a static reenactment on the accident car utilizing the methods that the conductor and conductor trainee used to ride the car before the fatal accident. The positions utilized by the conductor and trainee were derived from the security camera footage obtained by NTSB investigators.

The purpose of this reenactment was to observe the level of stability on the railcar that the conductor and trainee could have reasonably had in relationship to the location of the fixed safety appliances. The photographs in figure 4 document this reenactment:
