National Transportation Safety Board

RRD23FR001

ONBOARD IMAGE RECORDER

Location: Camden, New Jersey
Date: October 14, 2022
Time: 2121 eastern daylight time (EDT)
Vehicle: PATCO passenger train

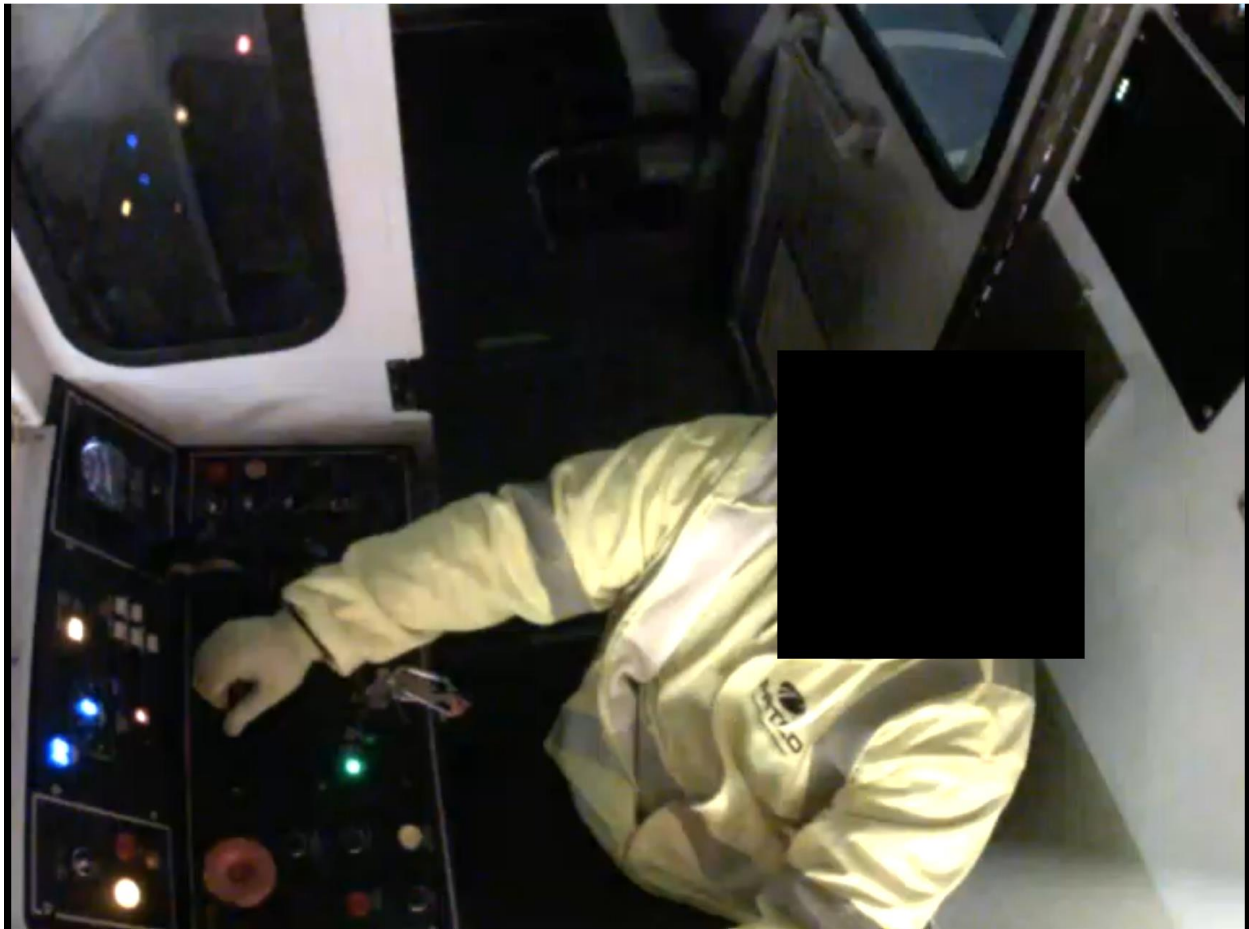
The inward-facing camera was facing the operator from the top left side of the operation cab. The video recording file began with the operator sitting in front of the control panel inside the operation cab. The train was not moving. The operator was

looking to his left and appeared to be checking on the view mirrors. Figure 1 depicts the field-of-view (FoV) of the camera.

Figure 1. A screenshot depicting the FoV of the onboard inward-facing video file.
