# National Transportation Safety Board

ERA24FA058

## **AUTOMATIC DEPENDENT SURVEILLANCE- BROADCAST (ADS-B) STUDY**

Location: Pulaski, Tennessee  
Date: December 7, 2023  
Time: 1103 central standard time (CST)  
Airplane: Beech 35-C33, N5891J

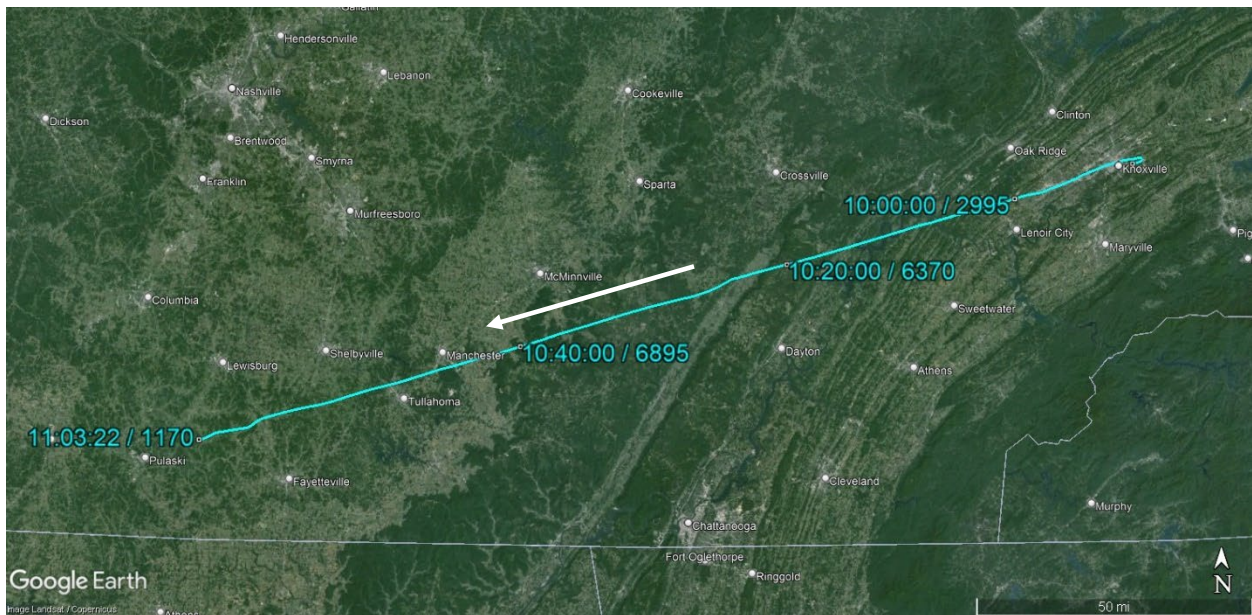
The airplane took off from Knoxville Downtown Island Airport (DKX) at 09:48 with the intention of flying to Benton, Arkansas. The airplane climbed and turned onto a southwesterly heading that remained relatively steady throughout the flight (Figure 2). However, altitude and speed showed considerable variation (Figure 3). During the climb to 6,500 ft, the airplane's groundspeed<sup>1</sup> dropped to 80 kts before accelerating to 130 kts once reaching altitude. The airplane maintained 6,500 ft and a groundspeed just below 130 kts for about 10 minutes. After 10:20, the airplane began a series of descents towards 6,000 ft while gaining speed before again climbing back to 6,500 ft while slowing.

**Figure 2.** Flight path with selected times and altitudes marked.

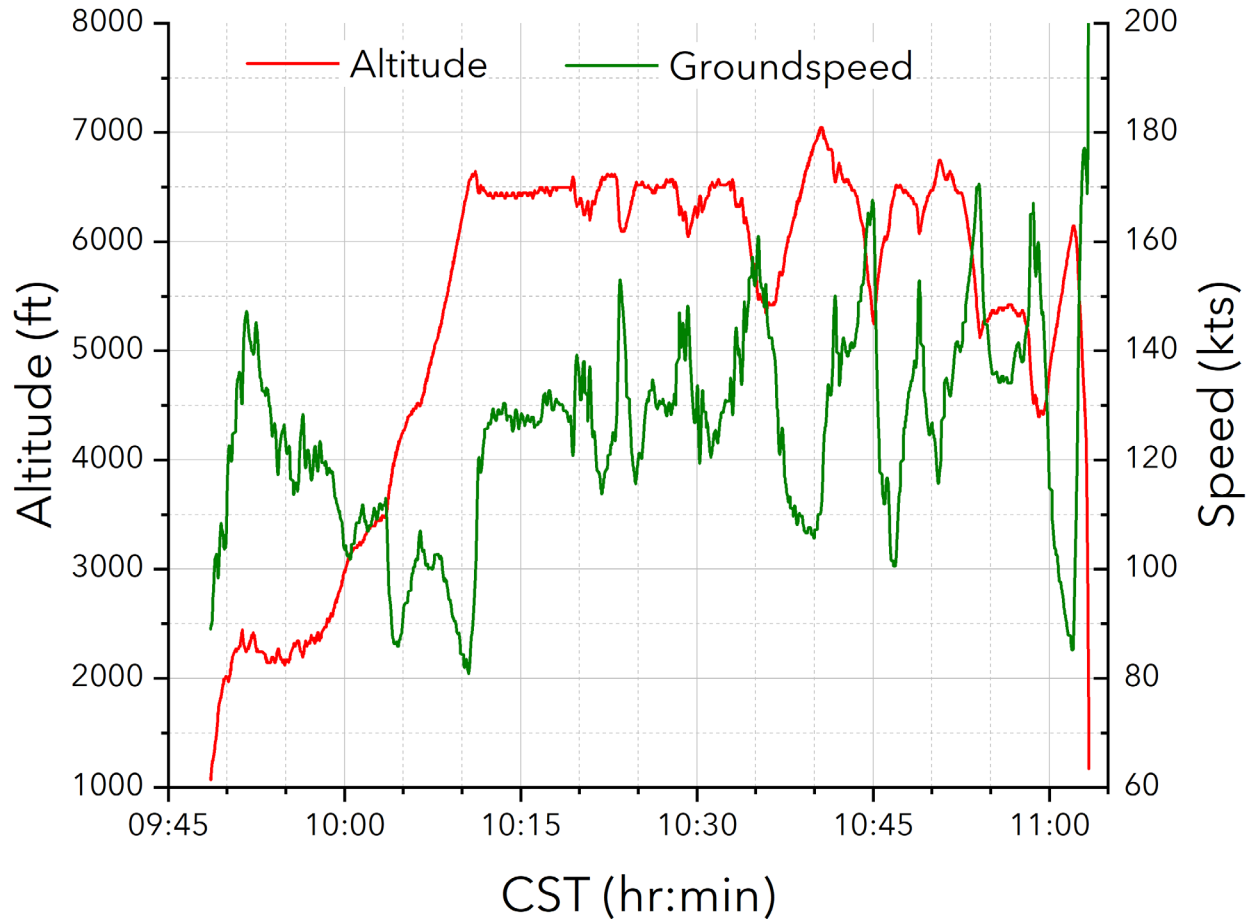
**Figure 3.** Altitude from ADS-B and calculated groundspeed for whole flight.

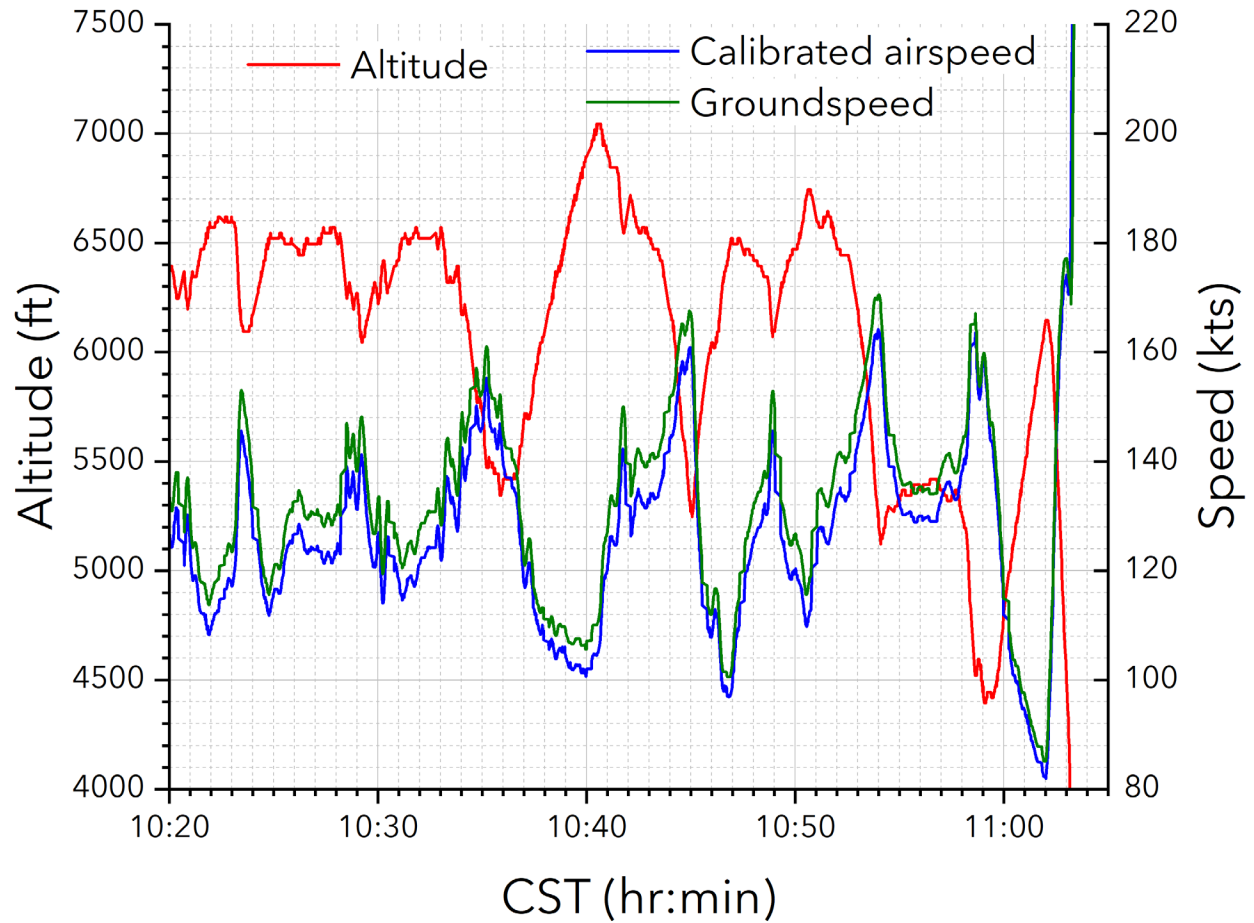
After 10:33 the altitude and speed fluctuations became larger in magnitude and the airplane no longer maintained a steady altitude for any significant amount of time. Accounting for winds aloft and the weather conditions at the time of the accident, the calibrated airspeed was about 5 kts lower than the groundspeed (Figure 4). The airplane descended while gaining airspeed and climbed while slowing. Airspeed fluctuated between 100 and 160 kts while gaining and losing 1,000 to 1,500 ft of altitude.

**Figure 4.** Altitude from ADS-B and calculated airspeed and groundspeed for final 40 minutes of flight.

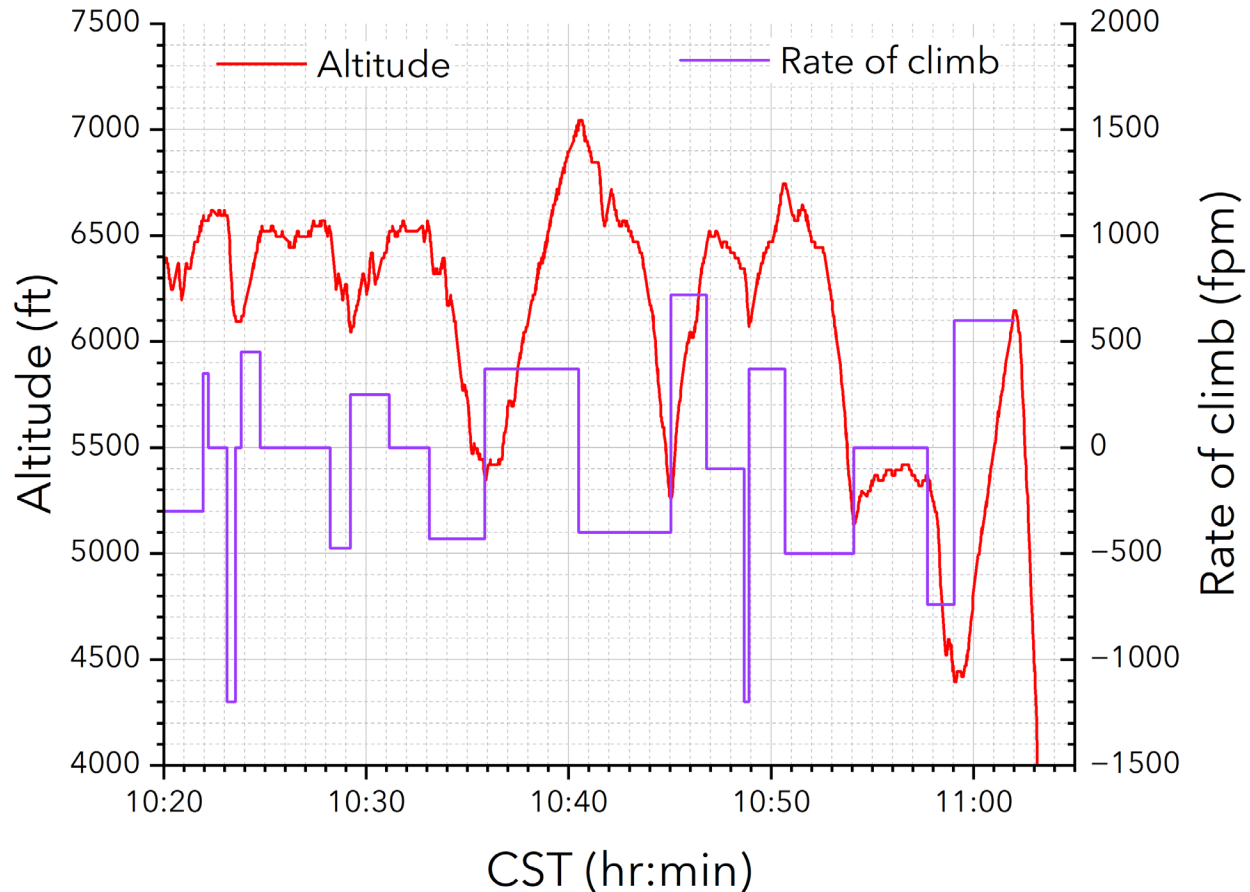
The rate of climb varied between -1,200 ft/min in the descents to near 500 ft/min during the climbs (Figure 5). Smaller variations in altitude during the climbs and descents were not considered in the rate of climb calculations.

**Figure 5.** Altitude from ADS-B and averaged rate of climb for final 40 minutes of flight.

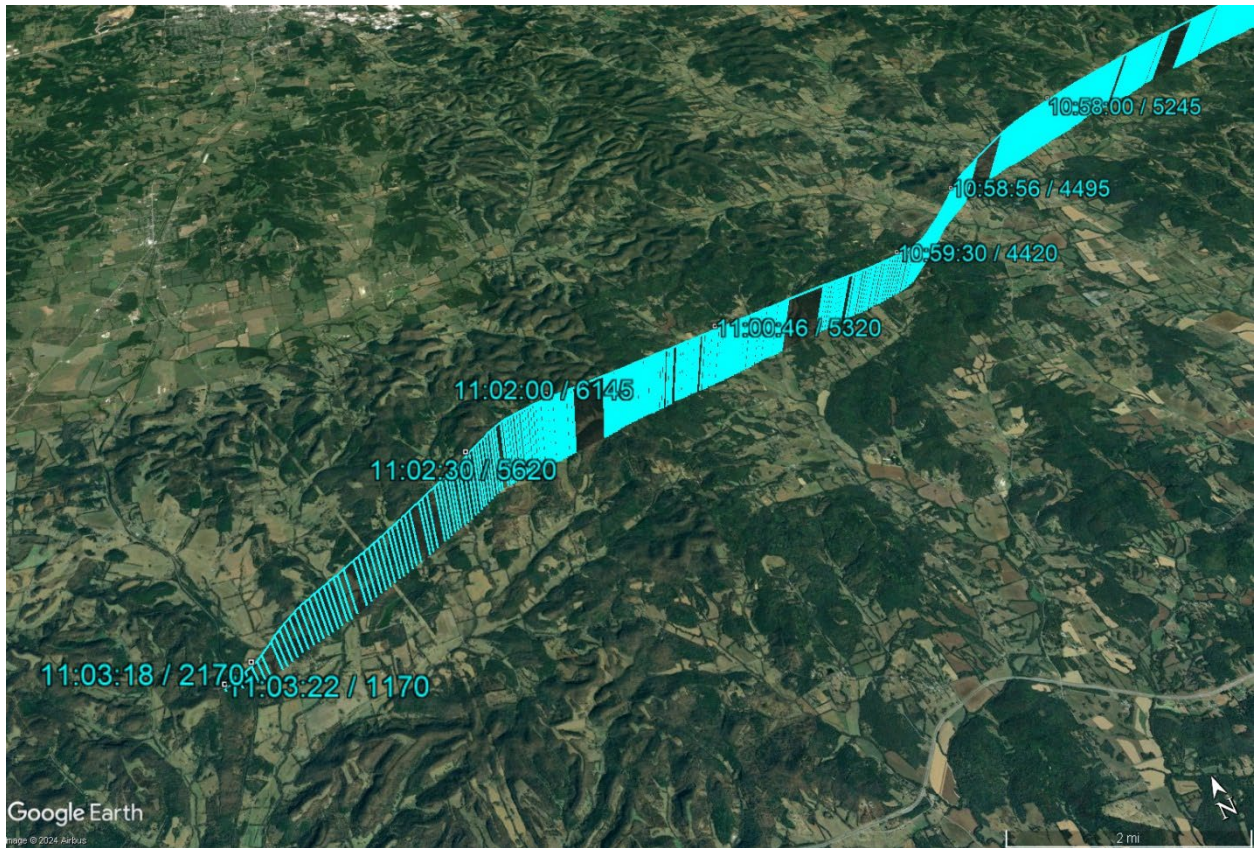
Just after 10:58, the airplane's track deviated to the left (Figure 6 and Figure 7). Air traffic control contacted the airplane to correct its heading and the airplane began to correct its course. After 10:59 it slowed from 160 kts to 140 kts while remaining level at about 4,500 ft before beginning a climb to above 6,000 ft. During the climb the airplane continued to slow. The controller twice contacted the airplane to switch to Memphis center control, but no response was received.

**Figure 6.** ADS-B flight path with selected times and corrected altitudes shown.

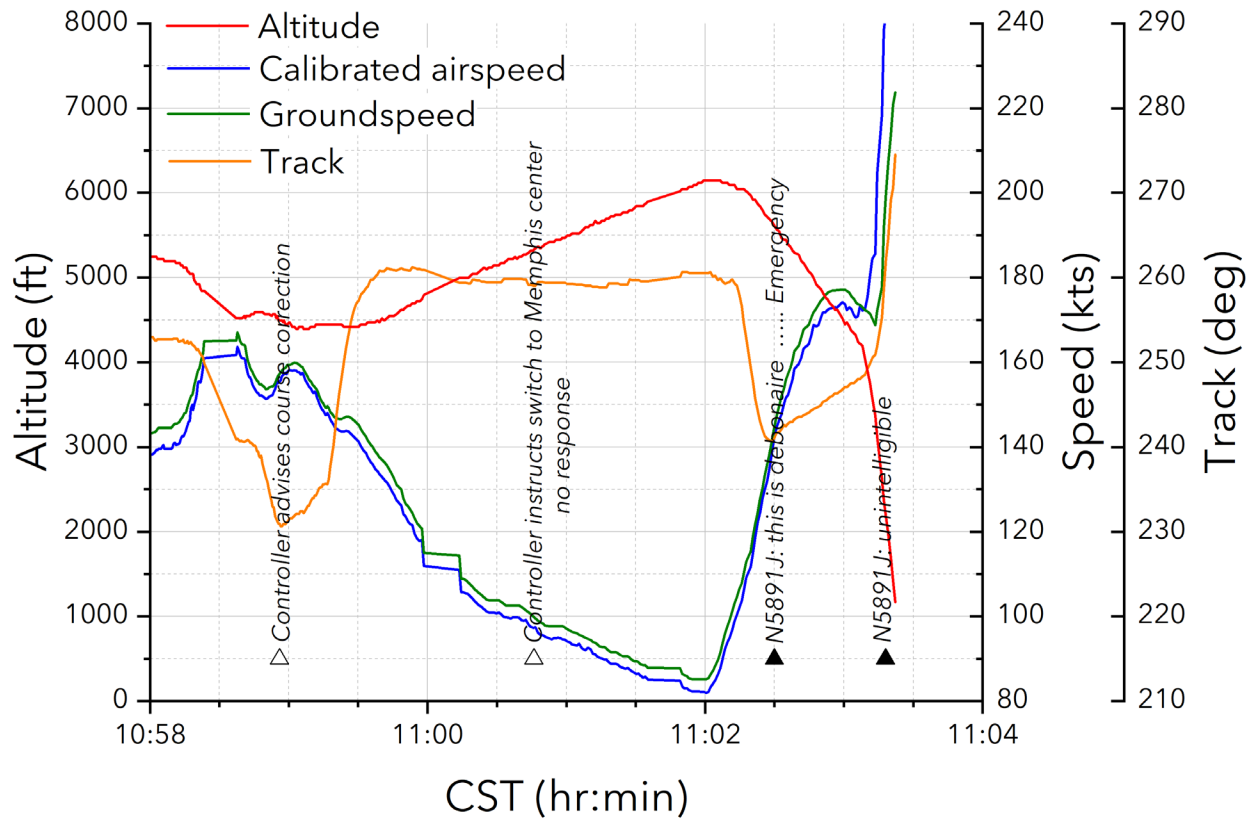
At 11:02, while at an airspeed of 82 kts, the airplane reached its final maximum altitude of 6,100 ft which it maintained for eight seconds. 82 kts was above any wings level stall speed for the airplane [1]. The airplane began to accelerate while on a straight course. At 11:02:08 the airplane began to descend while continuing to gain airspeed and then began a left turn.

At 11:02:30, ATC recorded a faint background transmission of "...this is debonaire .... emergency". The call coincided with the airplane turning back to the right. The airplane's descent rate was over 2,000 ft/min and the airspeed increased to over 170 kts until 11:03:08.

**Figure 7.** Altitude and track from ADS-B with calculated airspeed and groundspeed and selected ATC communications for end of flight.

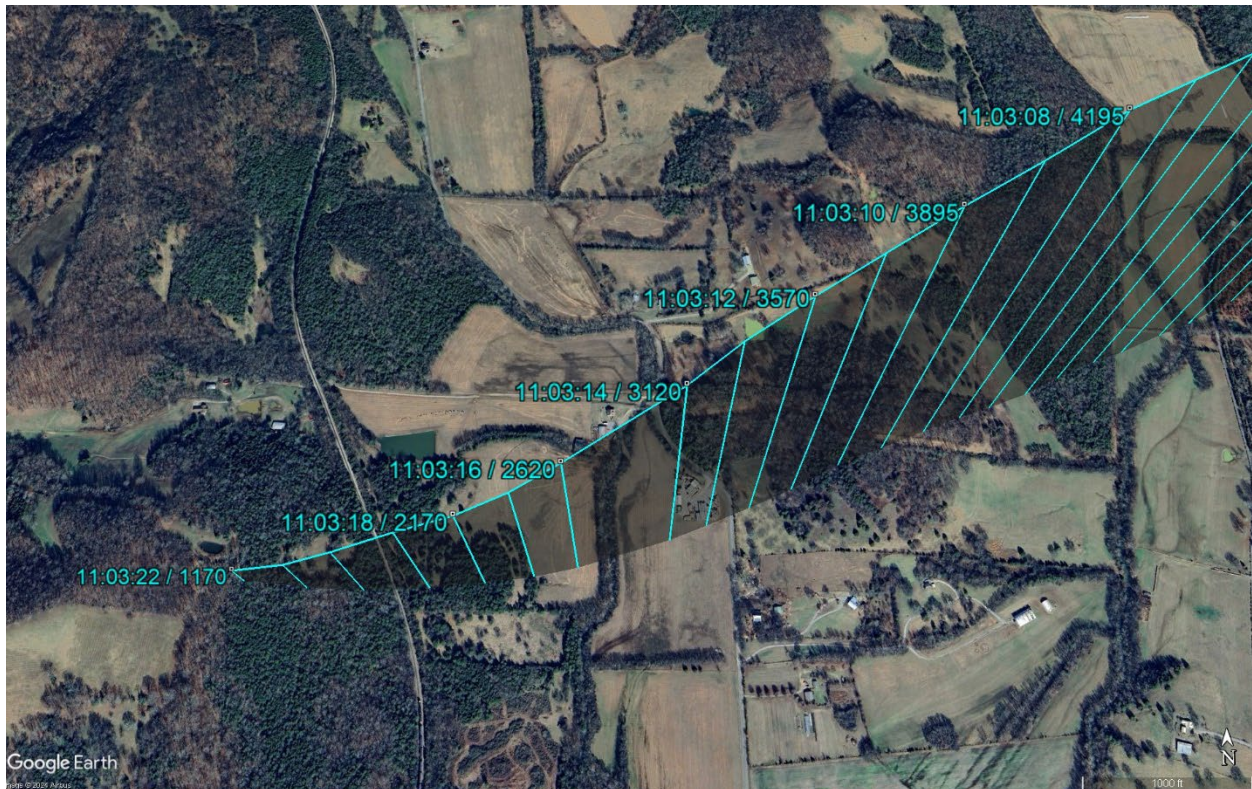
After 11:03:08, the descent rate increased to over 10,000 ft/min and the airplane turned slightly to the right (Figure 8). During the final descent an unintelligible call was made from the airplane. The final ADS-B transmission was about 200 ft above ground level and the airplane's groundspeed was over 220 kts and descent rate over 10,000 ft/min. The wreckage was consistent with the airplane impacting the ground at a high rate of speed.

**Figure 8.** End of ADS-B flight path with selected times and corrected altitudes shown.
